Service Bulletin Number: 4383753

Cylinder Liner Counterbore Ledge Reuse Guidelines

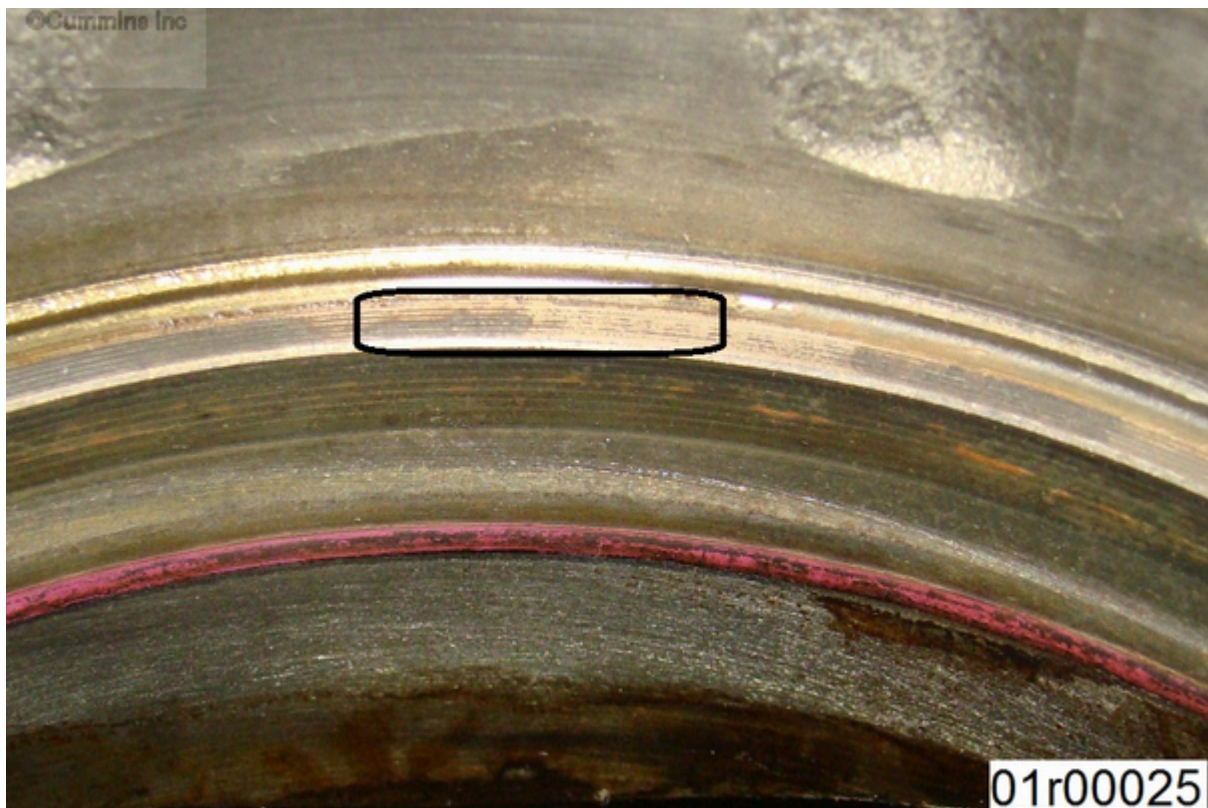
#### Cylinder Liner Counterbore Ledge Surface – Partial Surface Wear Present

| Appearance: | Some grooved machining marks are visible. The counterbore ledge shows signs of intermittent wear across the machined surface area. This is visible as varying depths of the grooved machining marks. |
| Cause: | Wear and/or fretting caused by cylinder liner movement. |

| Action: | Machine the cylinder liner counterbore ledge. Use the following procedure in the corresponding Service manual from the table above. See Procedure 001-058 in Section 1. |
