### General Information

The following procedure contains troubleshooting steps and information regarding the aftertreatment system.

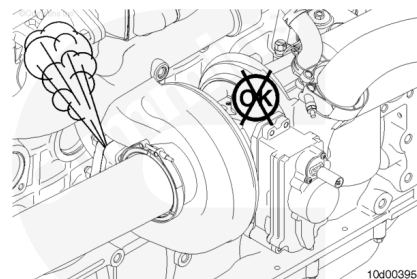
Leaks in the exhaust system can cause exhaust odor or white smoke.

Inspect the exhaust piping for leaks, cracks, and loose connections. Refer to Procedure 010-024 in Section 10.  
(</qs3/pubsys2/xml/en/procedures/10/10-010-024-tr.html>)

Tighten the exhaust clamps, if necessary. Refer to the OEM specifications and the correct torque value.

It may be necessary to perform a stationary (parked) regeneration to locate exhaust leaks. Refer to Procedure 014-013 in Section 14.

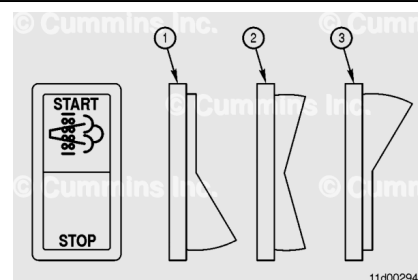
If the vehicle is operated for an extended period of time with the permit switch OFF, fault codes for the above normal levels of aftertreatment diesel particulate filter soot load may result

(Fault Codes 1921, 1922, and 2639).

If the aftertreatment diesel particulate filter soot load reaches the moderately severe level (Fault Code 2639), and the permit switch is OFF, the ECM will also log a Fault Code 2777.

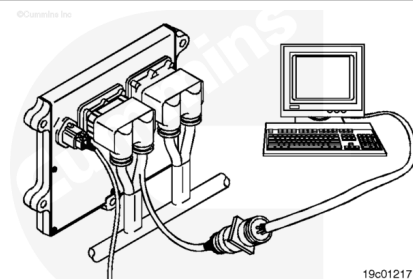
If the aftertreatment exhaust gas temperature sensors are **not** connected properly, or if the wiring in the harness between the engine and aftertreatment is **not** correct, the engine may experience frequent DPF lamp illuminations, or stationary (parked) regenerations that do **not** complete.

Inspect the exhaust aftertreatment temperature sensor connectors to verify they are connected to the correct connector on the aftertreatment system wiring harness. Two of the temperature sensors have identical wiring harness connectors. Because the sensors are the same part number, it is possible to install the wiring harness connectors to the wrong sensor.

To verify the correct sensor locations, use INSITE™ electronic service tool to monitor the following parameters with the ignition key ON, but with the engine **not** running.

Unplug each of the aftertreatment exhaust gas temperature sensors, one at a time.

If the voltage changes when the sensor is unplugged, the wiring harness connector is connected to the correct sensor.

If the voltage does **not** change when the sensor is unplugged, switch the connector location to the other temperature sensor, unplug it, and check for a voltage change.

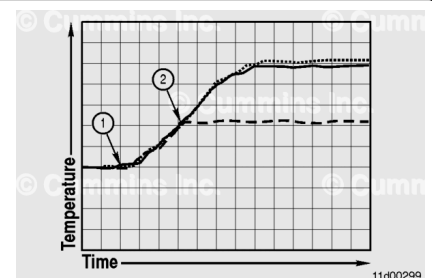
A normal stationary (parked) regeneration will follow the pattern shown.

- The dashed line is for the aftertreatment diesel oxidation catalyst inlet temperature sensor.

- The dotted line is for the aftertreatment diesel particulate filter inlet temperature sensor.
- The solid line is for the aftertreatment diesel particulate filter outlet temperature sensor.

When the stationary (parked) regeneration begins (1), all three temperatures should be approximately the same, and should increase at the same rate.

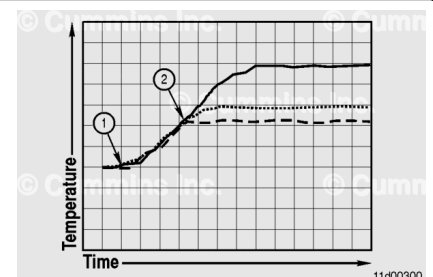
This graph illustrates a stationary (parked) regeneration where the inlet of the aftertreatment diesel oxidation catalyst is blocked.

Raising the aftertreatment temperature to the aftertreatment injection temperature may take longer to complete than normal if the inlet to the aftertreatment diesel oxidation

catalyst is plugged, restricting some of the exhaust flow.

Once aftertreatment injection begins (2), the aftertreatment diesel particulate filter inlet and outlet temperatures will differ greatly due to the plugged aftertreatment diesel oxidation catalyst being unable to oxidize the injected fuel. The aftertreatment diesel particulate filter has some capability to oxidize the injected fuel, but can **not** maintain this condition without damaging the filter material over time. It is possible that white smoke would be present from the vehicle tailpipe during this condition.

The possible cause of this condition is a plugged aftertreatment diesel oxidation catalyst. Refer to Procedure 011-049 (Aftertreatment Diesel Oxidation Catalyst) in Section 11 to inspect the aftertreatment diesel oxidation catalyst. (</qs3/pubsys2/xml/en/procedures/101/101-011-049-tr.html>)

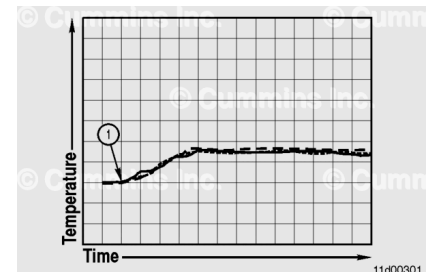
This graph illustrates a stationary (parked) regeneration where the engine can **not** build enough heat to start aftertreatment injection.

The engine speed will likely increase to the stationary (parked) regeneration speed of 1000 to 1400 rpm, but because the aftertreatment temperatures do **not** increase enough to start aftertreatment injection, the stationary (parked) regeneration will **not** complete.

Possible causes of this issue include:

- High resistance in the exhaust gas temperature sensor return circuit. Use the following procedure in the ISX CM871 and ISM CM876 Electronic Control System Troubleshooting and Repair Manual, Bulletin 4021560. Refer to Procedure 019-360 in Section 19. (</qs3/pubsys2/xml/en/procedures/99/99-019-360.html>)

- A malfunctioning turbocharger. Use the following procedure to verify the turbocharger sector gear has full travel. Refer to Procedure 010-134 in Section 10. (</qs3/pubsys2/xml/en/procedures/10/10-010-134.html>)
- Low ambient temperatures. Move the vehicle to a location with higher ambient temperatures.

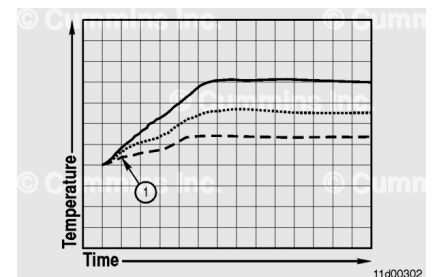
This graph illustrates a stationary (parked) regeneration where the wiring to the aftertreatment temperature sensors is incorrect.

In this condition, the engine speed will increase to the stationary (parked) regeneration speed of 1000 to 1400 rpm.

Aftertreatment injection will **not** occur in this condition because the aftertreatment diesel oxidation catalyst inlet temperature does **not** reach the required temperature. Because aftertreatment injection is **not** occurring, the aftertreatment temperatures should **not** read differently.

The possible cause of this condition is an incorrectly assembled aftertreatment wiring harness. See the aftertreatment exhaust gas temperature sensor wiring section of this procedure.

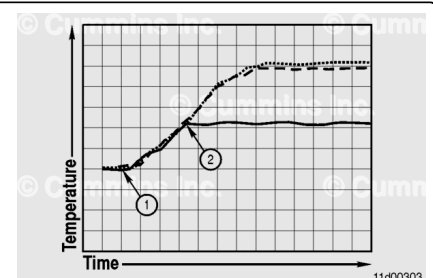
This graph illustrates a stationary (parked) regeneration where the connectors to the aftertreatment diesel oxidation catalyst inlet temperature sensor and the aftertreatment diesel particulate filter outlet temperature sensor are reversed.

In this condition, the engine speed will increase to the stationary regeneration speed of 1000 to 1400 rpm.

Aftertreatment injection may occur in this condition (2). However, the aftertreatment diesel oxidation catalyst inlet temperature increases after aftertreatment injection begins, while the aftertreatment diesel particulate filter outlet temperature remains constant.

The possible cause of this condition is that the connectors to the aftertreatment diesel oxidation catalyst inlet temperature sensor and the aftertreatment diesel particulate filter outlet temperature sensor are reversed. See the aftertreatment exhaust gas temperature sensor wiring section of this procedure.
