## Fault Code: 237

### Multiple-Unit Synchronization

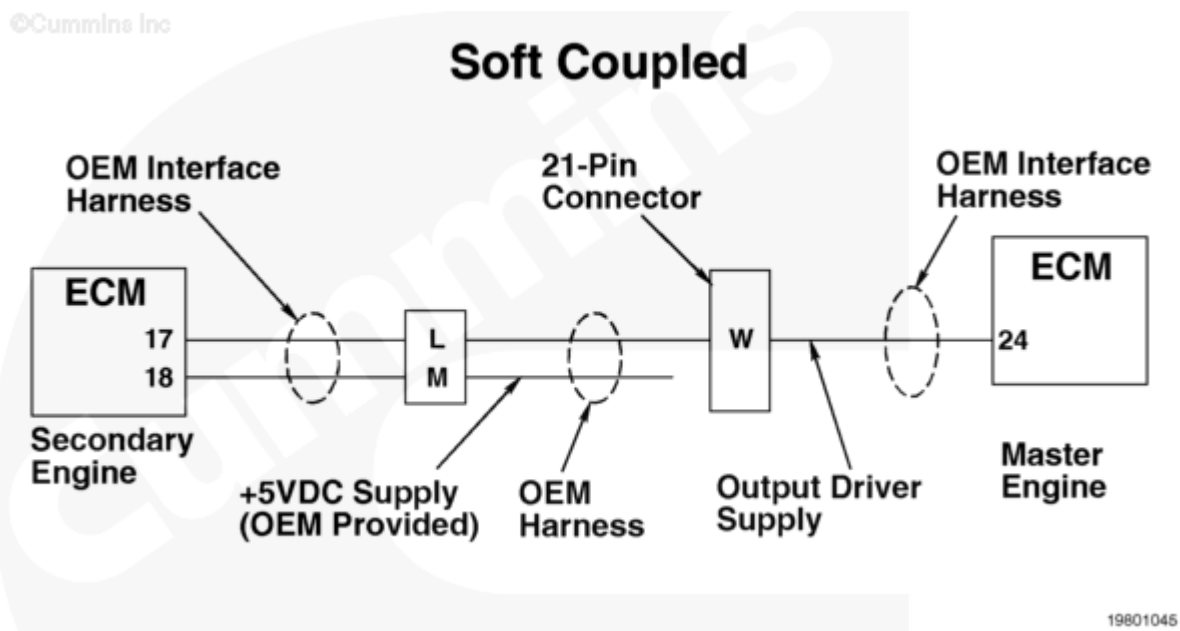
Multiple-Unit Synchronization Circuits: Soft-Coupled, Hard-Coupled, and Soft-Coupled Marine

The primary engine outputs a throttle duty cycle signal on pin 24. This signal is received by the secondary engine(s) and is used as the throttle input. To complete this circuit, a +5-VDC supply is provided by the OEM and connected to pin 18 of the secondary engine.

The secondary engine expects to see a duty cycle signal that varies between 3 and 97 percent. A signal less than 3 percent or greater than 97 percent will generate Fault Code 237 in the secondary engine.

Refer to Troubleshooting Fault Code t05-237 (</qs3/pubsys2/xml/en/procedures/19/19-t05-237.html>)
