# Fault Code: 468

## Rail Current Offset Error

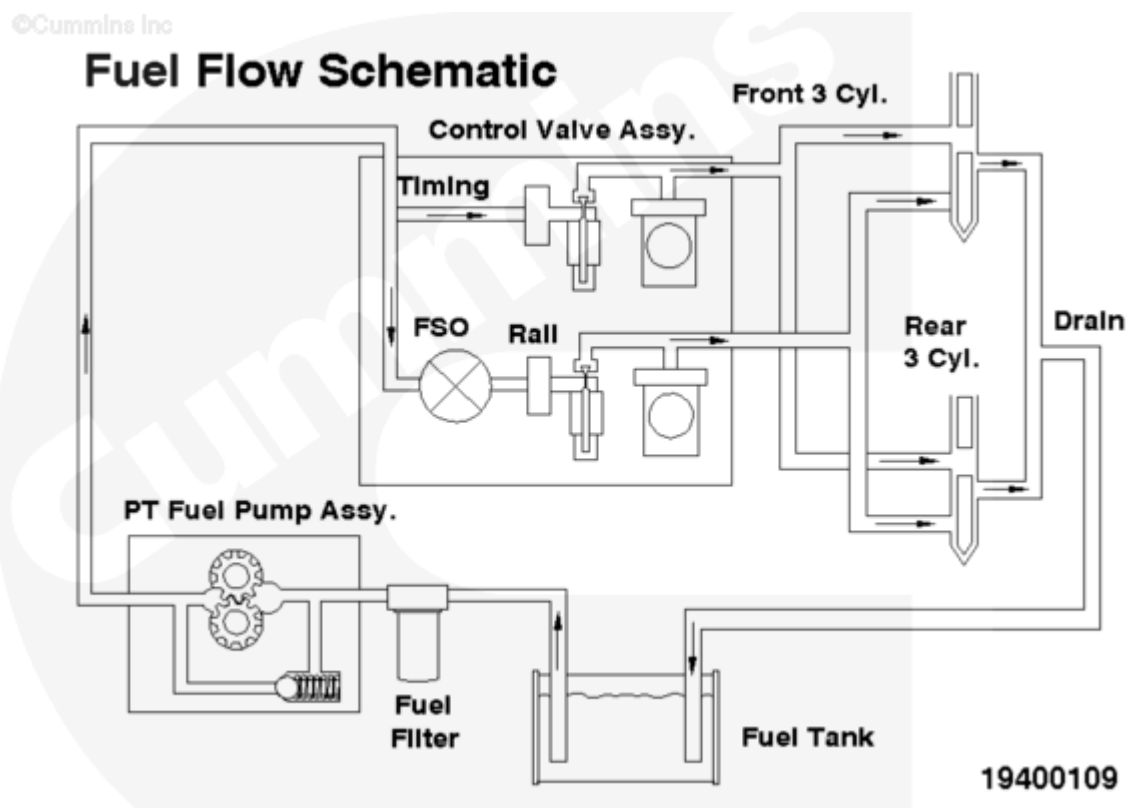
Fuel System Flow Schematic

The ECM uses the rail pressure signal and the engine speed to estimate the actual fueling that the engine is receiving and then constantly compares this value to the desired fueling for the given speed and load. When there is an error in these values, the current offset is adjusted to minimize the error. If the offset can **not** compensate to eliminate the error, it will reach its maximum/minimum threshold and Fault Code 468 is logged.
