## Fault Code: 729

### Blowby Pressure Sensor Circuit

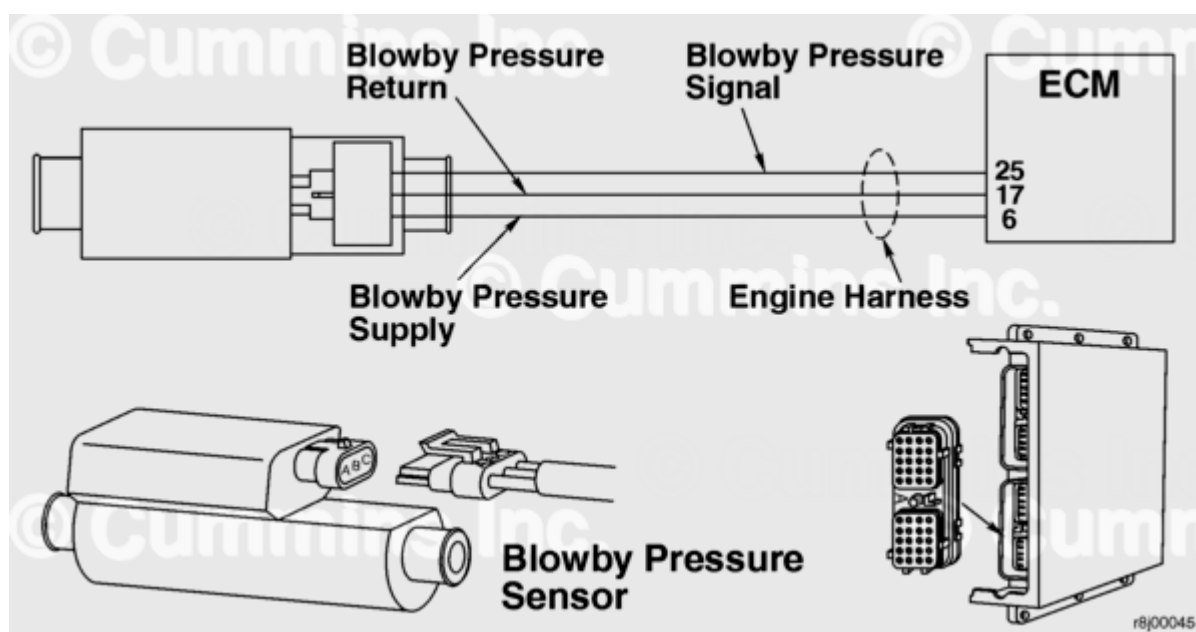
Blowby Pressure Sensor Circuit

| Codes | Reason | Effect |
|---|---|---|
| Fault Code: 729<br><br>PID(P): P22<br>SPN: 1264<br>FMI: 4<br>Lamp: Yellow<br>SRT: 00-678 | Less than 0.29-VDC detected at the blowby pressure sensor SIGNAL pin 25 of the engine harness. | No engine protection for blowby pressure. |

The blowby pressure sensor monitors blowby pressure and passes this information to the engine control module (ECM) through pin 25 of the engine harness. The ECM monitors the voltage on pin 25 and expects to see the voltage vary between 0.5 and 4.5-VDC during normal engine operation. Voltage below 0.29-VDC on pin 25 will trip Fault Code 729 and can be caused by shorts in the SUPPLY, SIGNAL, or RETURN wires, an open in the RETURN wire, or a malfunctioning sensor.

Confirm that the crankcase breathers, breather tubes, and blowby sensor are **not** obstructed.
