## Fault Code: 157

### Intake Manifold 2 Temperature Sensor Circuit - Voltage Below Normal or Shorted to Low Source

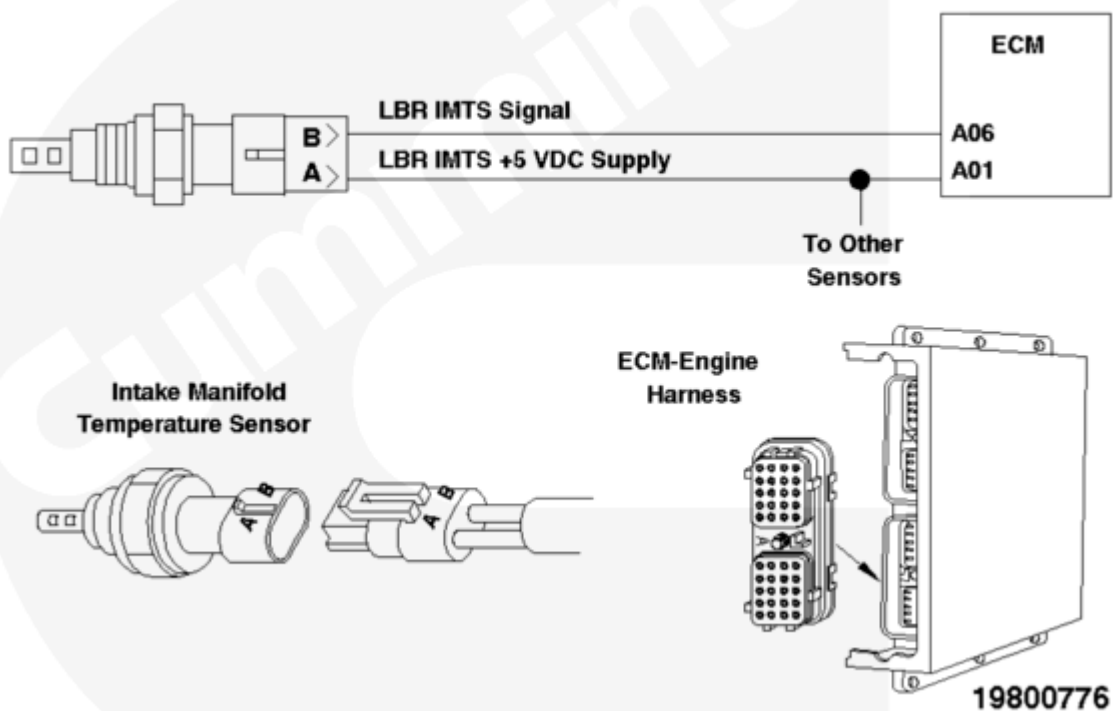
| Codes | Reason | Effect |
|---|---|---|
| Fault Code: 157<br><br>PID(P): 105<br>SPN: 1131<br>FMI: 4<br>Lamp: Yellow<br>SRT: 00-697 | Intake Manifold 2 Temperature Sensor Circuit - Voltage Below Normal or Shorted to Low Source. Low voltage detected on SIGNAL pin-06 of the main harness A engine control module (ECM) connector. | Fault Code 158 is disabled. |

The intake manifold 2 temperature sensor provides the left bank rear intake manifold air temperature signal to the CENSE™ ECM.

Refer to Troubleshooting Fault Code t05-157. (</qs3/pubsys2/xml/en/procedures/81/81-t05-157.html>)
