# Fault Code: 623

## Exhaust Gas Temperature Deviation Low for Cylinder 5 - Data Valid But Below Normal Operating Range - Least Severe Level

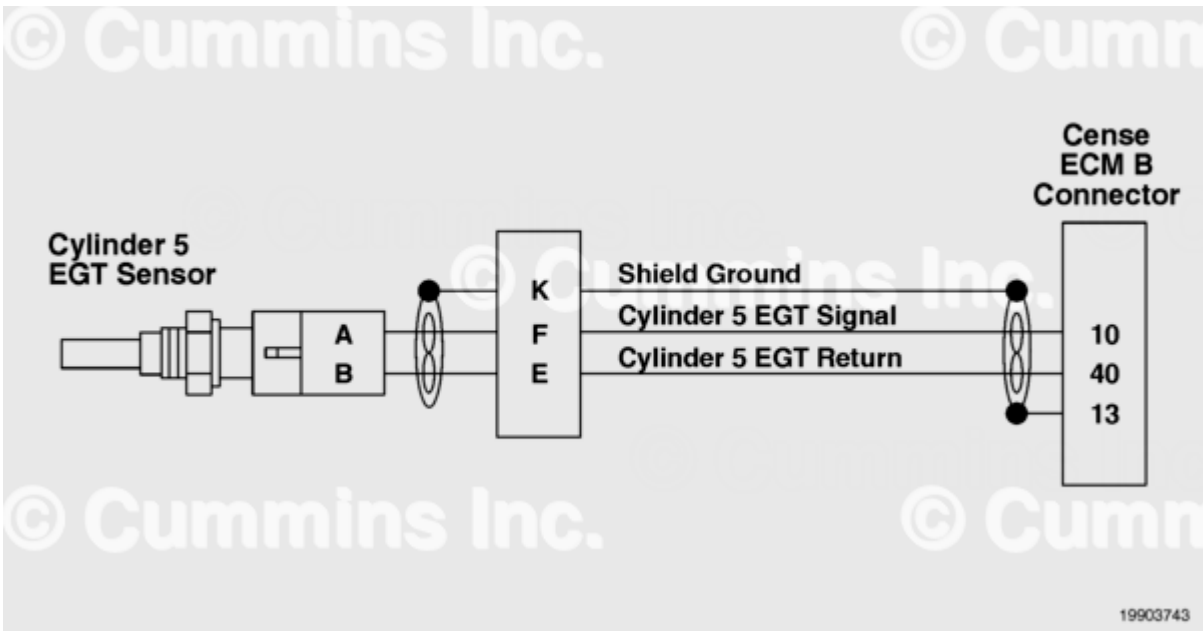
Exhaust Gas Temperature Sensor Circuit Cylinder 5 - QSK45 and QSK60 Engines

The exhaust gas temperature sensor circuit cylinder 5 monitors exhaust gas temperature and passes information to the engine control module (ECM) through the engine harness.

The exhaust gas temperature sensor circuit cylinder 5 for this fault code is located in the exhaust manifold at the cylinder head 5 to exhaust manifold interface.
