# Fault Code: 625

## Exhaust Gas Temperature Deviation Low for Cylinder 9 - Data Valid But Below Normal Operating Range - Least Severe Level

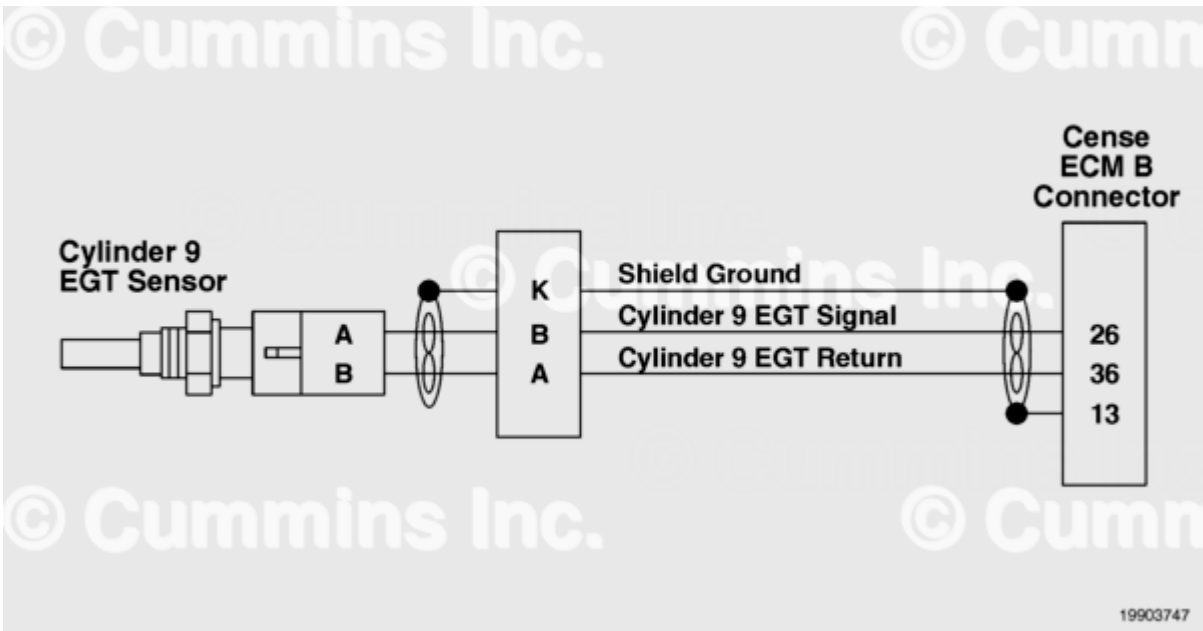
Exhaust Gas Temperature Sensor Circuit Cylinder 9 - QSK45 and QSK60 Engines

The exhaust gas temperature sensor circuit cylinder 9 monitors exhaust gas temperature and passes information to the engine control module (ECM) through the engine harness.

The exhaust gas temperature sensor circuit cylinder 9 for this fault code is located in the exhaust manifold at the cylinder head 9 to exhaust manifold interface.
