## Fault Code: 694

### Turbocharger 2 Compressor Intake Temperature Circuit - Voltage Above Normal or Shorted to High Source

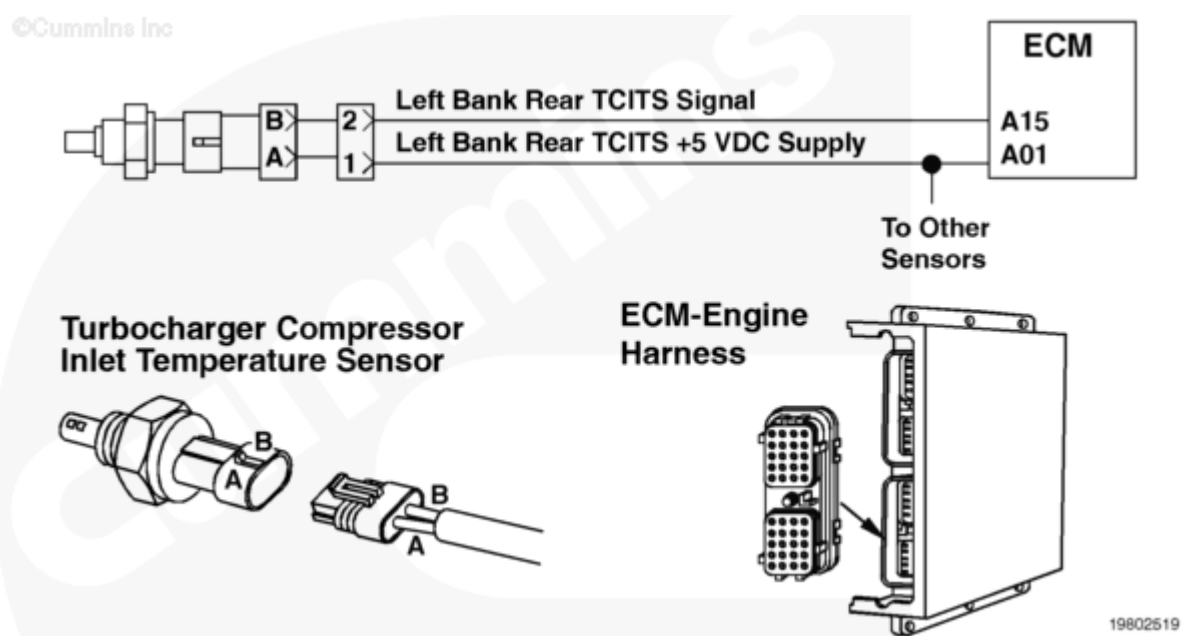
Left Bank Rear Turbocharger Compressor Inlet Temperature Sensor Circuit

| Codes | Reason | Effect |
|---|---|---|
| <p>Fault Code: 694</p> <p>PID(P):<br/>SPN: 1173<br/>FMI: 3<br/>Lamp: None<br/>SRT: 00-513</p> | <p>Turbocharger 2 Compressor Intake Temperature Circuit - Voltage Above Normal or Shorted to High Source.</p> <p>High voltage detected on SIGNAL pin 15 of the main harness A ECM connector.</p> | <p>Fault Code 616 is disabled.</p> |

The left bank rear turbocharger compressor inlet temperature sensor provides the left bank rear turbocharger compressor inlet temperature to the ECM. The resistance of the sensor varies with temperature. The ECM detects the change in resistance of the sensor by monitoring the voltage across an internal resistor that is in series with the sensor. The change in voltage across the internal resistor is translated into a temperature change.

Refer to Troubleshooting Fault Code t05-694 (</qs3/pubsys2/xml/en/procedures/81/81-t05-694.html>)
