## Fault Code: 695

### Turbocharger 2 Compressor Intake Temperature Circuit - Voltage Below Normal or Shorted to Low Source

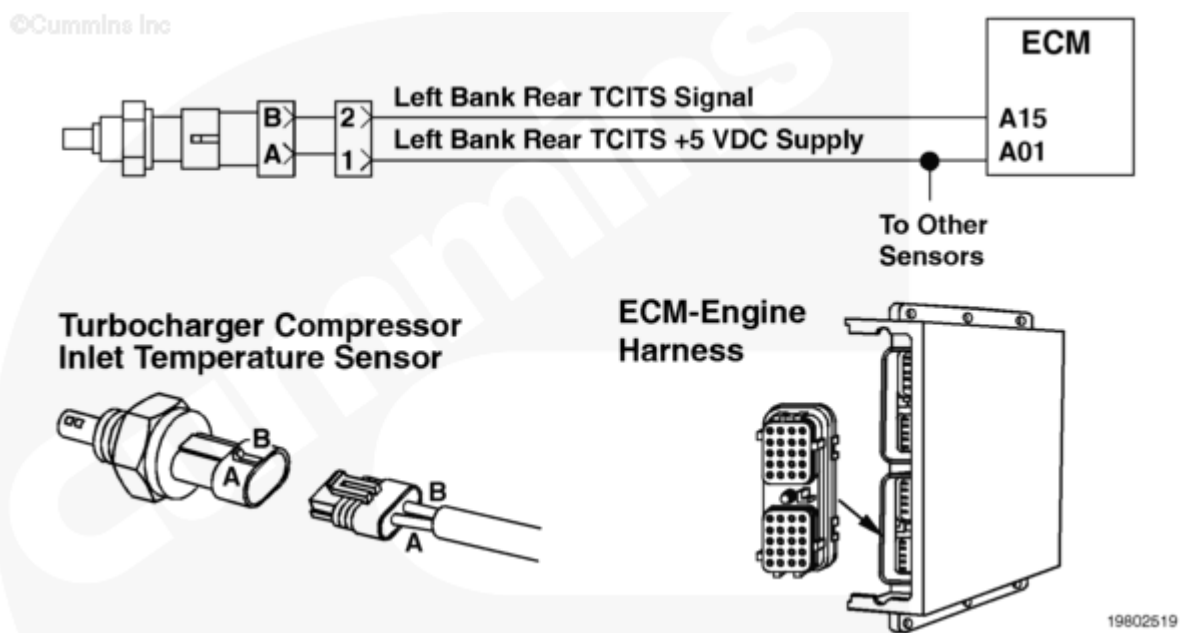
Left Bank Rear Turbocharger Compressor Inlet Temperature Sensor Circuit

| Codes | Reason | Effect |
|---|---|---|
| Fault Code: 695<br><br>PID(P):<br>SPN: 1173<br>FMI: 4<br>Lamp: None<br>SRT: 00-514 | Turbocharger 2 Compressor Intake Temperature Circuit - Voltage Below Normal or Shorted to Low Source. Low voltage detected on SIGNAL pin 15 of the main harness A ECM connector. | Fault Code 616 is disabled. |

The left bank rear turbocharger compressor temperature sensor provides the left bank rear turbocharger compressor inlet temperature to the ECM. The resistance of the sensor varies with temperature. The ECM detects the change in resistance of the sensor by monitoring the voltage across an internal resistor that is in series with the sensor. The change in voltage across the internal resistor is translated into a temperature change.

Refer to Troubleshooting Fault Code t05-695 (</qs3/pubsys2/xml/en/procedures/81/81-t05-695.html>)
