| Technical Service Bulletin: tsb090024 | Released Date: 07-Apr-2009 |
| Air Leak Past Compressor Inlet Hose Coupling At Cylinder Head | |

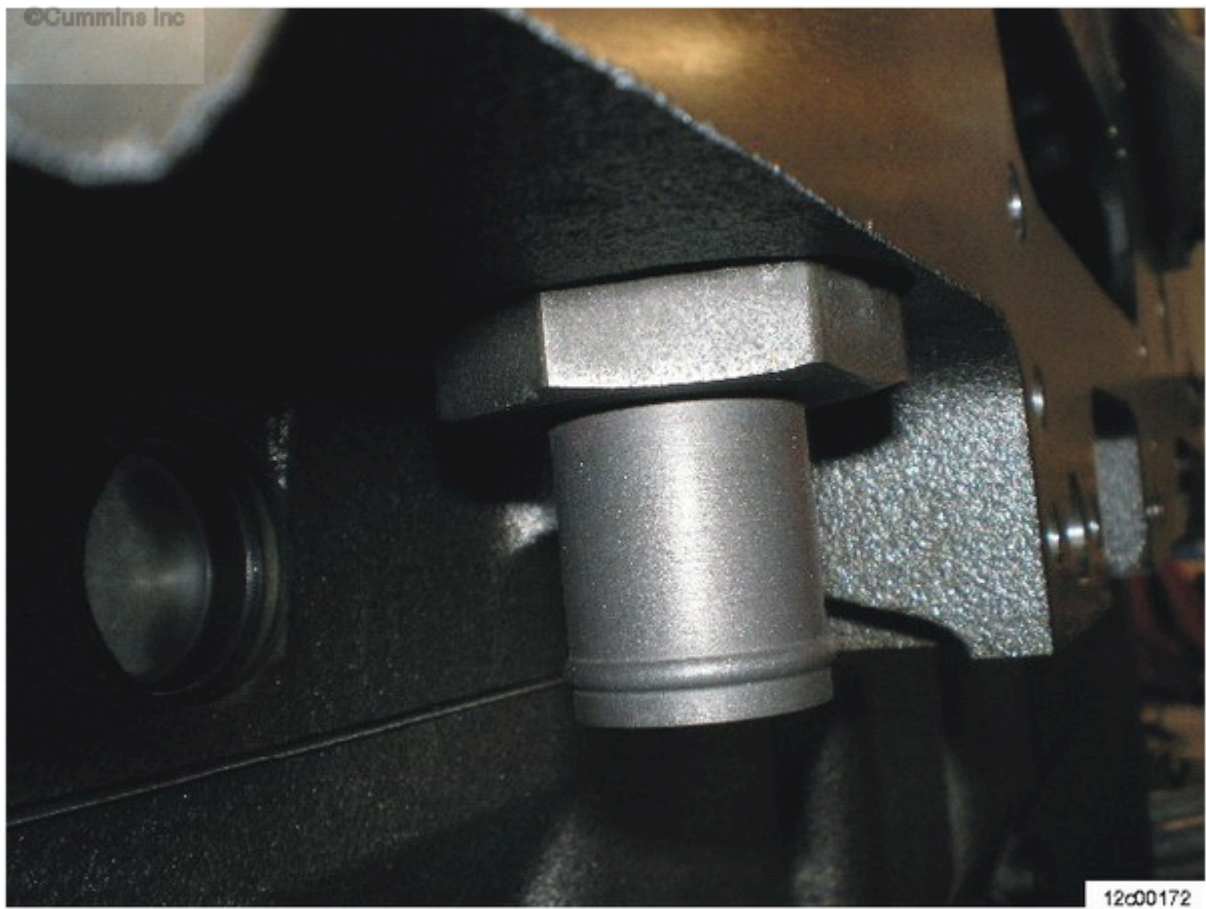
Confirm there is air leakage at the compressor inlet hose coupling due to interference between the coupling and the cast surface of the cylinder head.

The machined spot face is smaller than fitting diameter on some cylinder heads.

Figure 1: Interference between coupling and cylinder head.

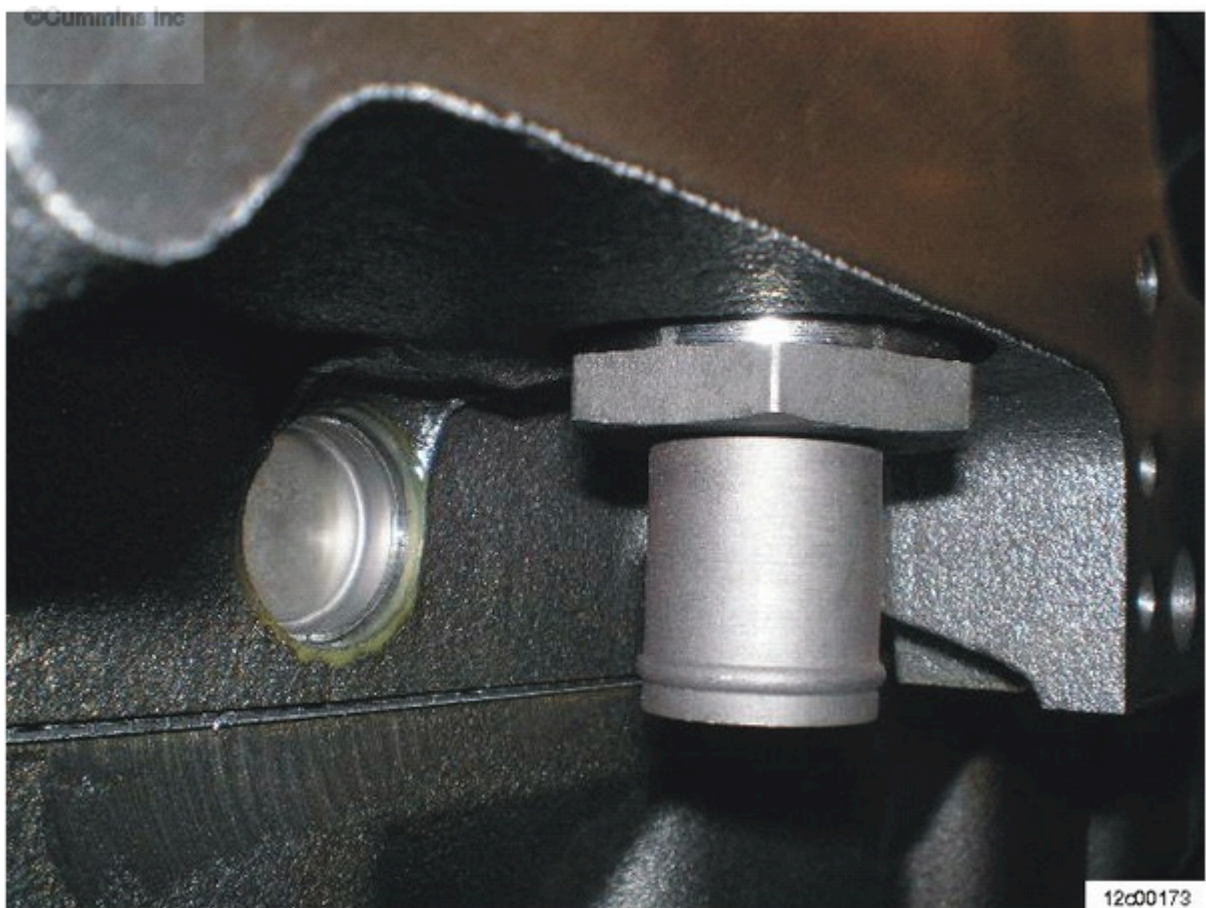
Figure 2: Interference corrected by modified coupling.

Modify the compressor inlet hose coupling to eliminate interference. Use a lathe to remove up to 3 mm [0.118 in] of material from the underside of the wrench flats to avoid interference and allow the coupling to seat in the machined spot face of the cylinder head.
