Technical Service Bulletin: TSB110002

Released Date: 21-Feb-2011

Possible Water Pump/Cylinder Block Interference on ISM and QSM11 Engine Applications

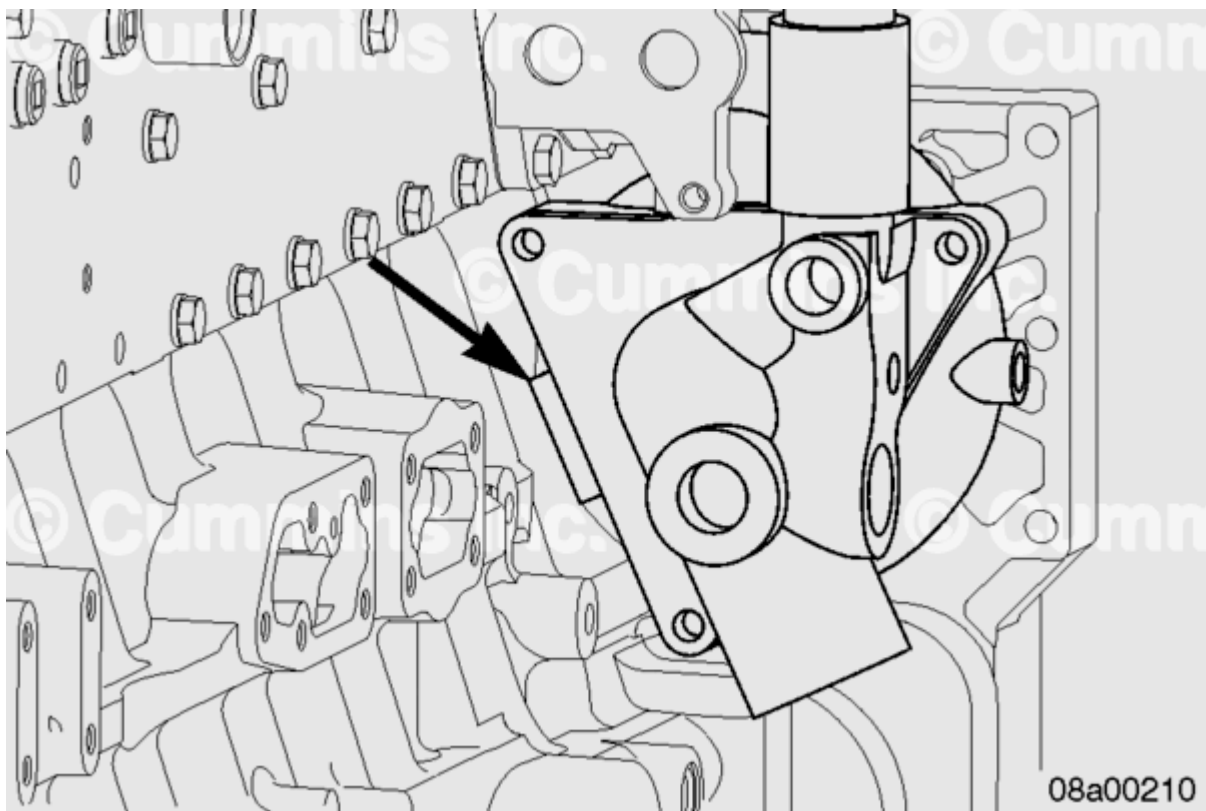
Water Pump Housing and Cylinder Block Casting

This document describes a condition in which there may be interference between the water pump housing and the cylinder block on some ISM and QSM11 engines. Due to the manufacturing and process variation between components, it is possible for the water pump housing to contact the cylinder block casting, behind the cylinder block to gear housing interface. This issue may result in an external coolant leak from the water pump housing or an issue with the water pump bearing. If the engine is experiencing an external coolant leak from the water pump housing or an issue with the water pump bearing, the engine **must** be inspected for this possible interference condition before the water pump is removed for repair.

Inspect for interference between the water pump housing and the cylinder block casting by sliding thin cardboard or cardstock between the components. See illustration below.

If interference is found, it may be necessary to remove the water pump from the engine to correct the interference by grinding a small amount of material from the affected area of the cylinder block casting or water pump housing. Use the following procedure in the ISM, ISMe, and QSM11 Service Manual, Bulletin 3666322. Refer to Procedure 008-062 in Section 8.

**Note :** Care must be taken to properly cover any exposed engine components during the grinding process and to seal or paint the area exposed by grinding.
