Technical Service Bulletin: TSB120067

ISX15 and QSX15 Fracture Split Connecting Rods

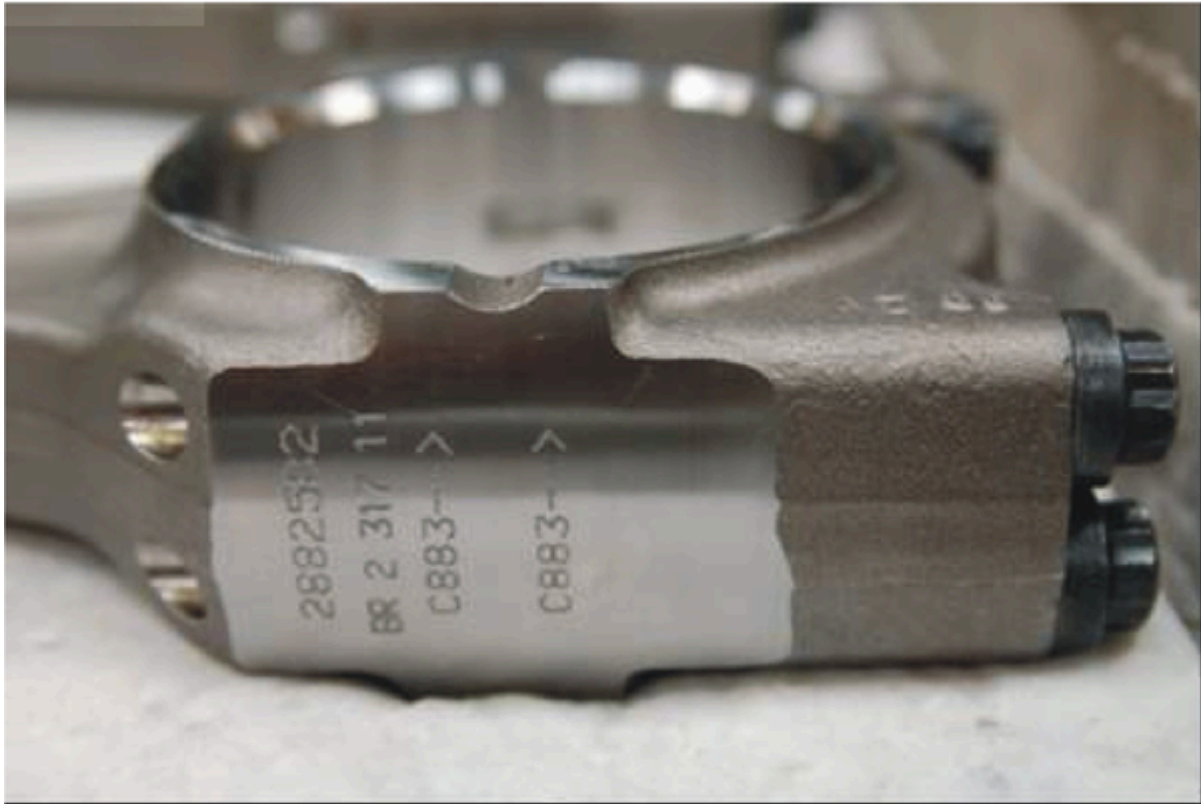
01y00001

Make sure that the rod cap is installed **only** on the connecting rod from which it was removed, and that the rod cap is properly oriented when installing. Both the rod cap and the connecting rod are serialized on one face to make sure of proper orientation.

Face Serialized for Proper Orientation

If the rod cap is placed backwards on the connecting rod, the mating fracture surface will be damaged and the rod **must** be replaced. Fracture split rod capscrew torque specification and sequence remains the same as the saw cut connecting rods.

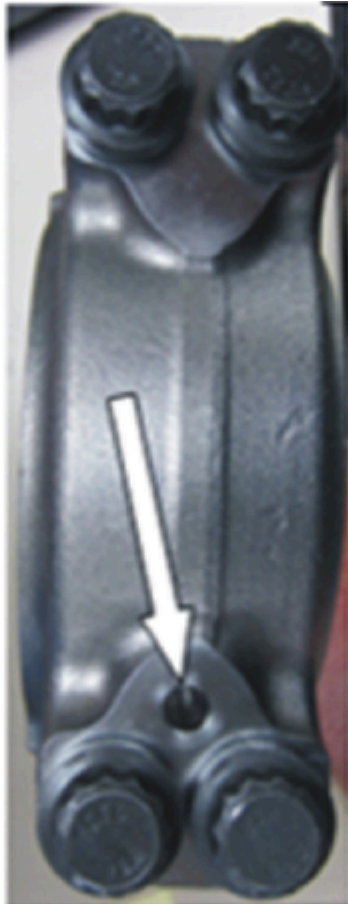
01o00099

Fracture Split Connection

It is important to understand if the rod has a fracture split or a saw cut connection. For identification, the fracture split connecting rod will have a visible hole drilled in the cap. (See photograph on left above).

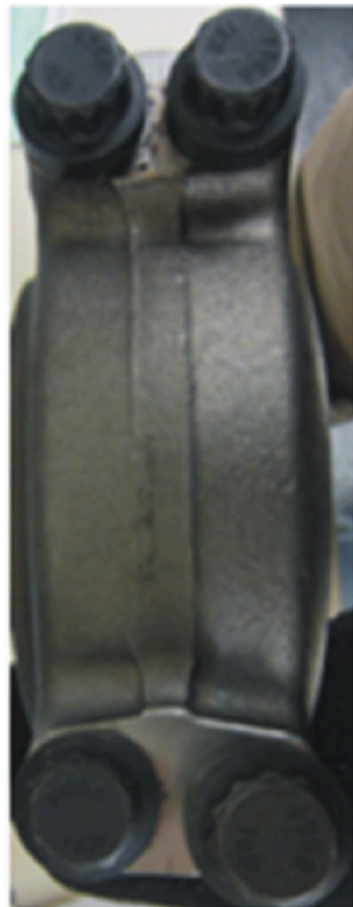
01o00100

Saw Split Connection
