Technical Service Bulletin: TSB140017

Breather Filter and Crankcase Tube Freezing Issue in Below Freezing Temperatures

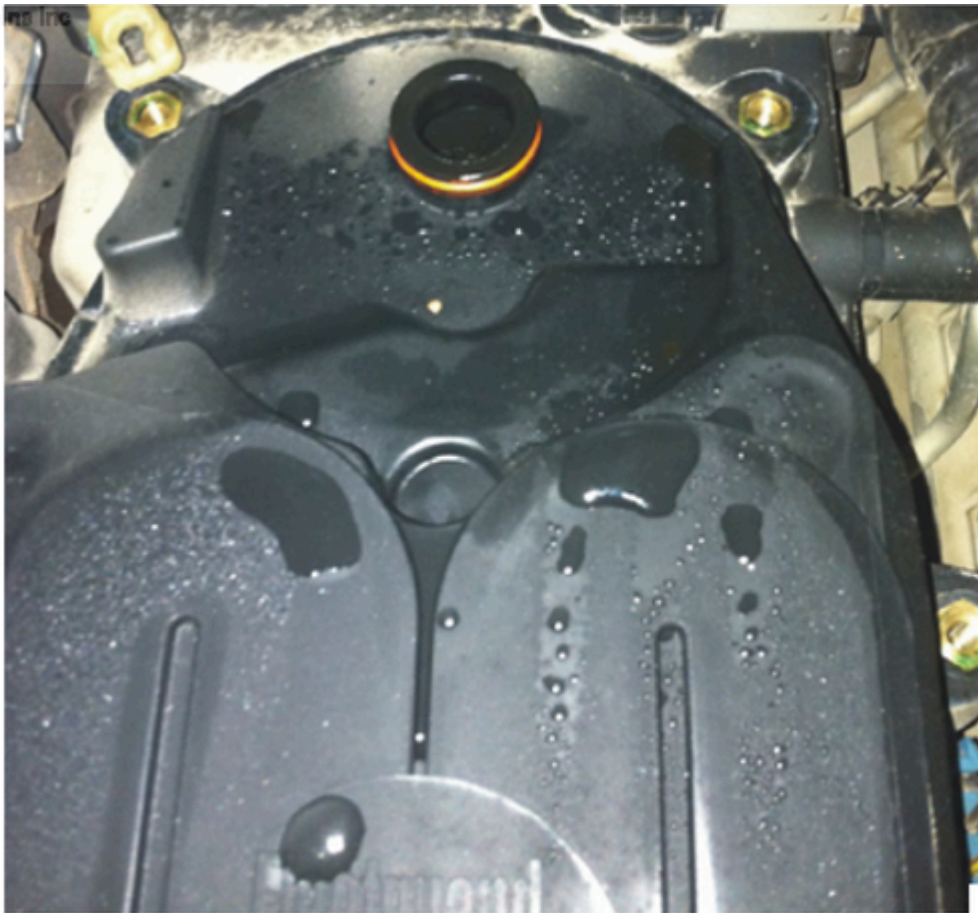
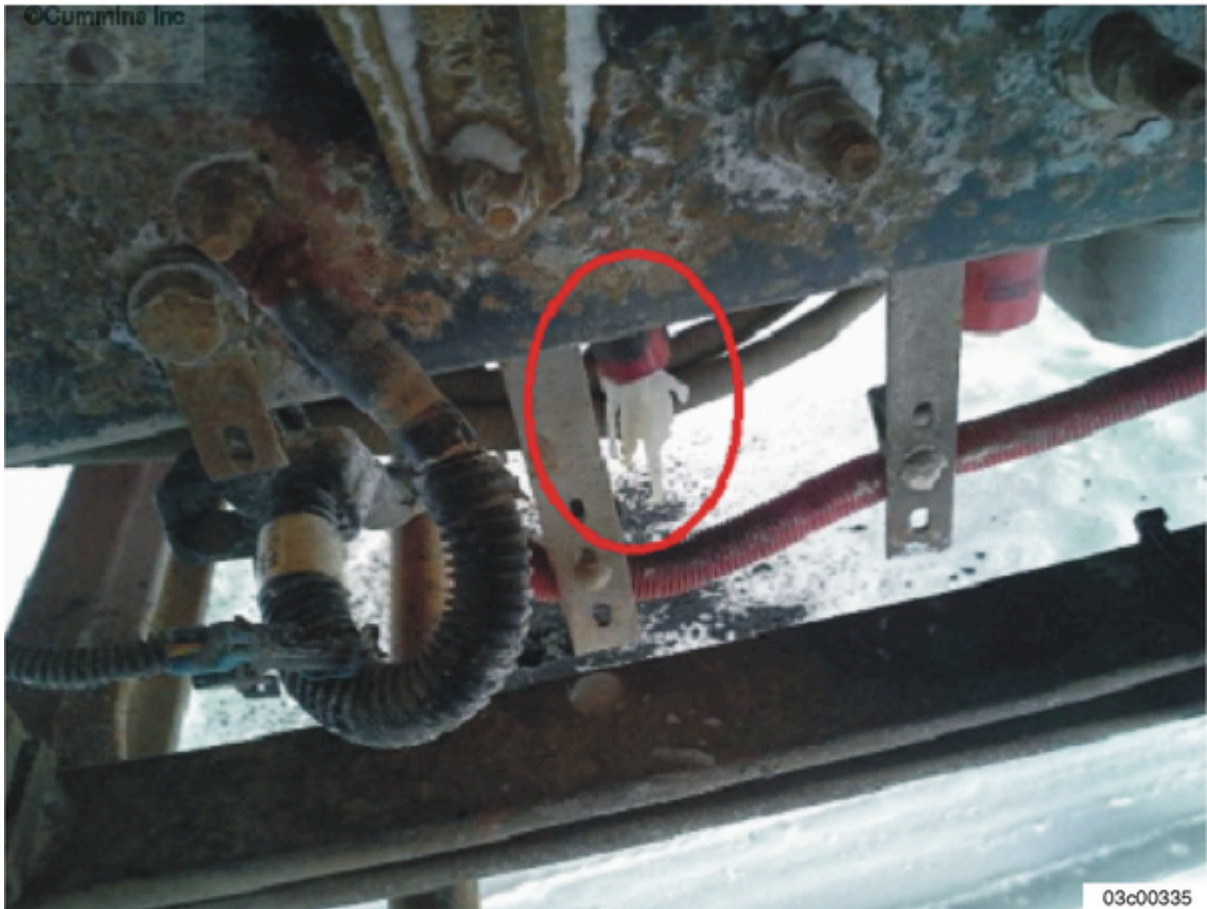
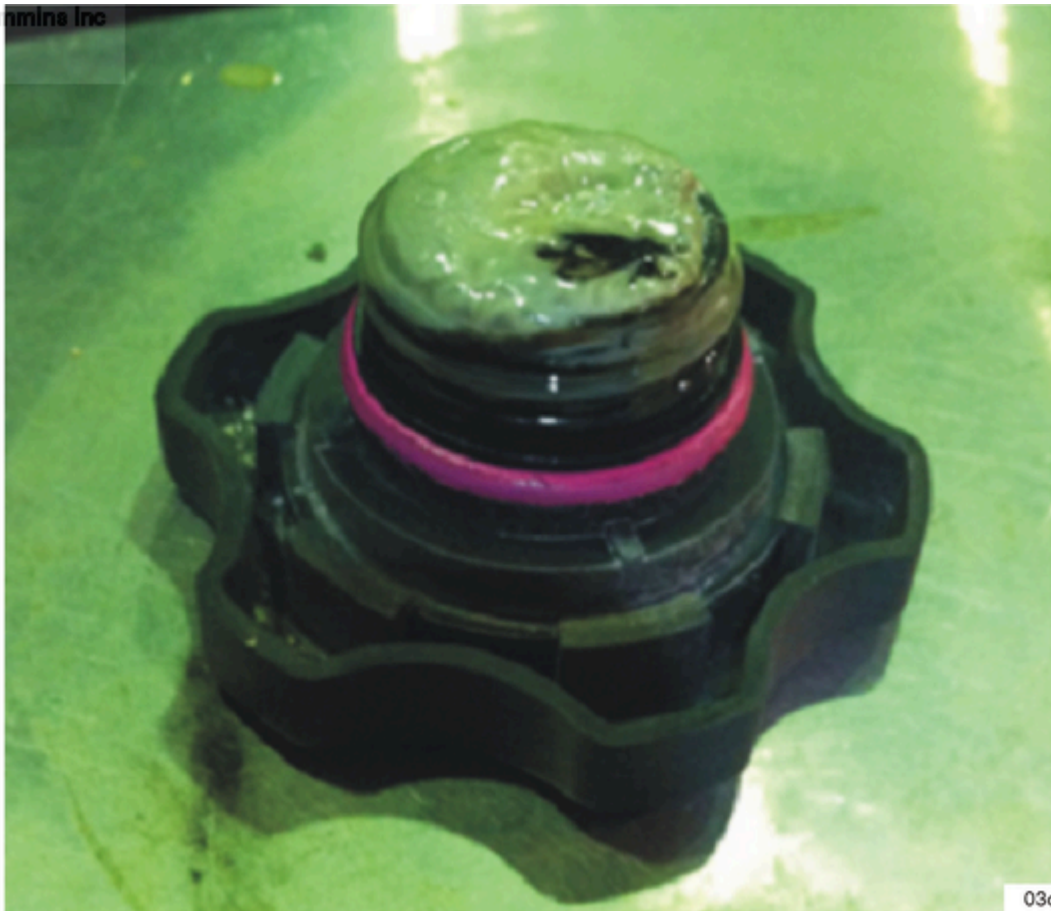
The crankcase breather filter and crankcase breather tube freezing could cause crankcase pressure to build, resulting in:

- Lubricating oil leaks at the turbocharger seal, valve cover gasket, and rocker housing gasket or front or rear crankshaft seals.
- Logging high crankcase pressure Fault Codes 555 and 556.

If these symptoms and fault codes are observed along with below freezing temperatures, check the breather filter (if equipped) and crankcase breather tube for freezing. Photographs are shown below for reference. Condensation might be observed on the breather element.

- If the crankcase breather filter and/or crankcase tube is found to be plugged by icing, install a cold weather upfit kit. These kits contain heaters that will keep the filter and/or tube from freezing in below freezing temperatures. These upfit kits are **not** covered by warranty.
- For engine service models B6.7 CM2450 B155B, install kit, Part Number 5690250. Reference Installation Instruction, Bulletin 5414731 for detailed installation instructions.
- For all other service models, install kit, Part Number 5314954. Reference Installation Instruction, Bulletin 4908173 for detailed installation instructions.
