Technical Service Bulletin: TSB190035

Released Date: 05-Mar-2019

Cylinder Liner Installer Kit 3164606 Update

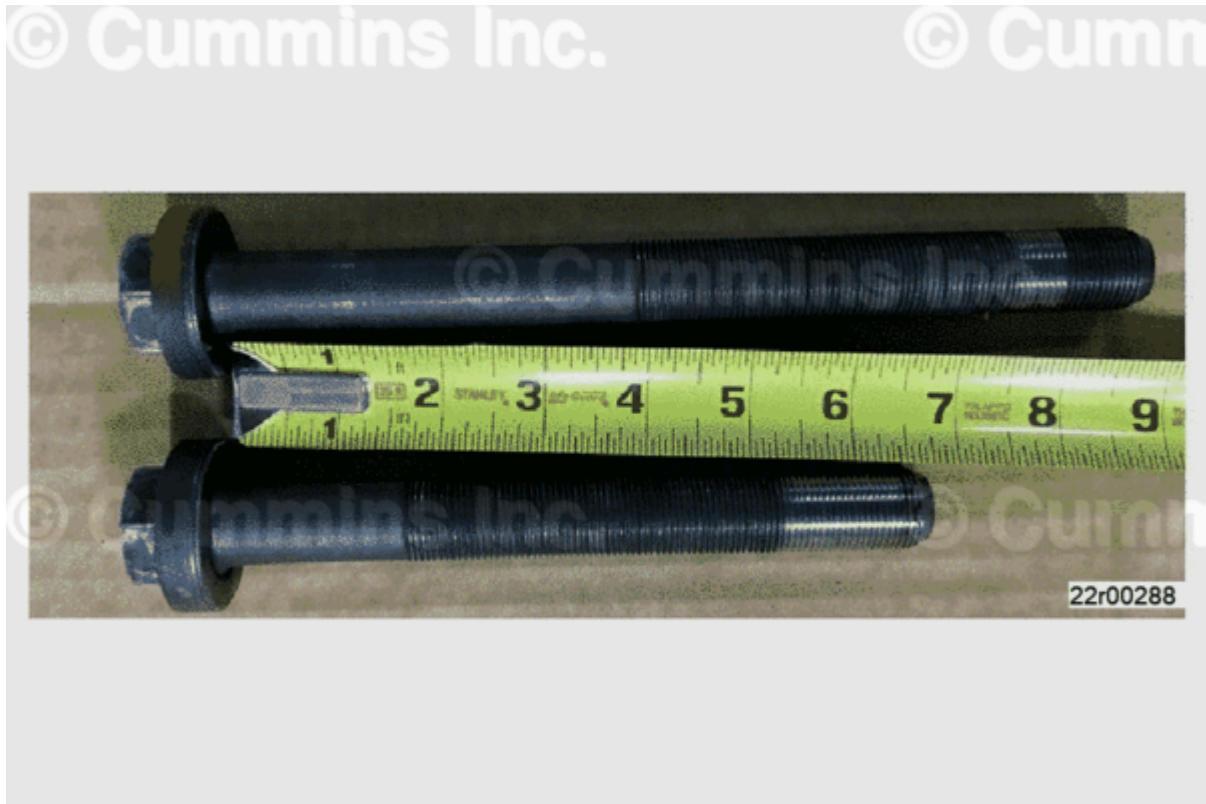
Lack of adequate thread engagement when using liner installation kit, Part Number 3164606. Short head bolts can lead to stripped head bolt threads or damaged cylinder block threads.

Cylinder blocks are now machined with a deeper cylinder head bolt counterbore that prevents adequate thread engagement when using the short head bolts. The long head bolts are too long to use without spacers.

Figure 1, Top: Long Cylinder Head Bolt to be Used With Spacers. Bottom: Short Cylinder Head Bolt.

Existing Kit, Part Number 3164606, has been updated to include spacers, Part Number 5395470, that allow the longer cylinder head bolts to be used with the kit to achieve adequate thread engagement.

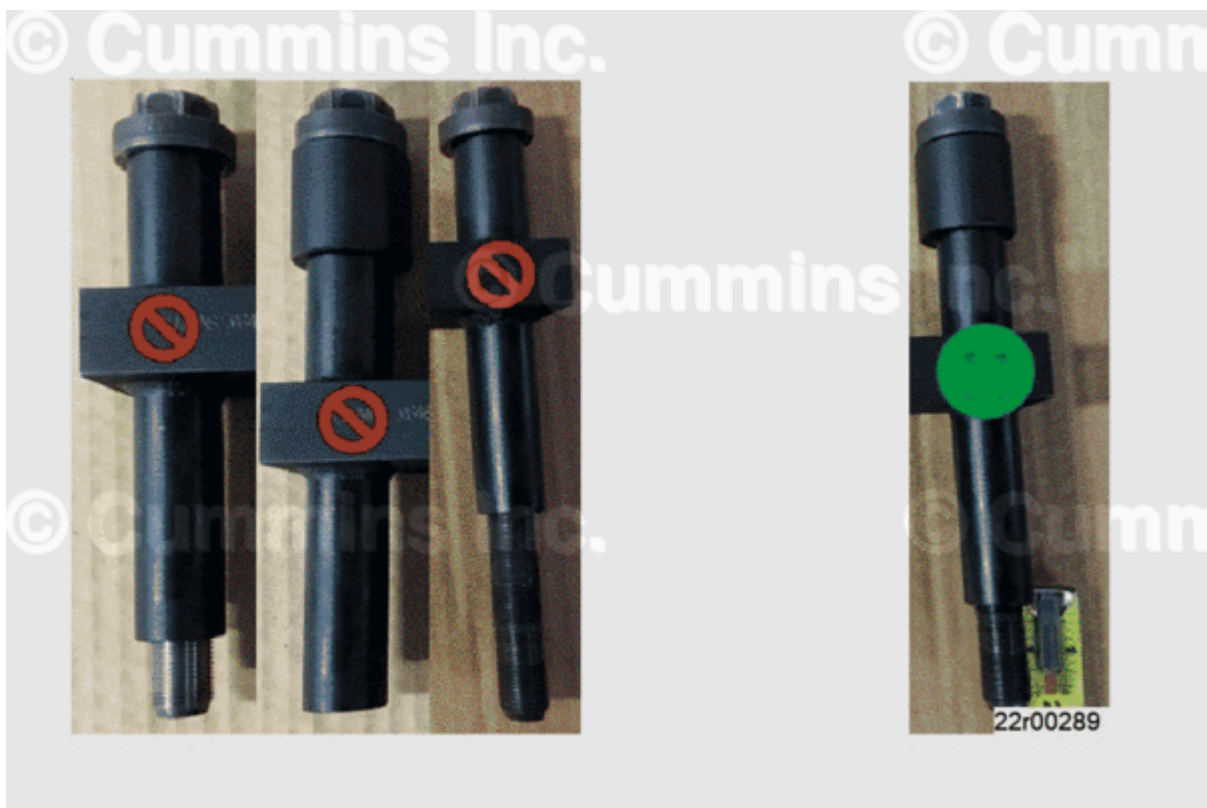
Figure 2, Left: Incorrect Spacer Arrangement. Right: Correct Spacer Arrangement.

- Order quantity 2 of spacer, Part Number 5395470.
- Replace existing kit.
- Individual owners are fully responsible for any cost associated with upfit or replacement.

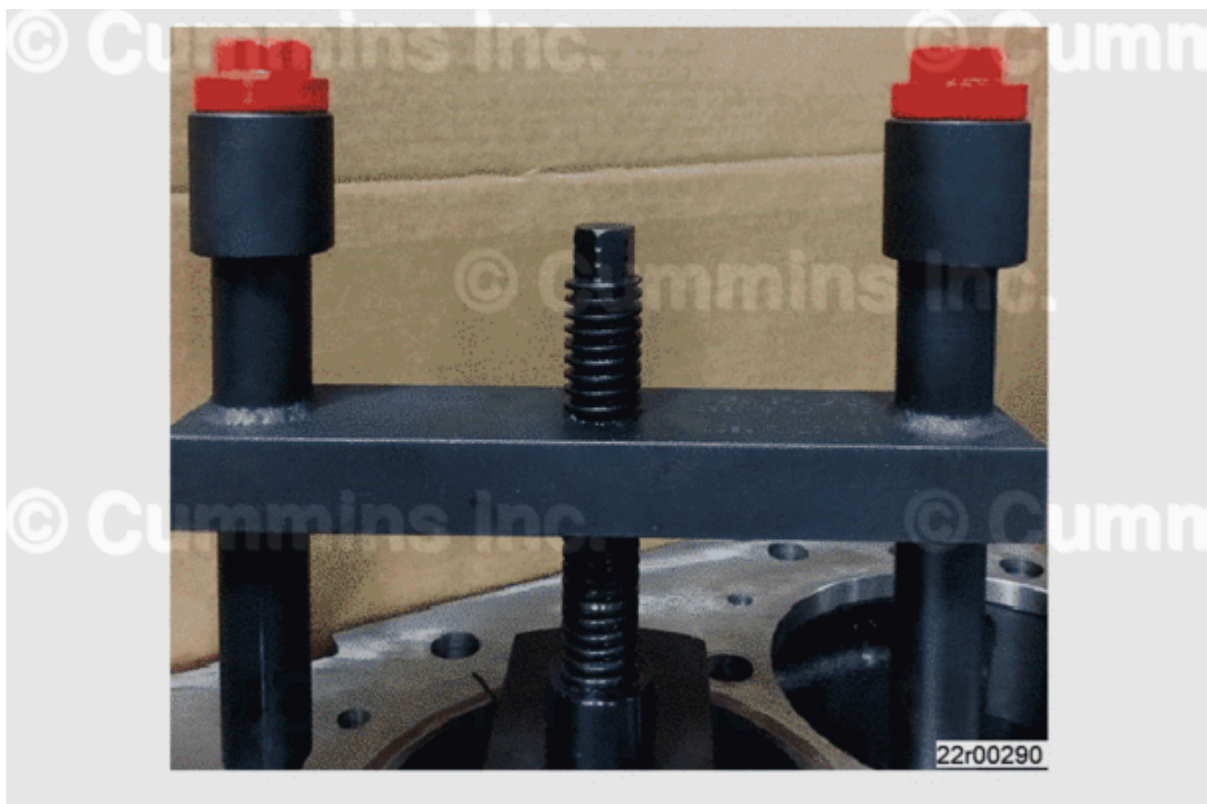
Figure 3, Kit Correctly Assembled on Block
