Technical Service Bulletin: TSB190180

Incorrect Diagnoses of Exhaust Manifold Lubricating Oil Carryover

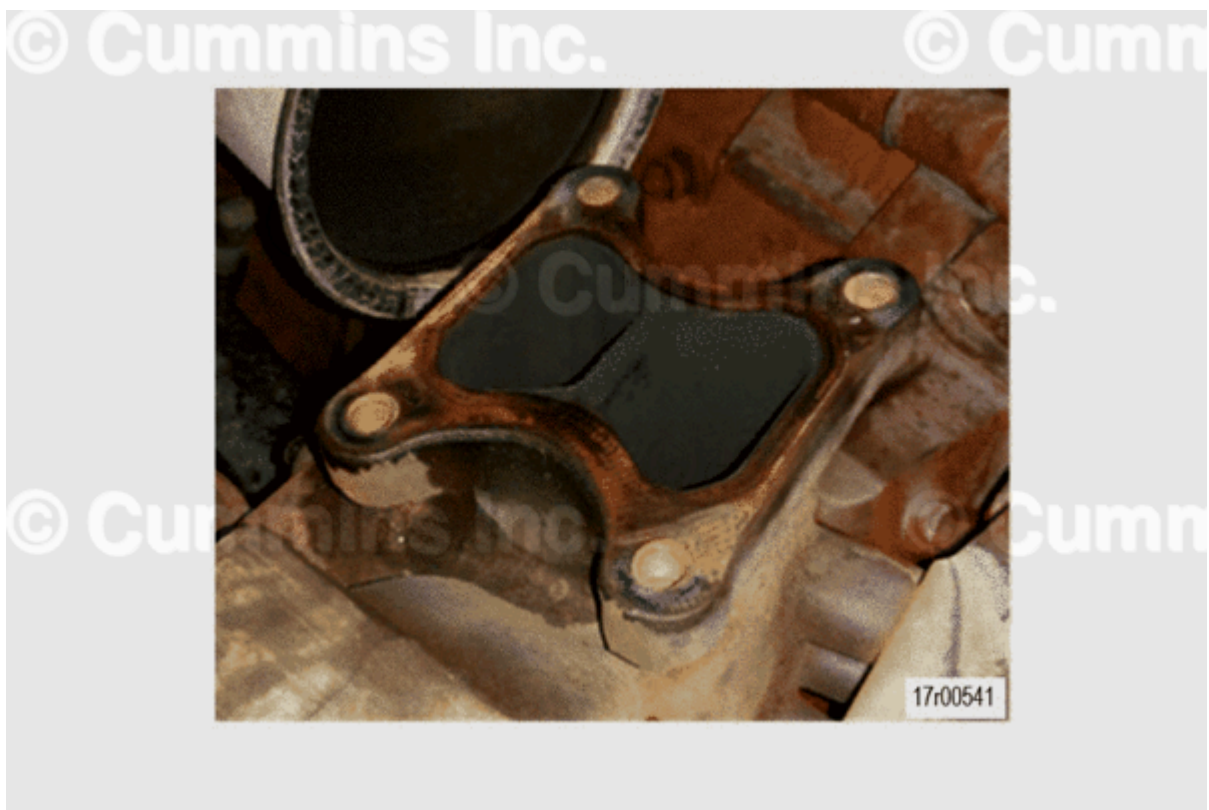
- Extended engine operation at low idle creates condensate and fluid buildup in the exhaust system.

Once the exhaust manifold is removed, the exhaust manifold may show what looks like high exhaust manifold oil carryover.

Figure 1, Condensate: Turbocharger Flange.

- If the engine will experience extended idle time, engine idle protection should be turned on or the idle speed needs to be increased to 1000 rpm to eliminate condensation buildup.

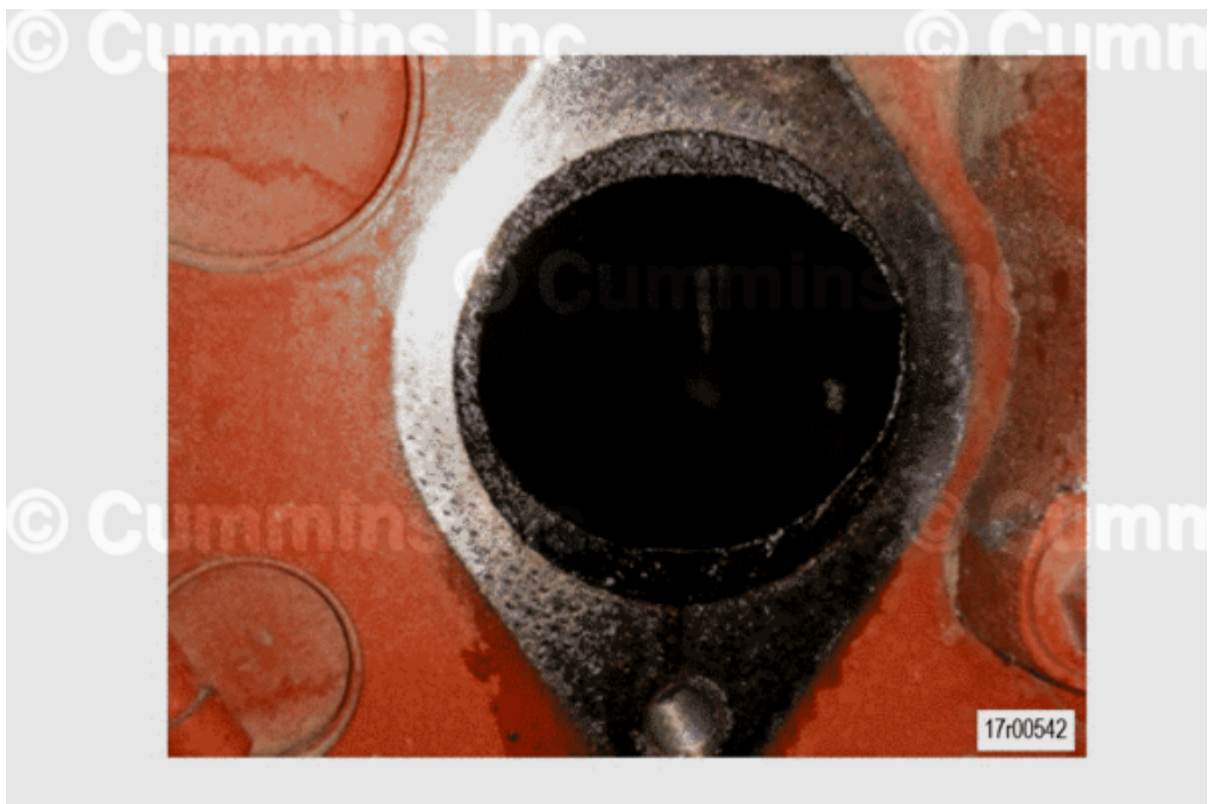
Figure 2, Condensate: Exhaust Manifold Port.

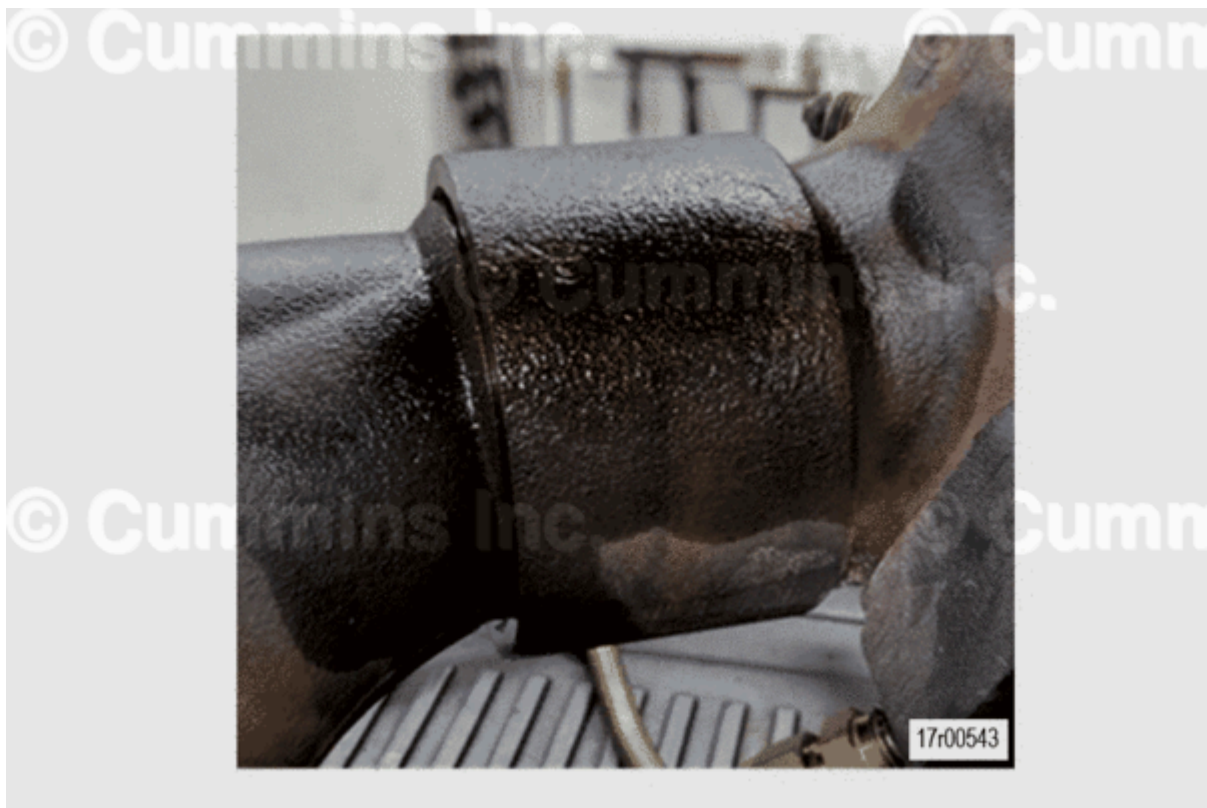
Figure 3, Condensate: Exhaust Manifold J-Seal.
