Technical Service Bulletin: TSB190206

New OEM Software to Prevent Engine Brake Rocker Lever Assembly Wear on Epiroc's MT-42 Unit

- MT-42 Mining Truck

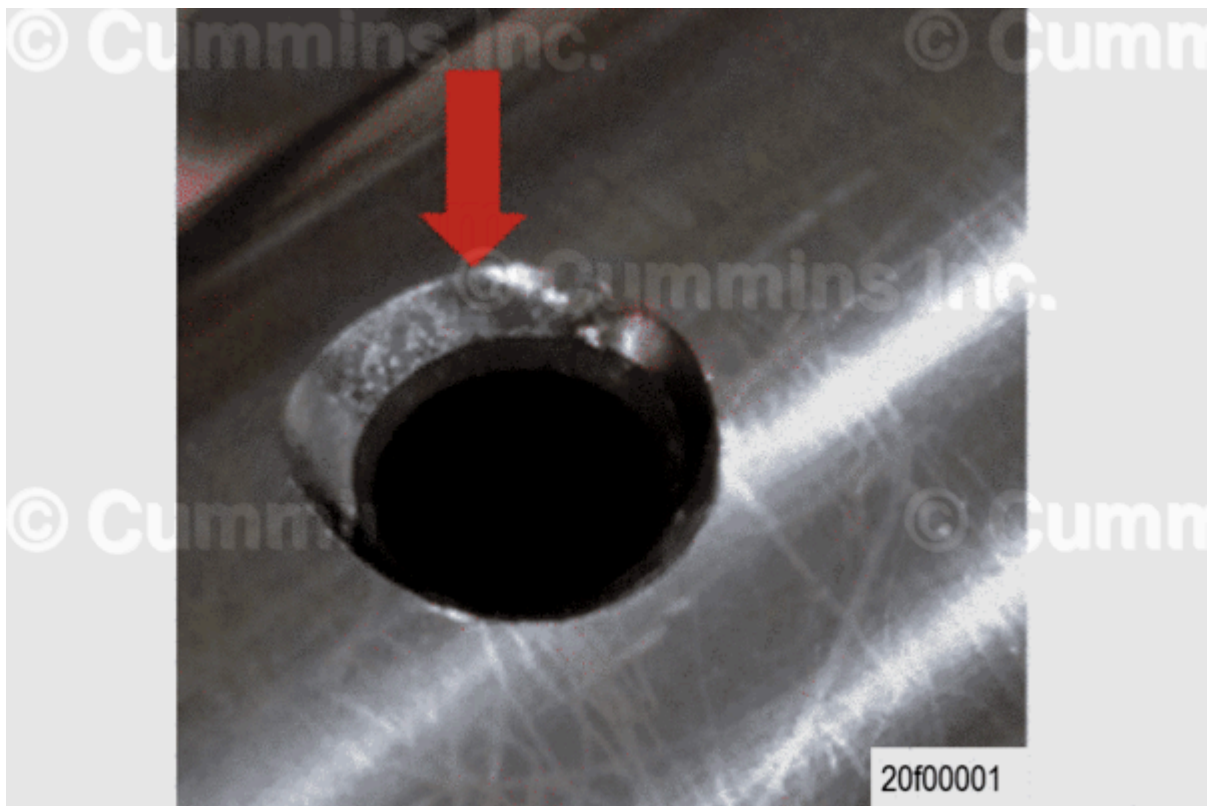
- Inspect the back of the engine brake switch in the dashboard for any abnormal wiring. All wires should be directed to their respective ports. See equipment manufacturer service information.
- Perform a complete overhead inspection of the engine brake parts. Take apart the rocker lever/shaft assembly and inspect the following:
  - Shaft detent: Detent will show rough wear around the edges as a result of the control valve unable to sit permanently. See Figure 1 below.
  - Control valve springs: Springs will be shortened in comparison to otherwise healthy or new springs. See Figure 2 below.
  - Rocker levers brake actuator piston: Piston will show rough wear around the edges. See Figure 3 below.
  - Engine brake contact bridge pin: Bridge pin will show rough wear around the edges. See Figure 4 below.
  - The figures below show examples of worn out components.

Figure 1, Engine Brake Shaft Detent Hole.

- Contact the OEM for further instructions on how to address this type of failure.

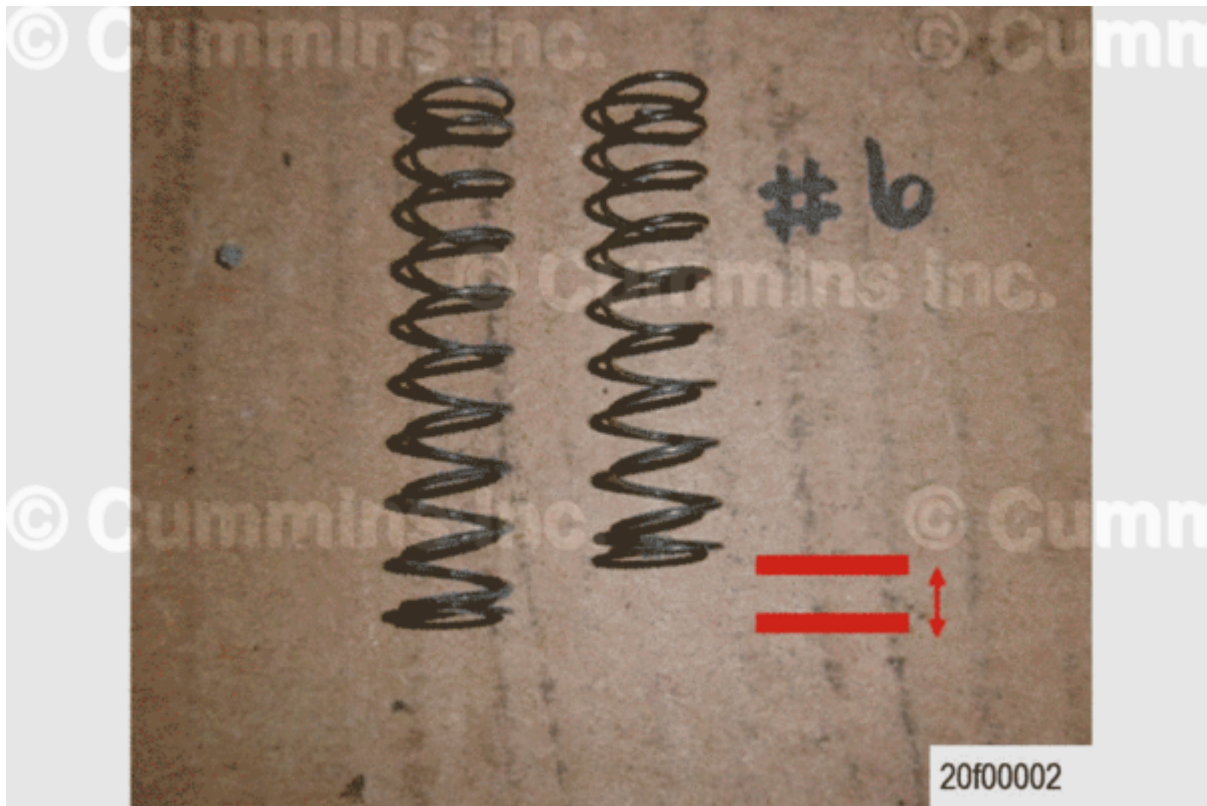
Figure 2, Engine Brake Control Valve Spring.

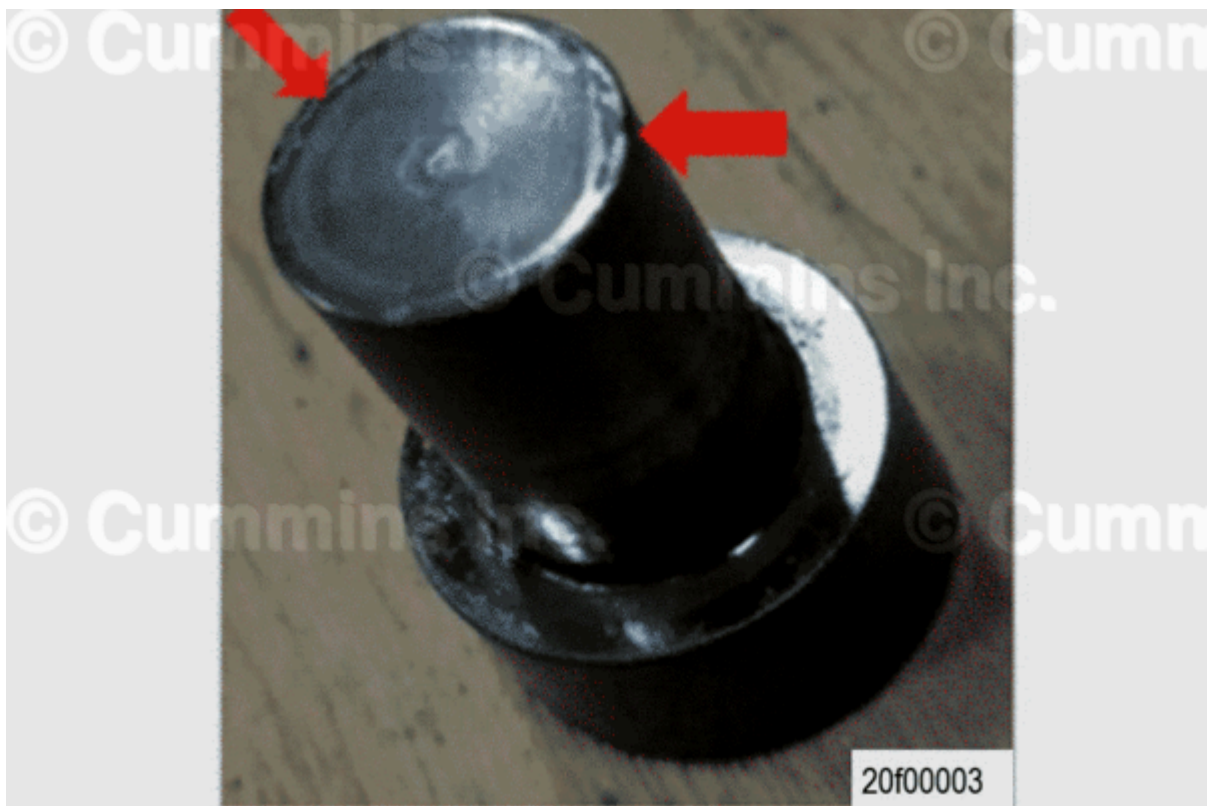
Figure 3, Engine Brake Actuator Piston.

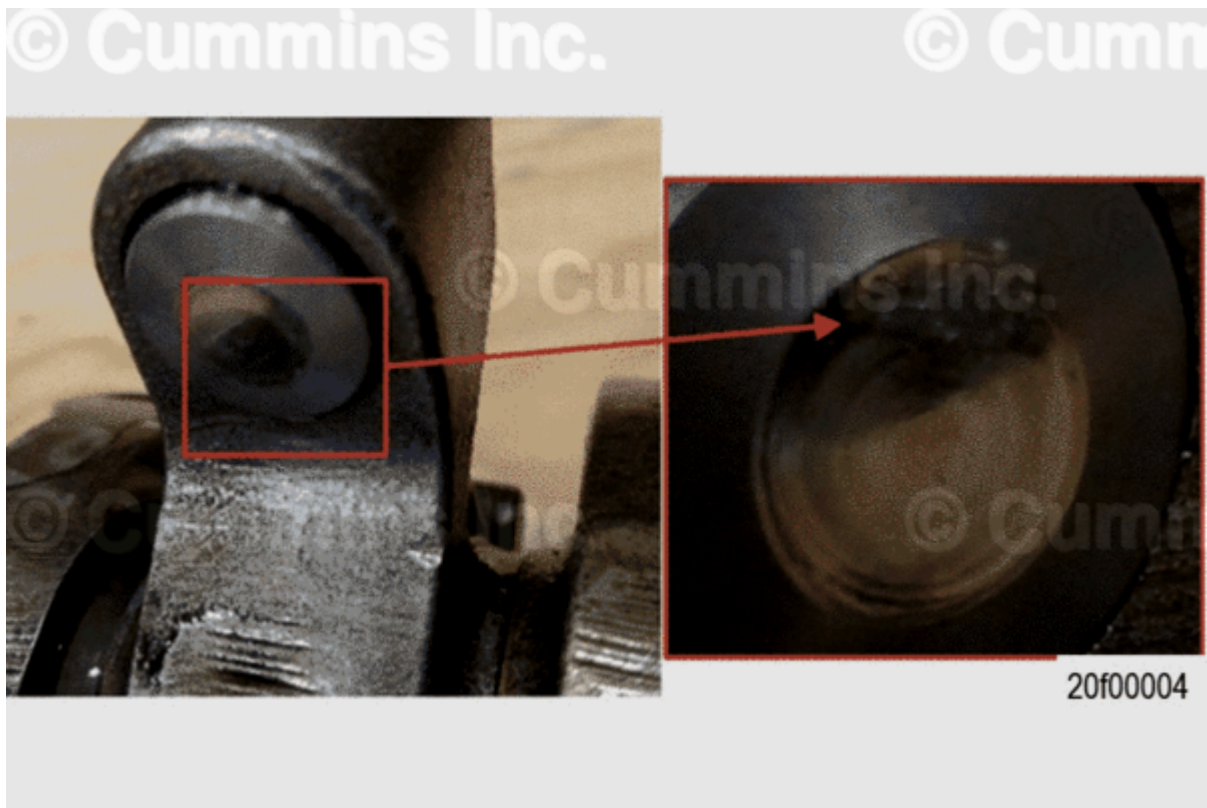
Figure 4, Engine Brake Contact Bridge Pin.
