Technical Service Bulletin: TSB250061

New Accessory Drive Support: Excessive Engine Noise

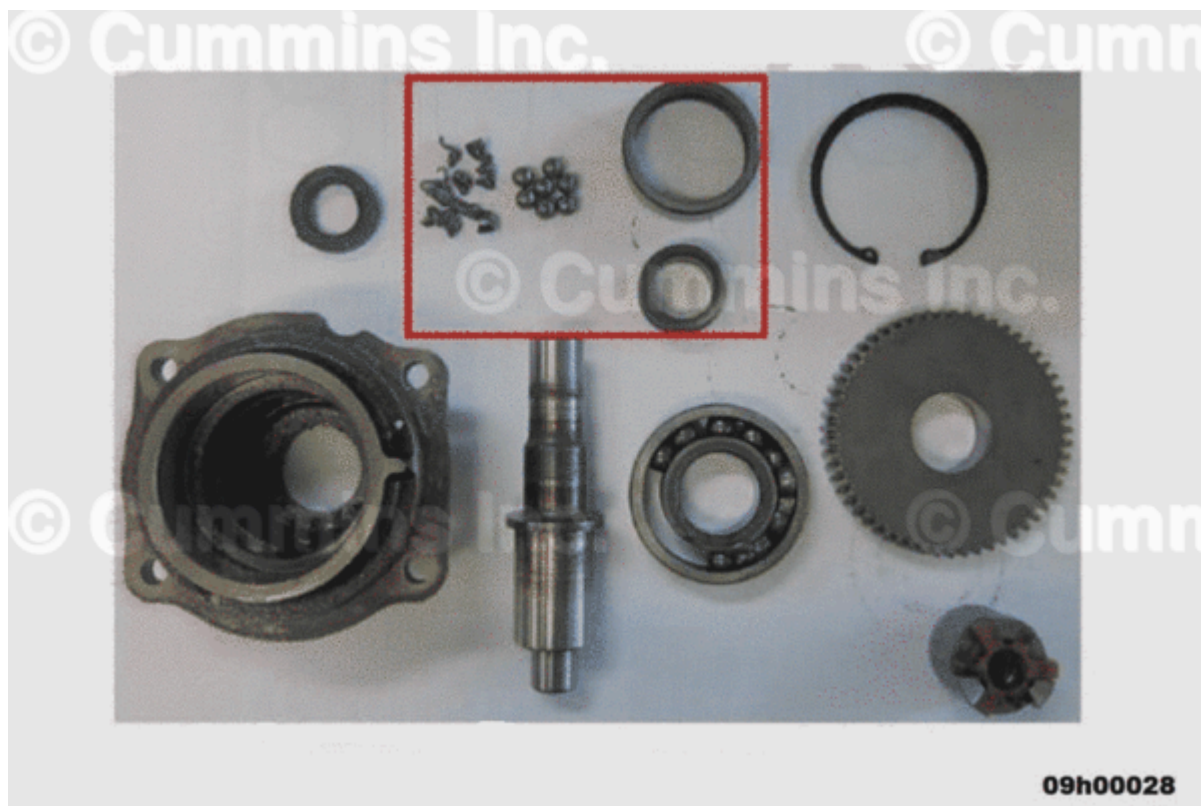
- Excessive noise from front side of engine
- Seized and overheated accessory drive
- Worn or malfunctioning accessory drive bearings

- Insufficient lubrication
- Excessive load applied to the accessory drive support
- Improper belt tension

Figure 1, Disassembled Accessory Drive Support, Bearing Malfunction / Shaft and Housing Damage.

Seized or malfunctioning accessory drive bearings resulting in damaged or malfunctioning adaptor assemblies. See Figure 1.

- A new increased load bearing capacity accessory drive support with a rear cylindrical roller bearing has been released.
- Both front and rear bearings of accessory drive are now updated to cylindrical roller type.
- New accessory drive is equipped with direct feed external lubricating oil line.
