# Fault Code: 455

## Rail Actuator Circuit

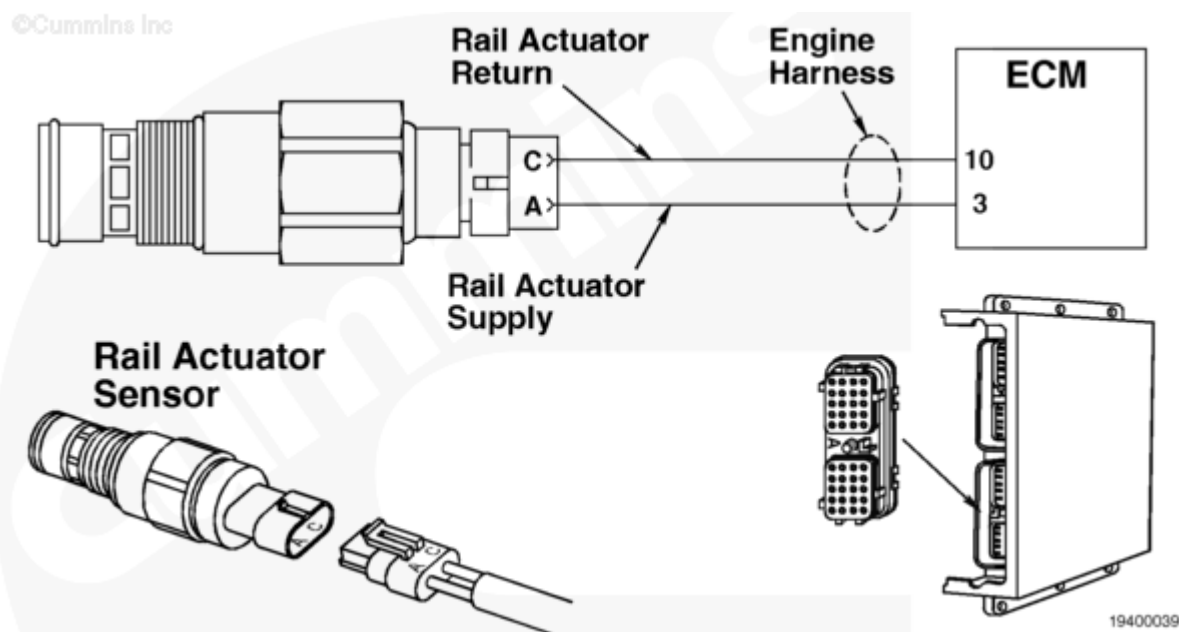
Rail Actuator Circuit

| Codes | Reason | Effect |
|---|---|---|
| Fault Code: 455<br><br>PID(P): S18<br>SPN: 633<br>FMI: 3<br>Lamp: Red<br>SRT: 00-376 | Rail actuator circuit is open, or supply pin 3 is shorted to battery voltage or ground, or return pin 10 is shorted to battery voltage or ground in the engine harness. | No action by the ECM is taken. Actuator is closed, or partially closed. Engine will <b>not</b> run, or runs at one speed. Fault Code 514 can be logged. |

The rail actuator circuit supplies current to the rail actuator. The ECM commands a varying amount of current to the rail actuator to control the amount of rail pressure to the injectors.

- Confirm that the actuator connector is firmly in place.
- When there is no power to the actuator, the actuator closes and fuel flow stops. This will cause Fault Code 514, fueling flow mismatch.
- When there is shorted power to the actuator, the actuator opens and fuel flow is uncontrolled. This will cause Fault Code 234, engine overspeed, or Fault Code 514, fueling flow mismatch.
