# Fault Code: 467

## Timing Current Offset Error

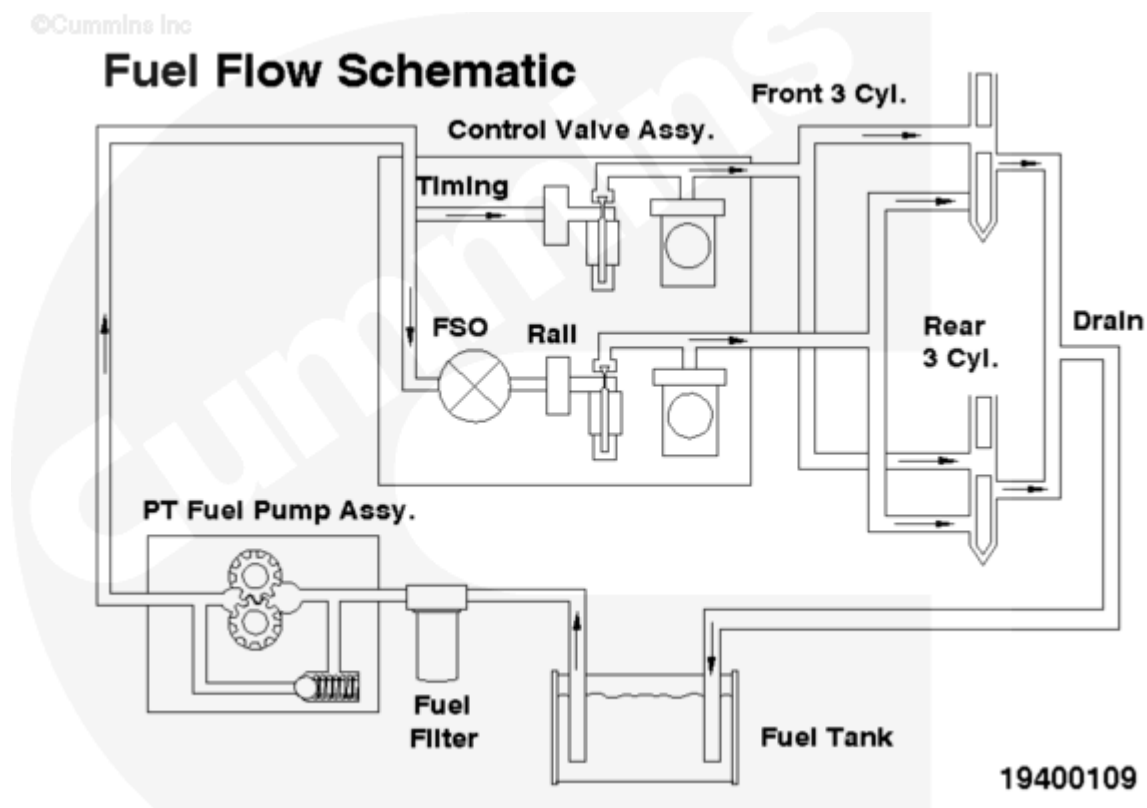
Fuel System Flow Schematic

The ECM uses the timing pressure signal and engine speed to estimate the actual timing the engine is receiving and then constantly compares this value to the desired timing for the given speed and load. When there is an error in these values, the current offset is adjusted to minimize the error. If the offset can **not** compensate to eliminate the error, it will reach its maximum/minimum threshold and Fault Code 467 is logged.

Refer to Troubleshooting Fault Code t05-467 (</qs3/pubsys2/xml/en/procedures/19/19-t05-467.html>)
