Service Bulletin Number: 5579934

Exhaust Gas Recirculation (EGR) System Intake Air Connection Inspection and Cleaning Guidelines

All midrange engines with exhaust gas recirculation (EGR)

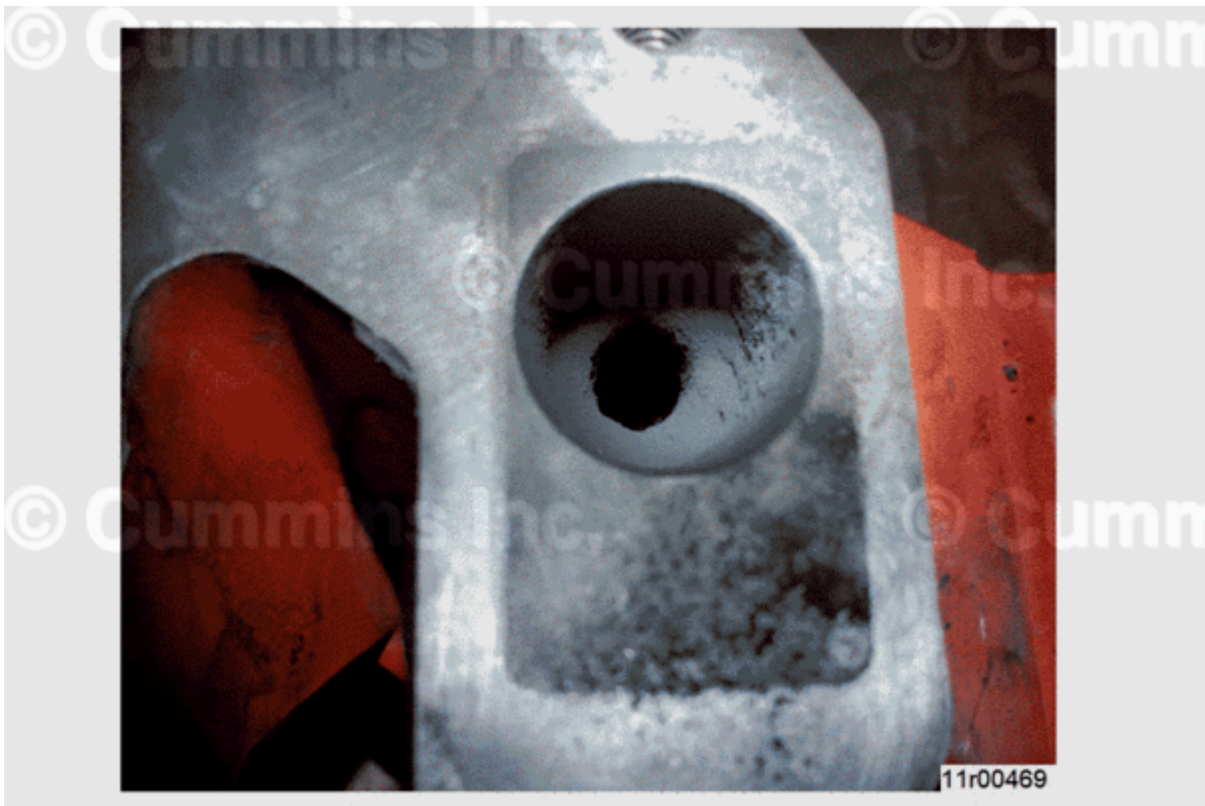
Figure 3, Flow Orifice of a Field Return Intake Air Connection With Excessive Soot.

| Appearance | Signs of uneven deposits can be seen on the walls of the intake exhaust gas entrance ports; asymmetrical exit diameter is observed to be smaller compared to a normal functioning part. |
| Cause | Soot accumulation taking place inside intake air connection exhaust gas entrance ports. |

| Action | Clean intake air connection exhaust gas entrance ports using a nylon brush and solvent. |

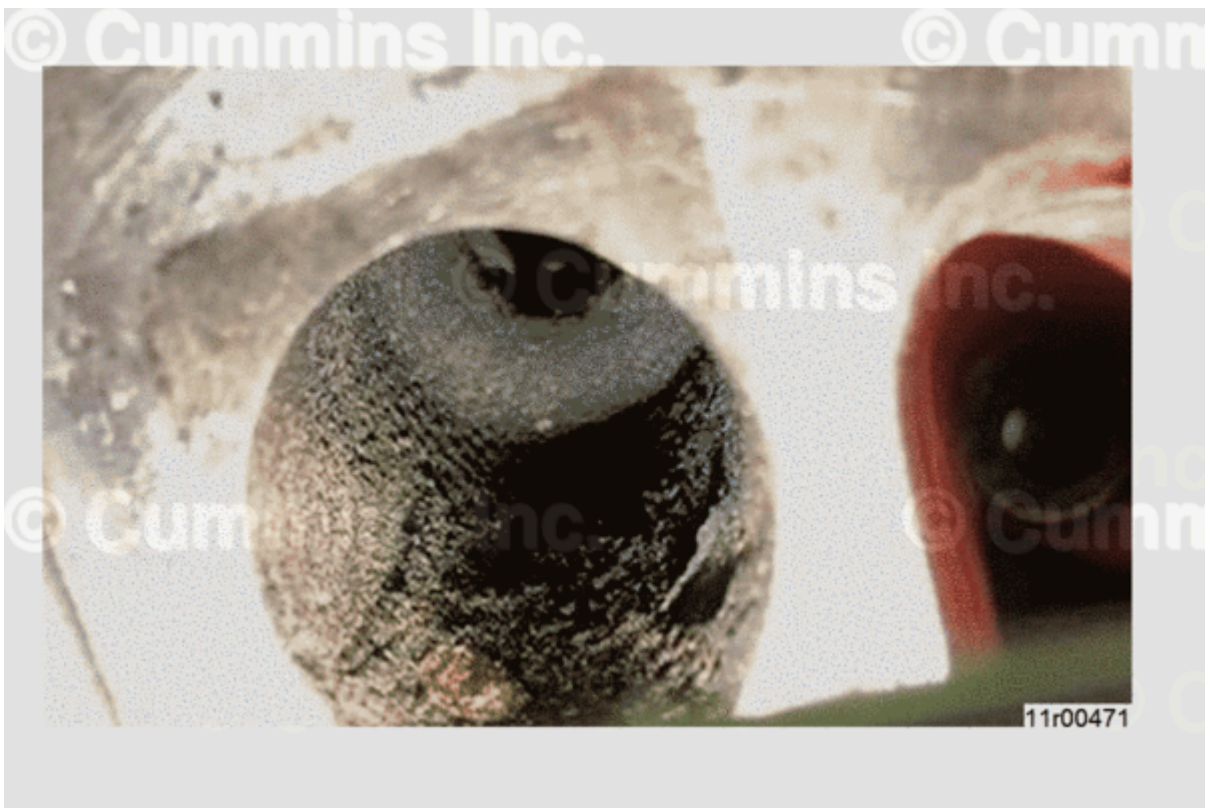
Figure 5, Flow Orifice of a Field Return Intake Air Connection With Excessive Soot.

| Appearance | Signs of soot layer unevenness observed with localized soot lumps; exhaust gas entrance port exit diameter is observed to <b>not</b> be smoother but smaller when compared to normal intake air connection. |
| Cause | Soot accumulation taking place inside intake air connection exhaust gas entrance ports. |

| Action | Clean intake air connection exhaust gas entrance ports using a nylon brush and solvent. |

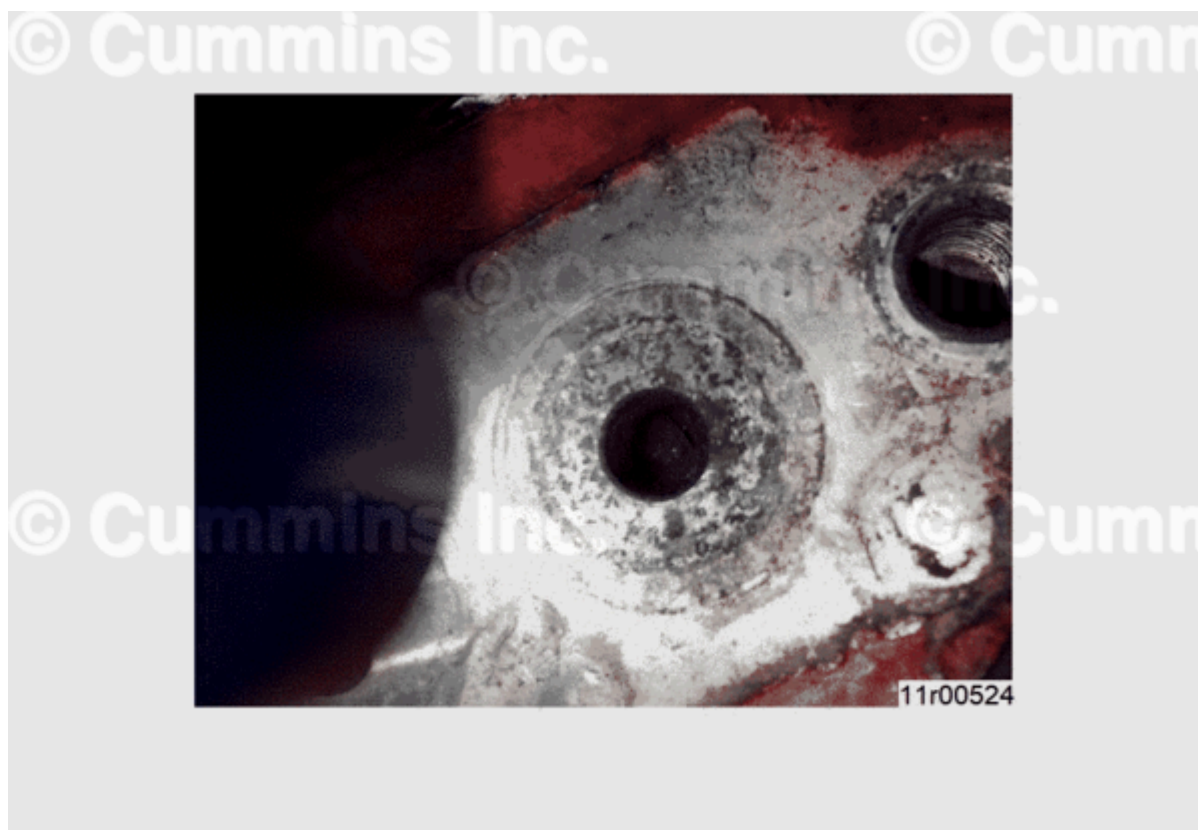
Figure 7, EGR Differential Pressure Sensor Ports of an Air Intake Connection With Excessive Soot.

| Appearance | Soot buildup/plugging observed in the EGR differential pressure sensor port. Light is not observed on the other end of port when using a flashlight. |

| Cause | Soot accumulation inside the EGR differential pressure sensor port. |

| Action | Clean the EGR differential pressure sensor ports with a nylon brush or similar device. |

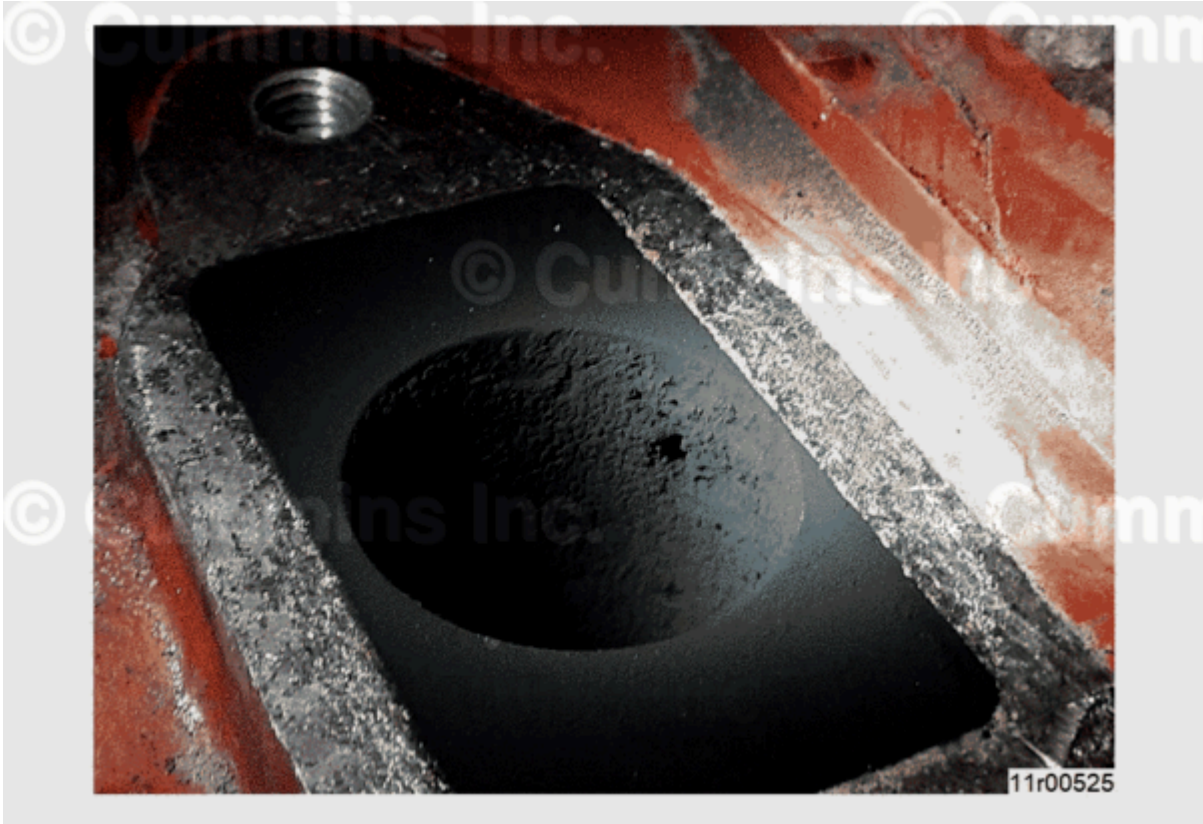
Figure 8, Exhaust Gas Entrance Port of an Air Intake Connection With Excessive Soot.

| Table 8, Exhaust Gas Entrance Port of an Air Intake Connection With Excessive Soot | |
|---|---|
| Appearance | Soot layer observed inside the exhaust gas entrance port; soot buildup/plugging observed at the EGR differential pressure cross drilling. Port/cross drilling is observed to be barely visible or completely missing. |
| Cause | Soot accumulation taking place inside Air Intake Connection exhaust gas entrance ports and plugging EGR differential pressure cross drilling. |

| Table 8, Exhaust Gas Entrance Port of an Air Intake Connection With Excessive Soot | |
|---|---|
| Action | Clean the EGR differential pressure cross drilling and the exhaust gas entrance ports using a nylon brush and solvent. |

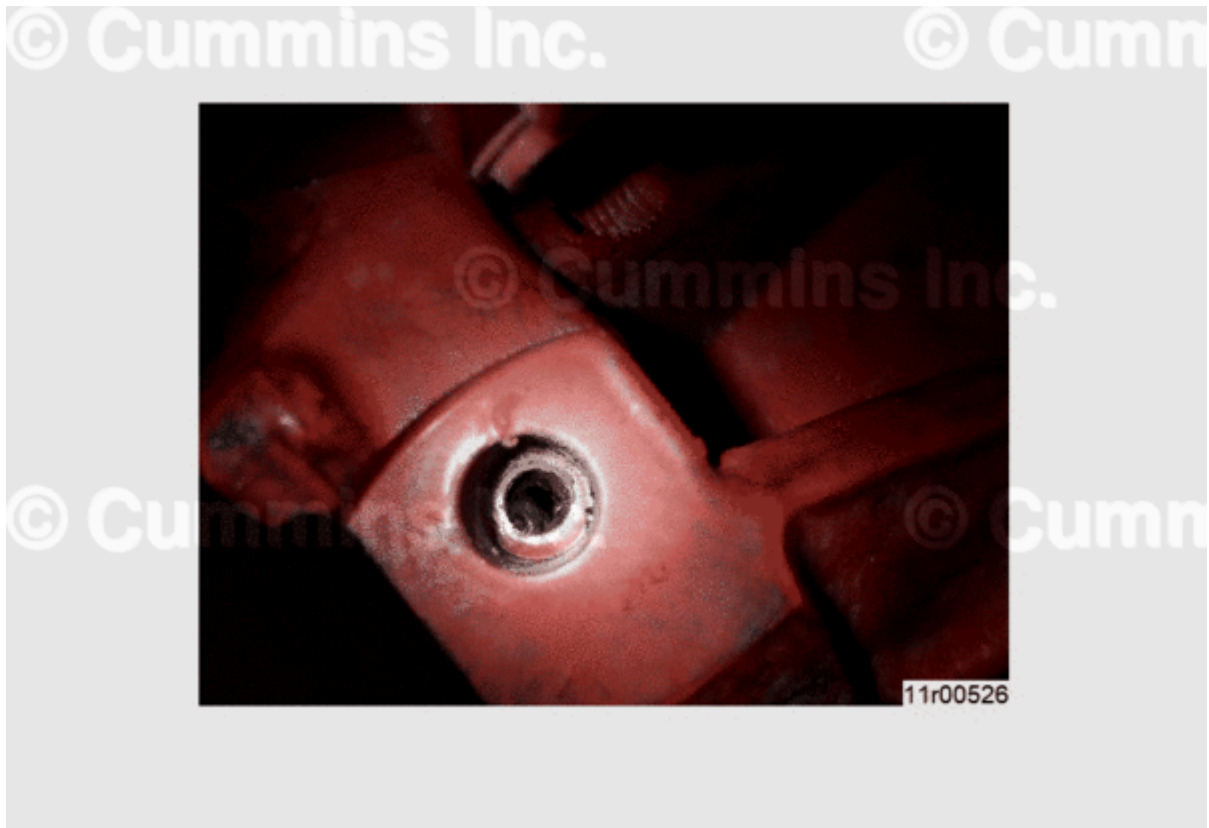
Figure 9, EGR Differential Pressure Cross Drilling of an Air Intake Connection With Excessive Soot.

| Appearance | Soot buildup/plugging observed inside the EGR differential pressure cross drilling after removing pipe plug. |
| Cause | Soot accumulation inside the Air Intake Connection EGR differential pressure cross drilling. |

| Action | Clean the EGR differential pressure cross drilling with a nylon brush or similar device. If the cross drilling is blocked, it may be necessary to soak the air intake connection in safety solvent before using device to remove the blockage. After cleaning the cross drilling, install the pipe plug. Use thread sealant, Part Number 3375066, or equivalent, to prevent leaks. |

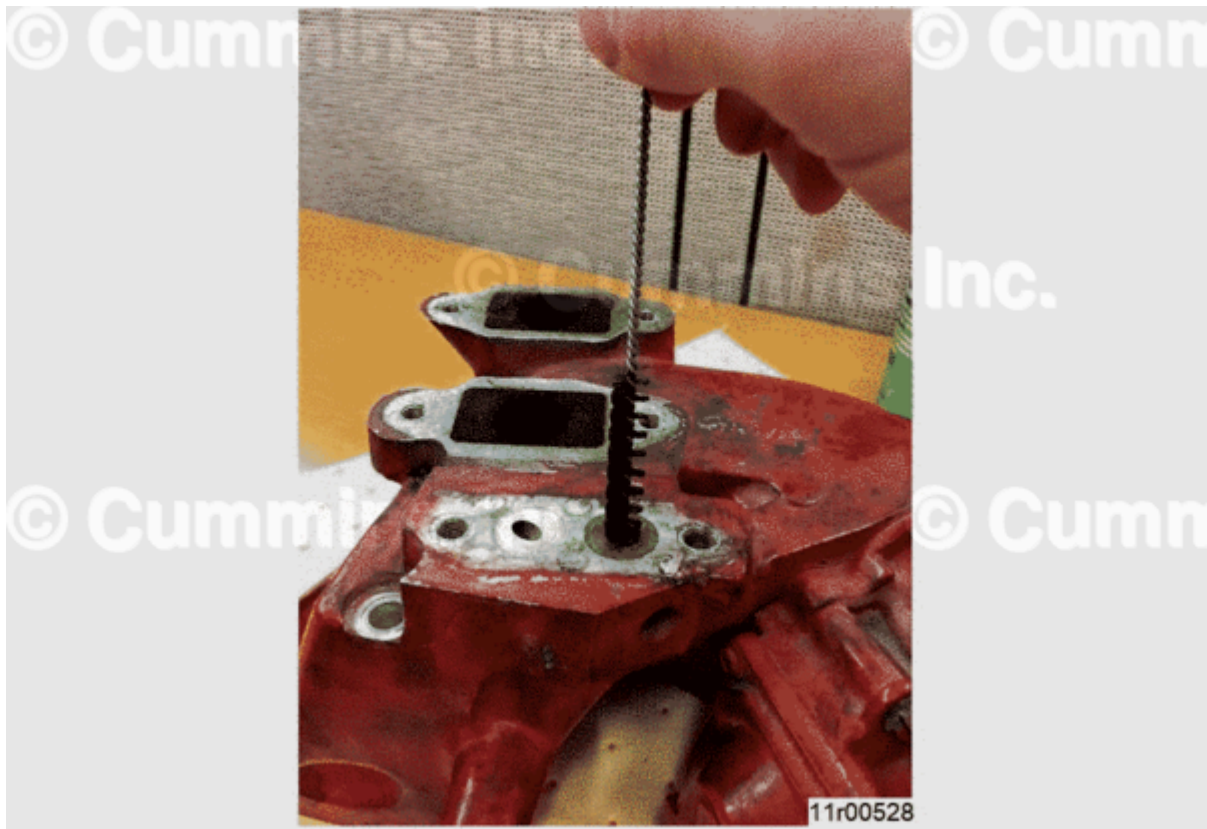
Figure 11, Cleaning EGR Differential Pressure Sensor Port of an Air Intake Connection With Excessive Soot.

| Appearance | Nylon brush or similar device and solvent being used to clean soot off inside of EGR differential pressure sensor port. |

| Action | Complete cleaning of EGR differential pressure sensor port. |

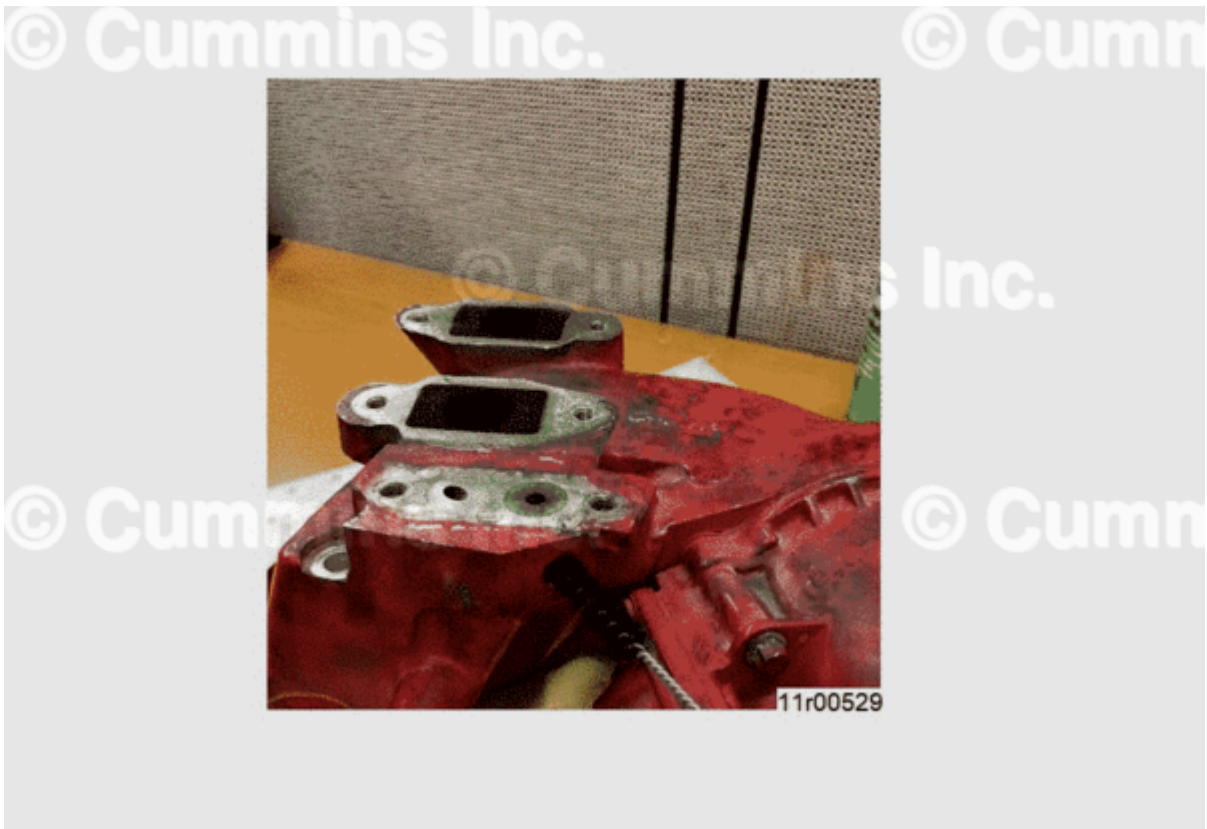
Figure 12, Cleaning EGR Differential Pressure Cross Drilling of an Air Intake Connection With Excessive Soot.

| Appearance | Nylon brush or similar device and solvent being used to clean soot off inside of EGR differential pressure cross drilling. |

| Action | Clean the EGR differential pressure cross drilling with a nylon brush or similar device. If the cross drilling is blocked, it may be necessary to soak the air intake connection in safety solvent and use device to remove the blockage. After cleaning the cross drilling, install the pipe plug. Use thread sealant, Part Number 3375066, or equivalent, to prevent leaks. |

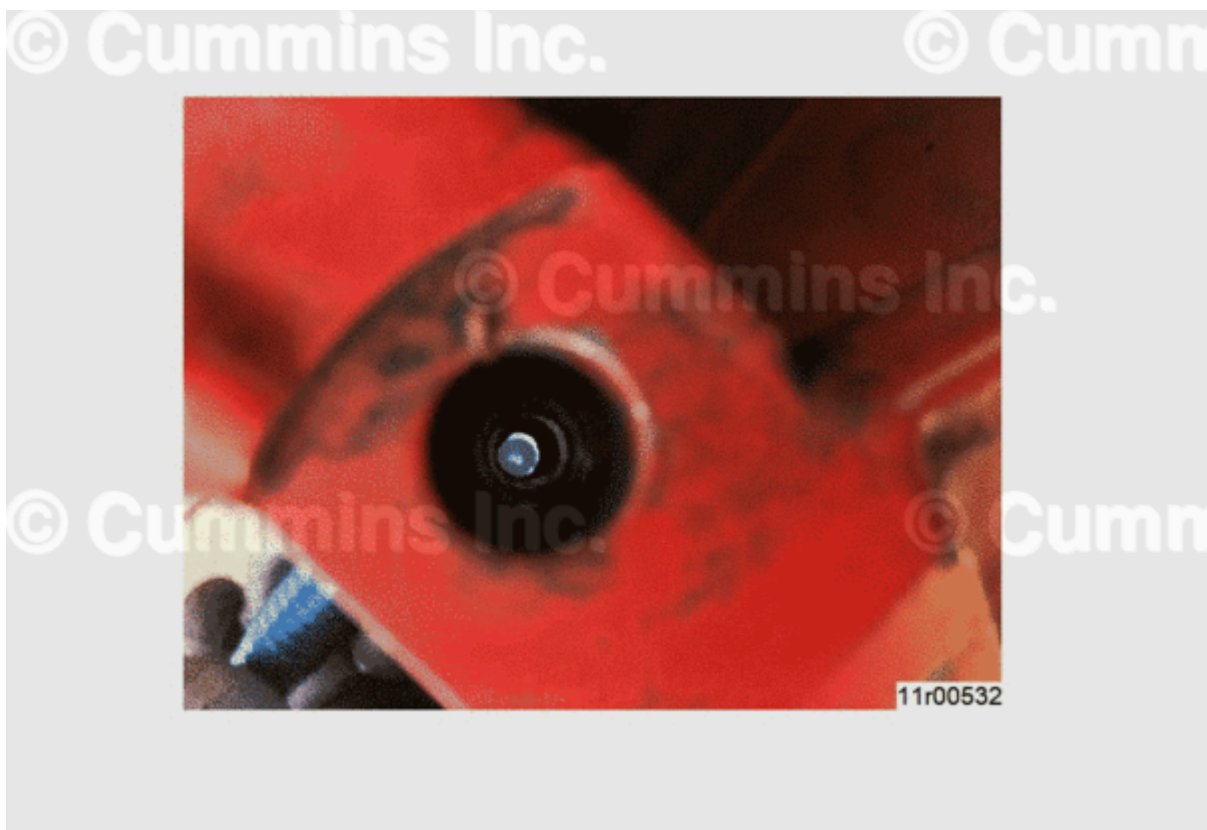
Figure 15, EGR Differential Pressure Cross Drilling of an Air Intake Connection After Proper Cleaning.

| Appearance | Soot buildup is properly cleaned, no blockage or plugging is observed; diameter of the EGR differential pressure cross drilling is symmetrical and flashlight light can be seen. |
| Cause | EGR differential pressure cross drillings were properly cleaned during repair. |

| Action | Install the pipe plug. Use thread sealant, Part Number 3375066, or equivalent, to prevent leaks. |
