Technical Service Bulletin: TSB150171

High Mount / Mid Mount - Angled Turbochargers with Top Mount Turbocharger Actuator - Lubricating Oil Found at Turbocharger Sector Gear and Turbocharger Actuator Gear When Turbocharger Actuator is Removed

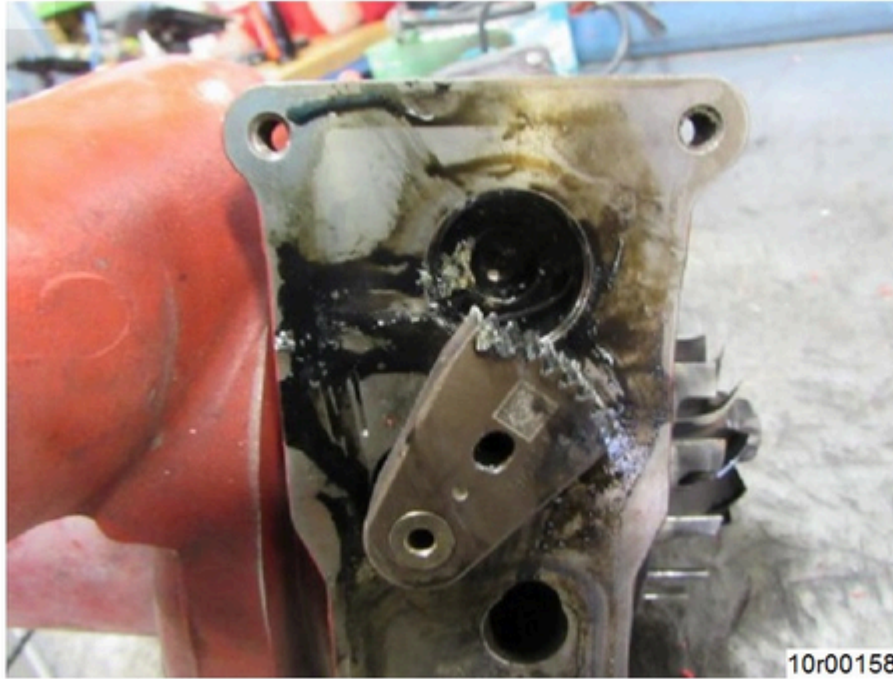
During troubleshooting on engines equipped with high mount turbochargers with top mount turbocharger actuators, lubricating oil has been found around the turbocharger sector gear and the variable geometry turbocharger actuator gear. This is normal and does **not** indicate a malfunction has occurred.

See Figure 1 and Figure 2 below for examples of acceptable lubricating oil leakage near the turbocharger sector gear and the variable geometry turbocharger actuator gear.

Figure 1, Acceptable Lubricating Oil Leakage Around the Turbocharger Sector Gear

Turbochargers and variable geometry turbocharger actuators should **not** be replaced if lubricating oil is found as shown in Figure 1 and Figure 2 above. For confirmation of actual lubricating oil leak from the turbocharger or turbocharger actuator:

- See the corresponding Service Manual. Reference Procedure 010-033 and 010-134 in Section 10.

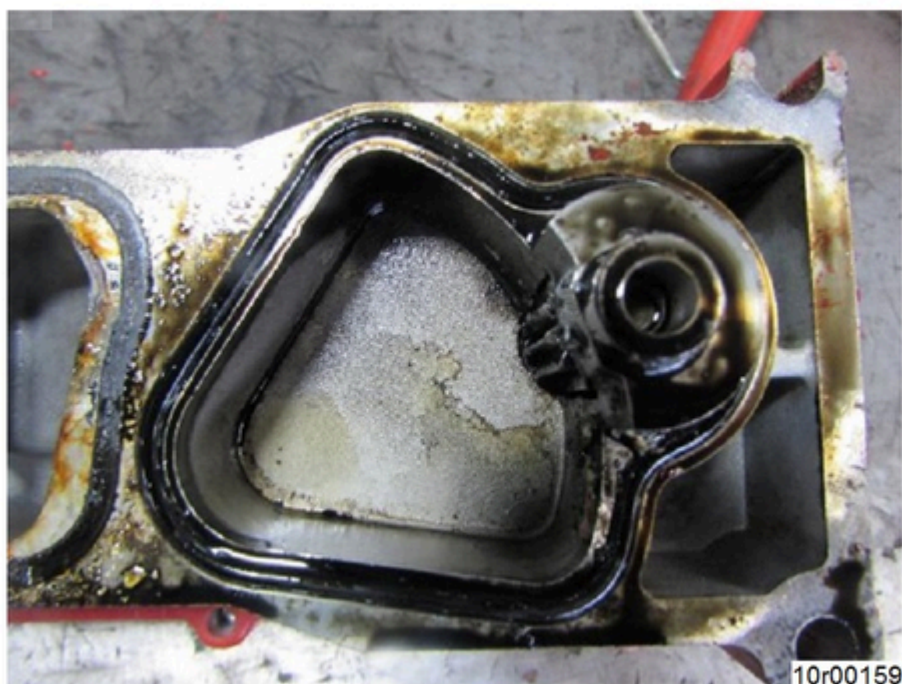
Figure 2, Acceptable Lubricating Oil Leakage Around the Variable Geometry Turbocharger Actuator Sector Gear
