Technical Service Bulletin: TSB150187

Released Date: 23-May-2024

Fault Codes 322, 323, 324, 325, 331, and 332 Generated By Metallic Debris on Injector

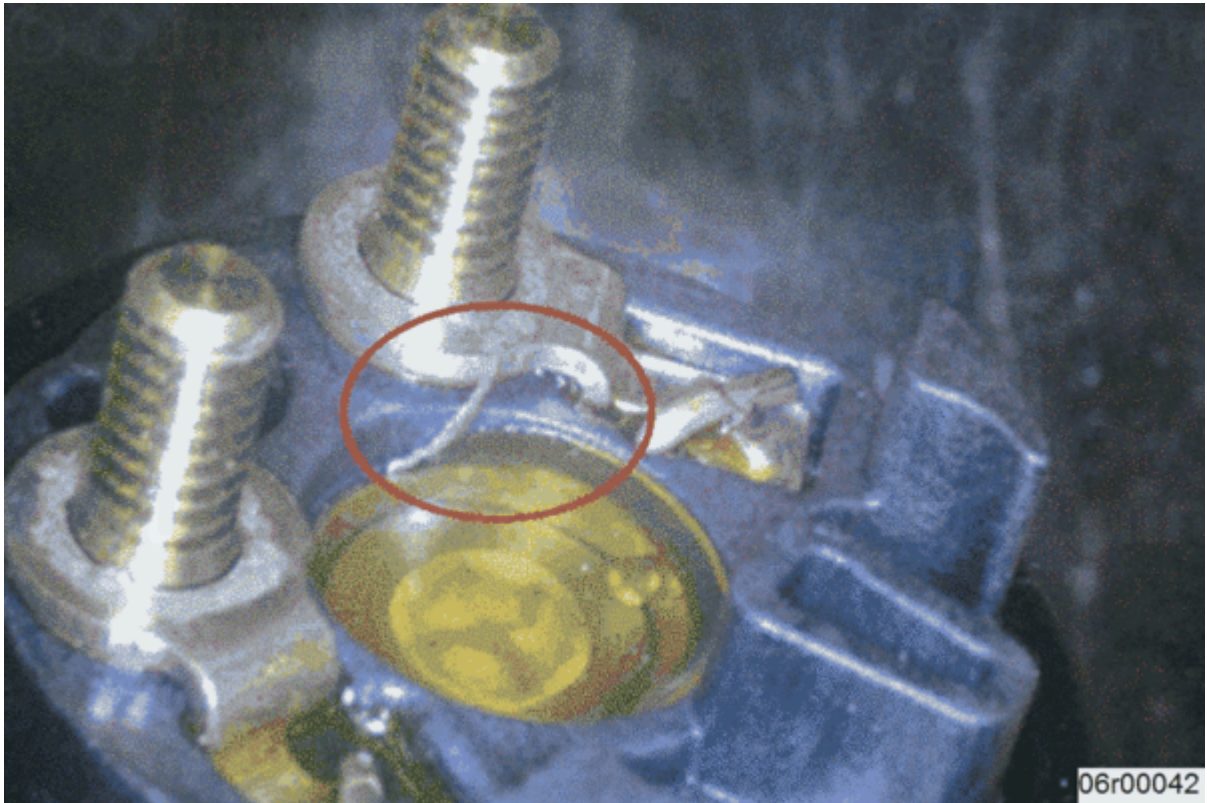
- Metallic debris was introduced onto the injector(s) as a result of a machining processes during engine assembly.
- Metallic sliver can be created when torqueing the injector solenoid wires to the injector solenoid signal post.
- The metallic debris can cause a short circuit path within the injector(s) stator terminals leading to fault code(s).

Figure 1, Injector Stator Contaminated With Metal Debris.

If metal debris is identified as shown in Figure 1 and 2 above, perform the following:

- With injectors in place, disconnect injector solenoid wires for affected injector. Clean the affected area of the metallic debris with safety solvent and a soft, clean cloth.
- Connect and torque injector solenoid wires. See corresponding service manual. Reference Procedure 019-063 in Section 19.
- Inspect the top of the injector to verify that no metal slivers were created or are present on the top of the injector.

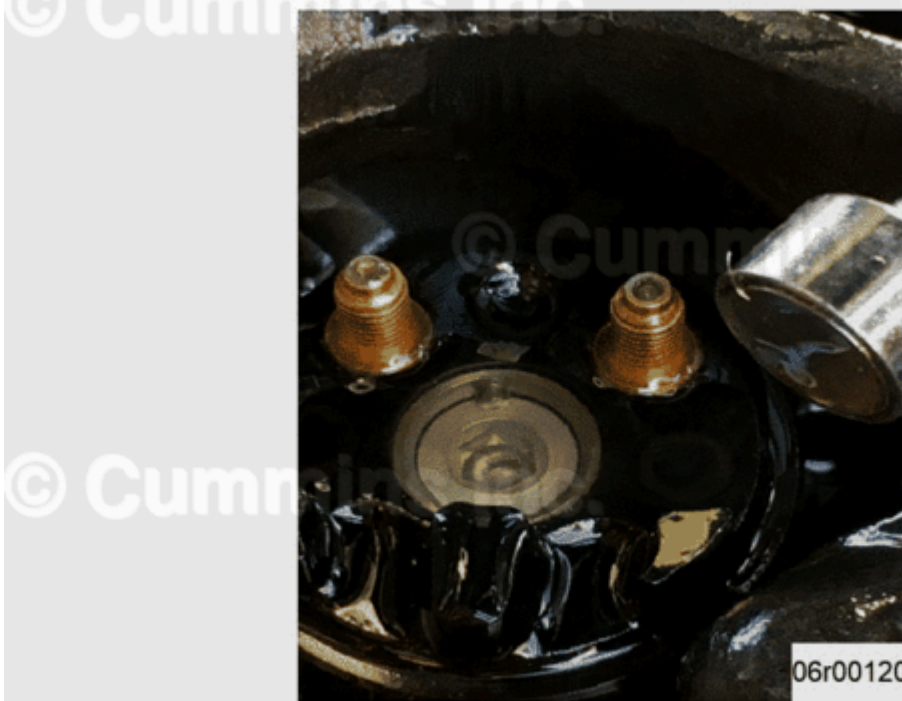
Figure 2, Medium Duty Injector Stator Contaminated with Metal Debris.
