Technical Service Bulletin: TSB160010

**INSITE™ Electronic Service Tool Error When Adjusting Aftertreatment Diesel Exhaust Fluid Level System Configuration Programmable Parameters**

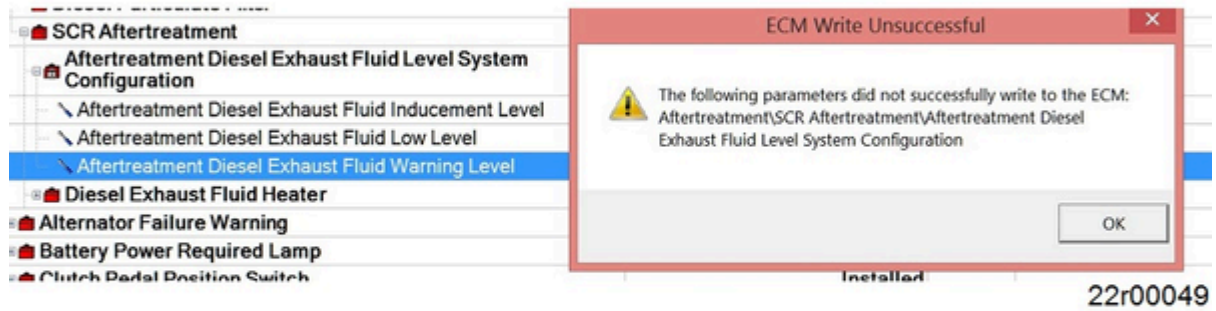
Figure 1, ECM Write Unsuccessful Error Message

When adjusting the values of Aftertreatment Diesel Exhaust Fluid Inducement Level, Aftertreatment Diesel Exhaust Fluid Low Level, or Aftertreatment Diesel Exhaust Fluid Warning Level with INSITE™ electronic service tool on Model Year 2015 and Model Year 2016 engines, an error message will display as shown in Figure 1 below.

- Disregard the engine control module (ECM) Write Unsuccessful error message. The parameters will write and save to ECM memory.
- The error message issue will be resolved in a future software release scheduled for mid-year 2016.
