Technical Service Bulletin: TSB170047

Aftertreatment System Alignment Arrows Misaligned on Firetruck Applications

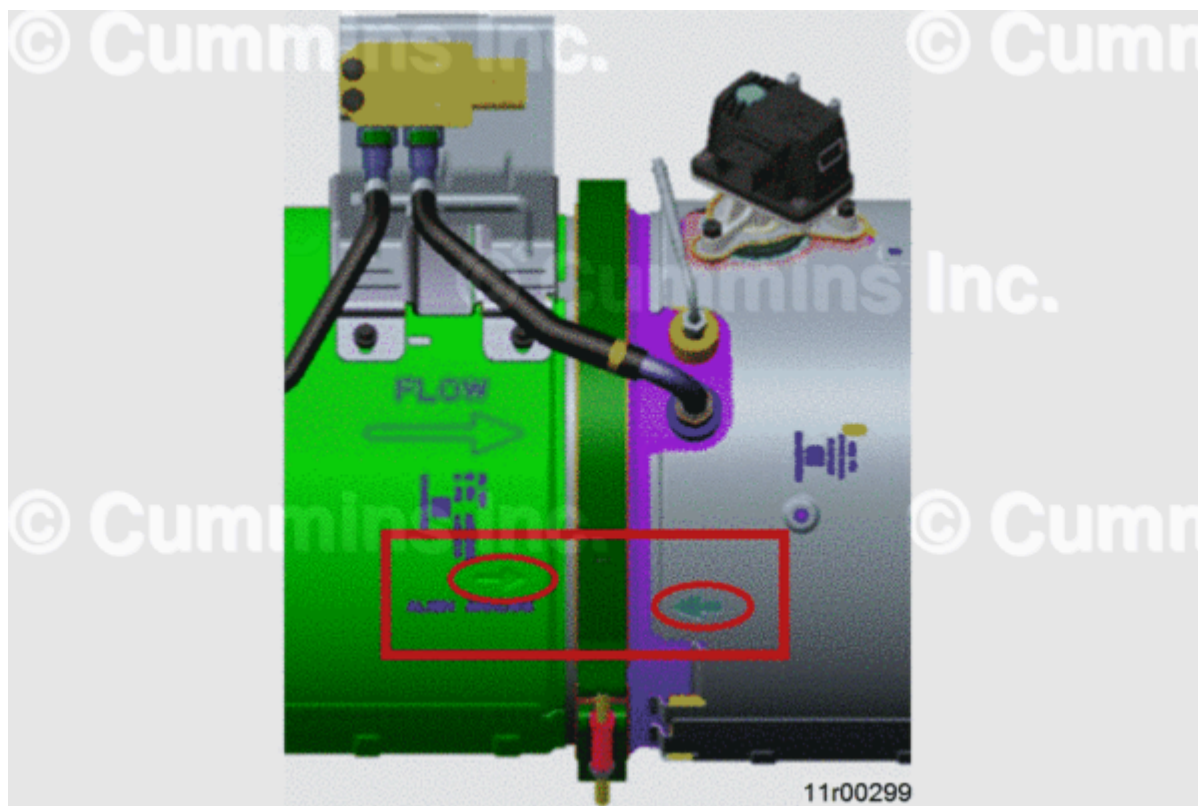
Figure 1, Alignment Arrows.

Alignment arrows on aftertreatment diesel particulate filter (DPF) and aftertreatment decomposition tube are intentionally misaligned by approximately 10 degrees. See Figure 1 below.

**If aftertreatment DPF and aftertreatment decomposition tube alignment arrows are in alignment, differential pressure sensor tube connected to aftertreatment decomposition tube will not fit properly and can become kinked and/or bent.**

- Misalignment of aftertreatment DPF and aftertreatment decomposition tube is required to allow for adequate aftertreatment system clearance in this application.
- Prior to loosening or removal of aftertreatment v-band clamp, aftertreatment DPF, or aftertreatment decomposition tube; an orientation reference line **must** be drawn across aftertreatment DPF, v-band clamp, and decomposition tube to aid in assembly.
- Use orientation reference lines added prior to loosening or removal to assist in correct differential pressure sensor tube alignment during assembly.
