# Fault Code: 128

## Intake Manifold Pressure Sensor 2 Circuit - Shorted High (Right Bank)

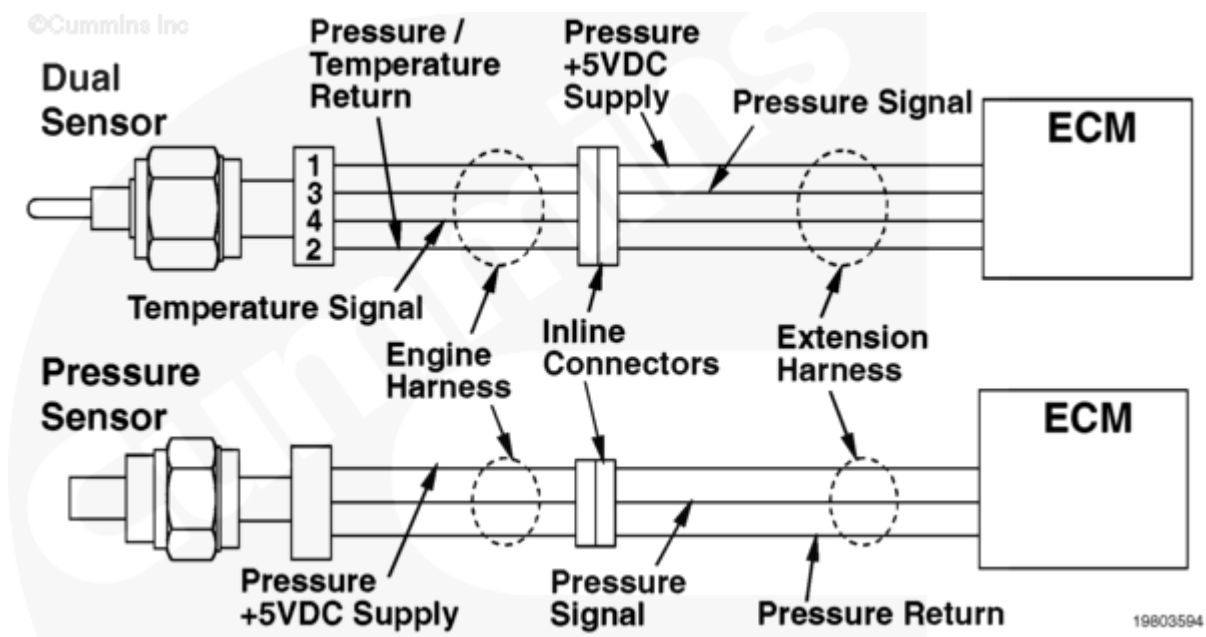
Intake Manifold Pressure Sensor 2 Circuit

The intake manifold pressure sensor monitors boost pressure and passes information to the electronic control module (ECM). High voltage will trip Fault Code 128 and can be caused by shorts in the supply, signal, or return wires, an open in the return wire, or a failed sensor.
