# Fault Code: 129

## Intake Manifold Pressure Sensor 2 Circuit - Shorted Low

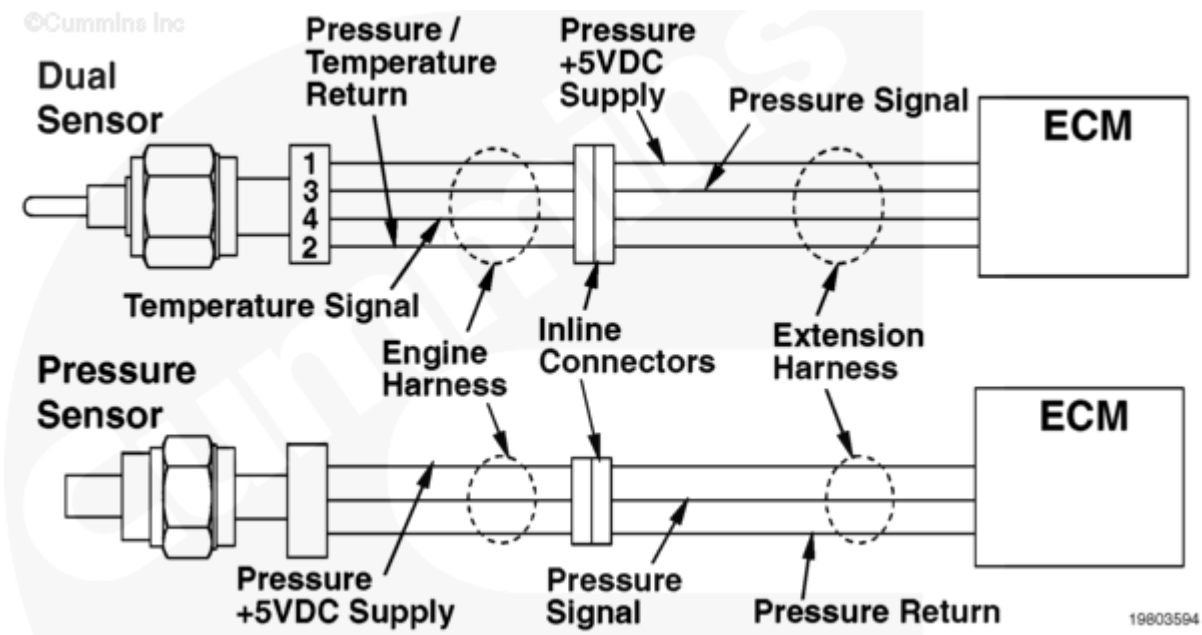
Intake Manifold Pressure Sensor 2 Circuit

The intake manifold pressure sensor monitors boost pressure and passes information to the electronic control module (ECM). Low voltage will trip Fault Code 129 and can be caused by shorts in the supply, signal, or return wires, an open in the supply or signal wires, low supply voltage from the ECM, or a failed sensor.
