## Fault Code: 2111

### Aftercooler Water Inlet Temperature Sensor - Shorted High

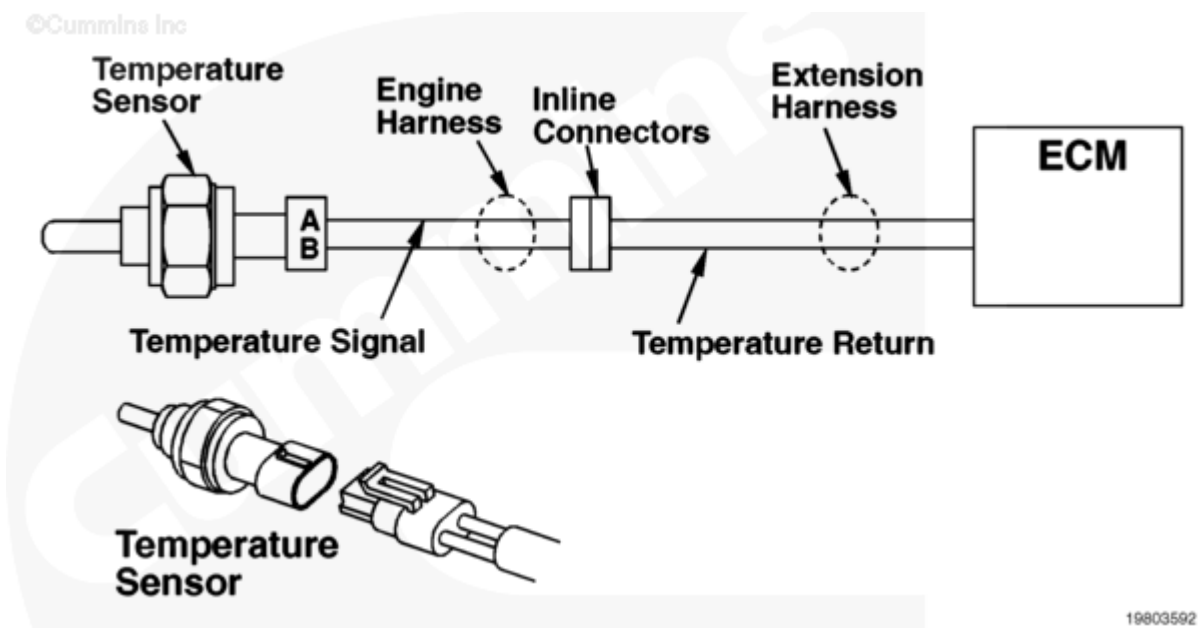
Aftercooler Water Inlet Temperature Sensor Circuit

The aftercooler water inlet temperature sensor is used by the electronic control module (ECM) to monitor the ability of the engine cooling system to cool down the engine coolant. The aftercooler water inlet temperature is used by the ECM for the engine protection system. The ECM monitors the voltage on the aftercooler water inlet temperature signal pin and expects to see a voltage

vary between 0.5 to 4.5 VDC during normal engine operation. High voltage will trip Fault Code 2111 and can be caused by shorts in the signal, or return wires, an open in the return wire, or a failed sensor.
