## Fault Code: 236

### Engine Speed/Position Sensor Circuit - Loss of Signal

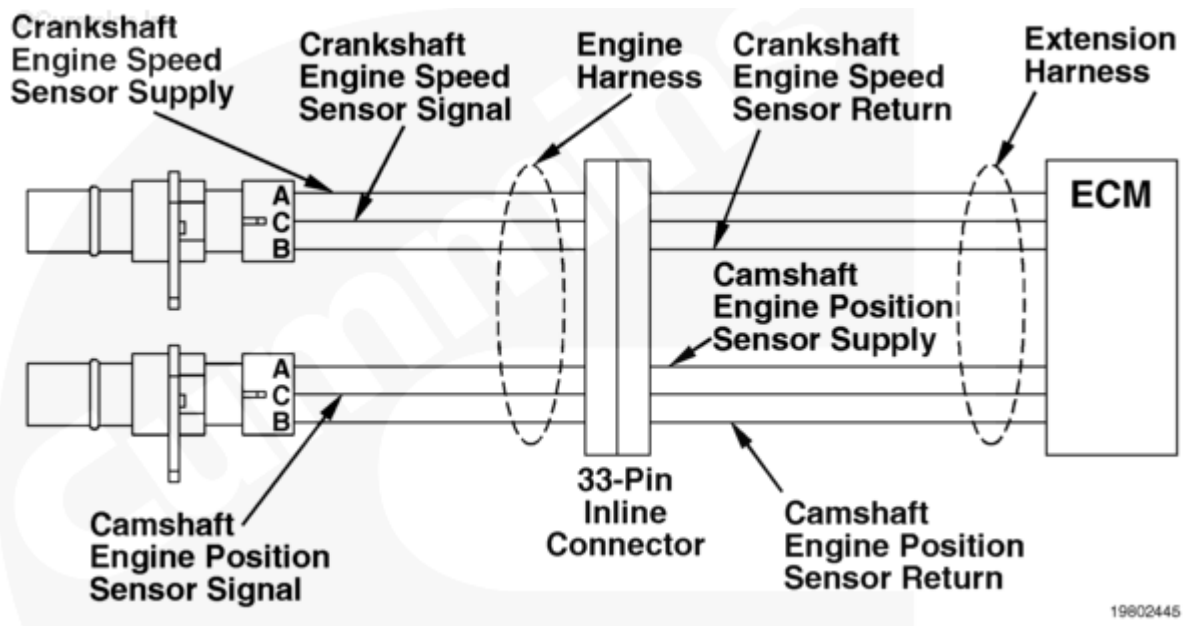
Engine Speed/Position Sensor Circuits

| Codes | Reason | Effect |
|---|---|---|
| Fault Code: 236<br><br>PID(P):<br>SPN:<br>FMI:<br>Lamp: Shutdown<br>SRT: | Engine speed/position sensors signal is <b>not</b> detected. | Engine will shut down. |

Possible causes of this fault code include damaged camshaft engine position sensor, open or shorted circuit, and power supply voltage failure.

Refer to Troubleshooting Fault Code t05-236 (</qs3/pubsys2/xml/en/procedures/01/01-t05-236.html>)
