## Fault Code: 467

### Timing Rail Actuator - Data Incorrect

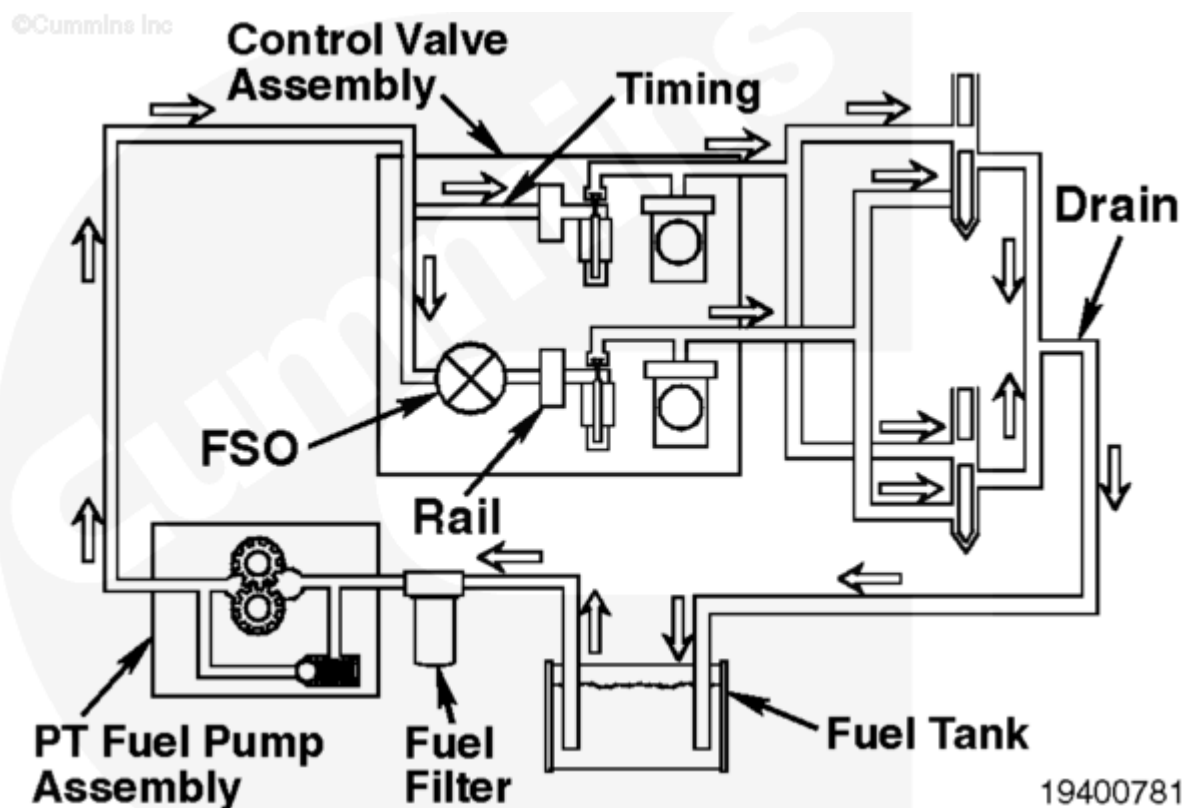
Fuel System Flow Schematic

| Codes | Reason | Effect |
|---|---|---|
| Fault Code: 467<br><br>PID(P):<br>SPN:<br>FMI:<br>Lamp: Warning<br>SRT: | Timing rail actuator circuit - data incorrect. The error between desired timing fueling and commanded timing fueling exceeds a normal limit. | No action taken by the ECM.<br>Possible loss of performance. |

The ECM uses the timing pressure signal and engine speed to estimate the actual timing the engine is receiving, and then constantly compares this value to the desired timing for the given speed and load. When there is too large of an error in these values for too long, Fault Code 467 is logged.

Refer to Troubleshooting Fault Code t05-467 (</qs3/pubsys2/xml/en/procedures/01/01-t05-467.html>)
