## Fault Code: 778

### Camshaft Engine Position Sensor Error

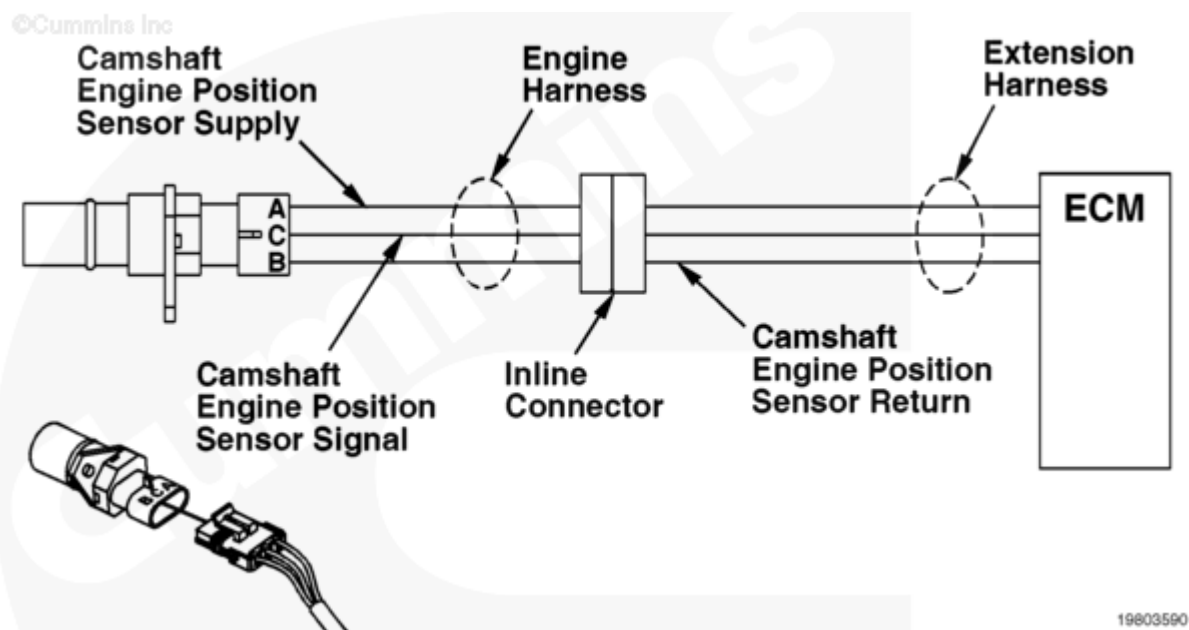
Camshaft Engine Position Sensor Circuit

| Codes | Reason | Effect |
|---|---|---|
| Fault Code: 778<br><br>PID(P):<br>SPN:<br>FMI:<br>Lamp: Shutdown<br>SRT: | No engine speed signal detected from the camshaft engine position sensor. | Engine will shutdown. |

The camshaft engine position sensor provides engine speed and position information to the electronic control module (ECM). The sensor **must** be powered up by 5 VDC to operate. The sensor generates the signal from an extra lobe on the camshaft.

Possible causes of this fault code include damaged camshaft engine position sensor, open or shorted circuit, or power supply voltage failure.

Refer to Troubleshooting Fault Code t05-778 (/qs3/pubsys2/xml/en/procedures/01/01-t05-778.html)
