## Fault Code: 153

### Intake Manifold Air Temperature Sensor Circuit - Voltage Above Normal or Shorted to High Source

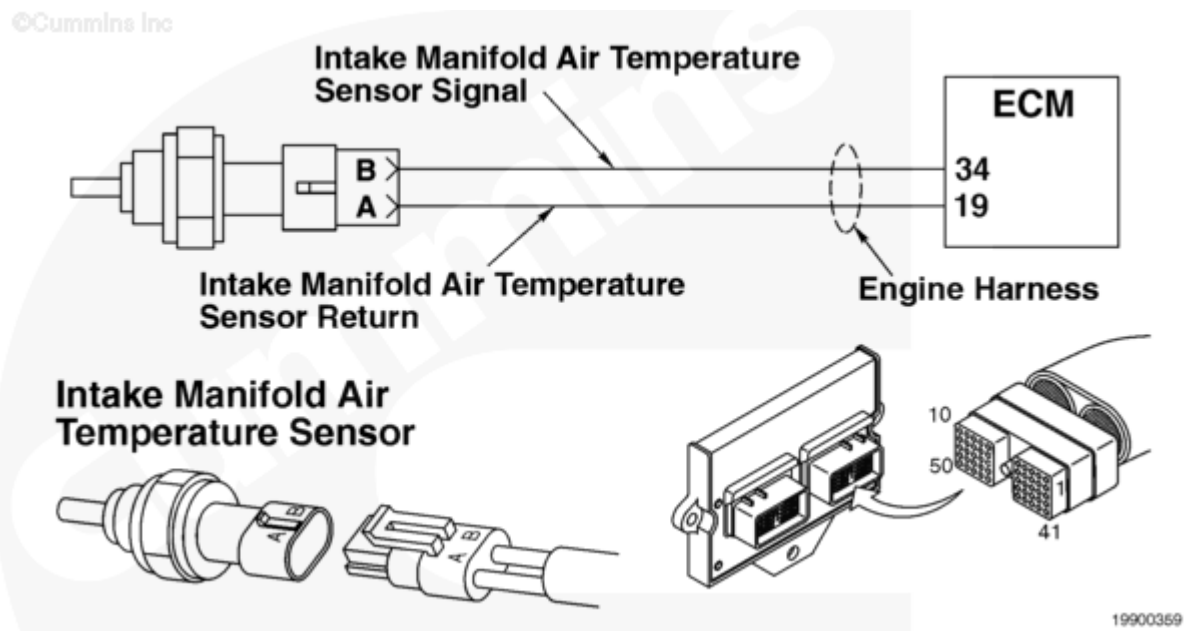
Intake Manifold Air Temperature Sensor Circuit

The intake manifold temperature sensor is used by the electronic control module (ECM) to monitor the temperature of the air in the intake manifold after the aftercooler. The intake manifold temperature sensor is used by the ECM for the engine protection system, timing, and fueling control.
