## Fault Code: 154

### Intake Manifold Air Temperature Sensor Circuit - Voltage Below Normal or Shorted to Low Source

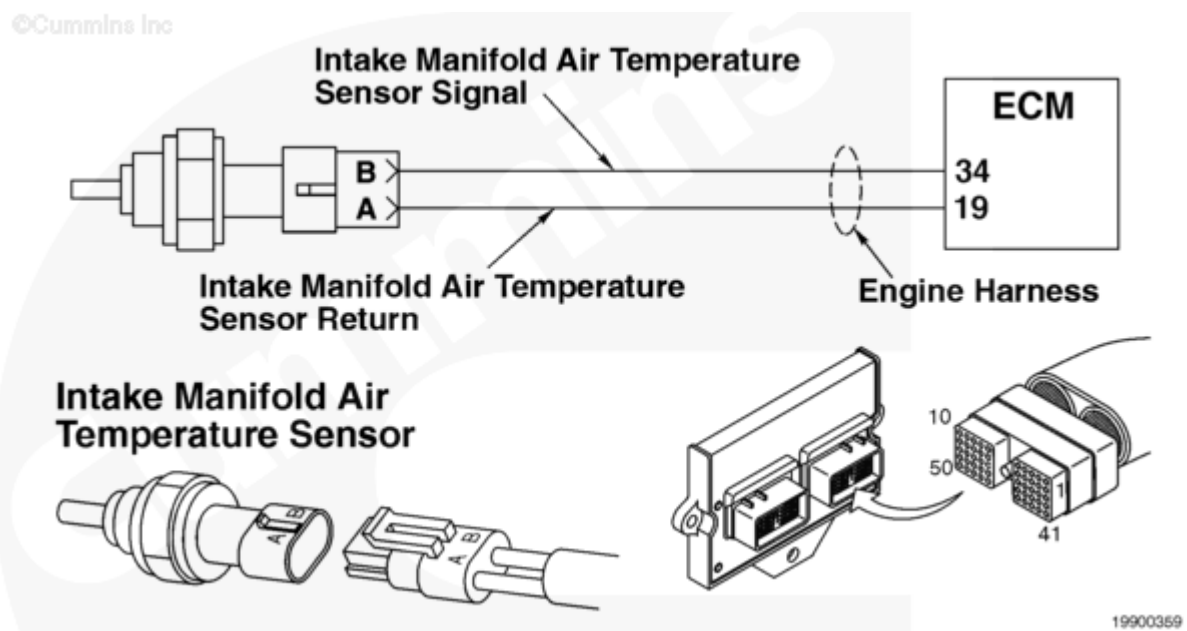
Intake Manifold Air Temperature Sensor Circuit

| Codes | Reason | Effect |
|---|---|---|
| Fault Code: 154<br><br>PID(P): P105<br>SPN: 105<br>FMI: 4<br>Lamp: Amber<br>SRT: | Intake manifold air temperature sensor circuit - voltage below normal or shorted to low source. | No engine protection for circuit or sensor failure. |

The intake manifold temperature sensor is used by the electronic control module (ECM) to monitor the temperature of the air in the intake manifold after the aftercooler. The intake manifold temperature sensor is used by the ECM for the engine protection system, timing, and fueling control.

Refer to Troubleshooting Fault Code t05-154 (</qs3/pubsys2/xml/en/procedures/07/07-t05-154.html>)
