## Fault Code: 4689

### Water in Fuel Indicator Sensor Circuit - Voltage Below Normal or Shorted to Low Source

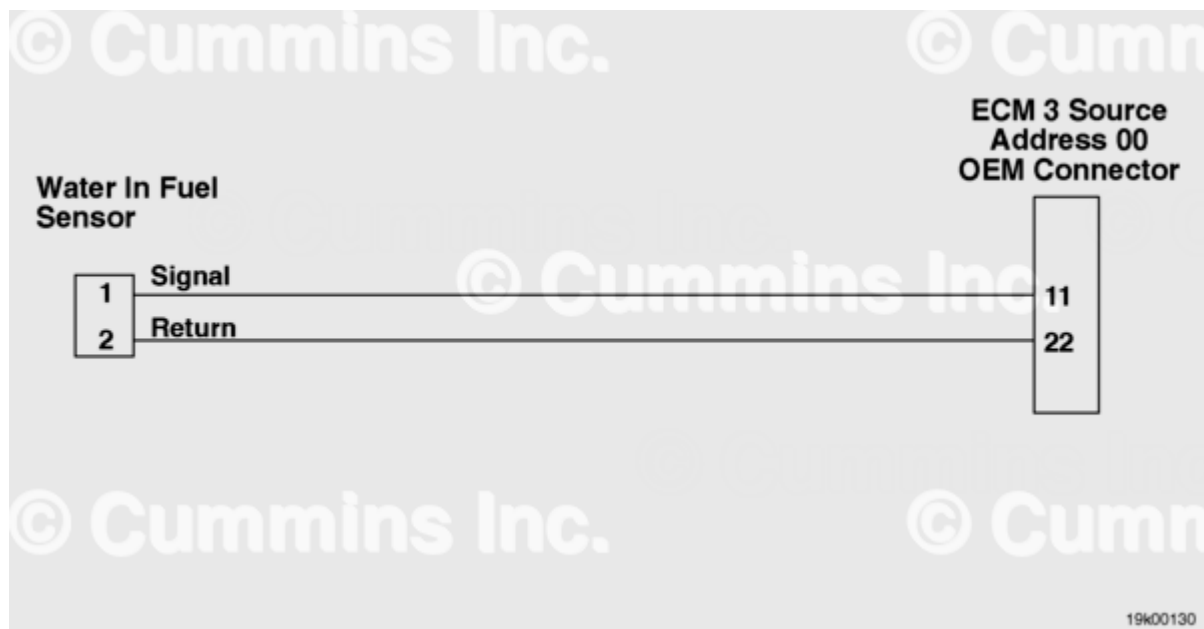
Water in Fuel Indicator Sensor Circuit

The water in fuel indicator sensor is installed by the original equipment manufacturer (OEM). The water in fuel indicator sensor sends a signal to the engine control module (ECM) when a set volume of water has accumulated in the fuel filter. The water in fuel indicator sensor circuit contains two wires: a water in fuel indicator RETURN (sensor return 1) ground wire and a water in fuel indicator SIGNAL wire.

- Signal circuit shorted to ground in the harness, sensor, or connector.

Refer to Troubleshooting Fault Code t05-4689. (</qs3/pubsys2/xml/en/procedures/122/122-t05-4689.html>)
