## Fault Code: 2185

### Sensor Supply 4 Circuit - Voltage Above Normal or Shorted to High Source

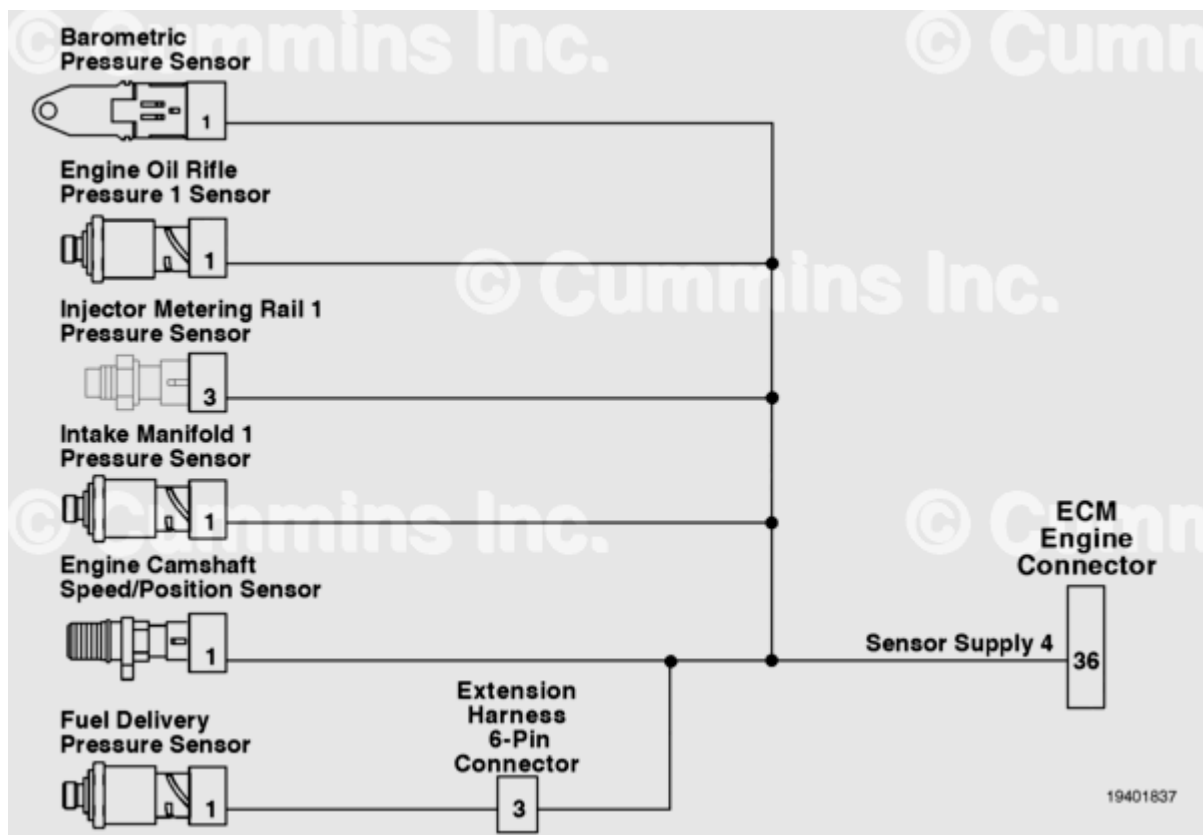
QSK19 CM2150 Industrial - Sensor Supply 4 Circuit

| Codes | Reason | Effect |
|---|---|---|
| Fault Code: 2185<br><br>PID(P):<br>SPN: 3512<br>FMI: 3<br>Lamp: Amber<br>SRT: | High voltage detected at the sensor supply 4 circuit. | Loss of some sensor functionality. |
