## Fault Code: 227

### Sensor Supply 2 Circuit - Voltage Above Normal or Shorted to High Source

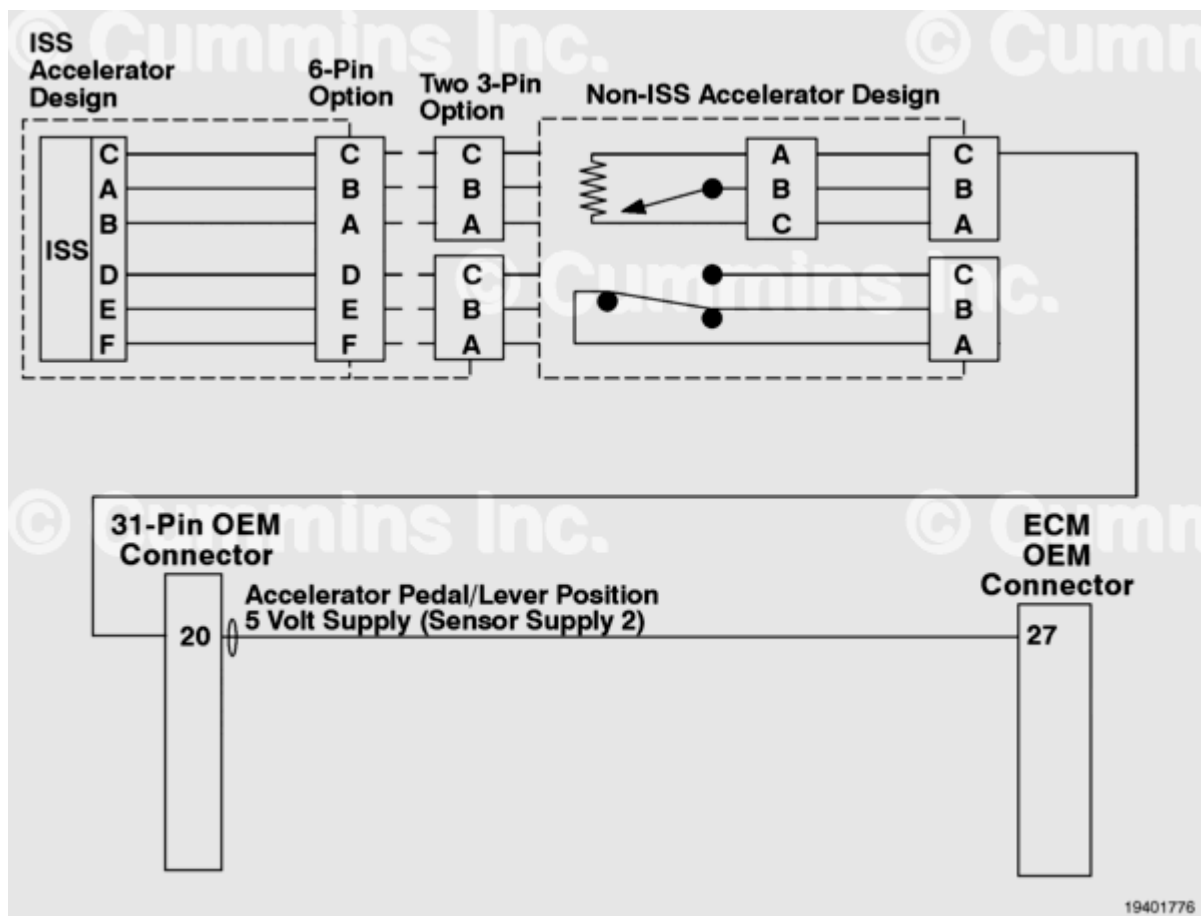
| Codes | Reason | Effect |
|---|---|---|
| Fault Code: 227<br><br>PID(P):<br>SPN: 3510<br>FMI: 3/3<br>Lamp: Amber<br>SRT: | High voltage detected at sensor supply number 2 circuit. | Loss of some sensor functionality. |

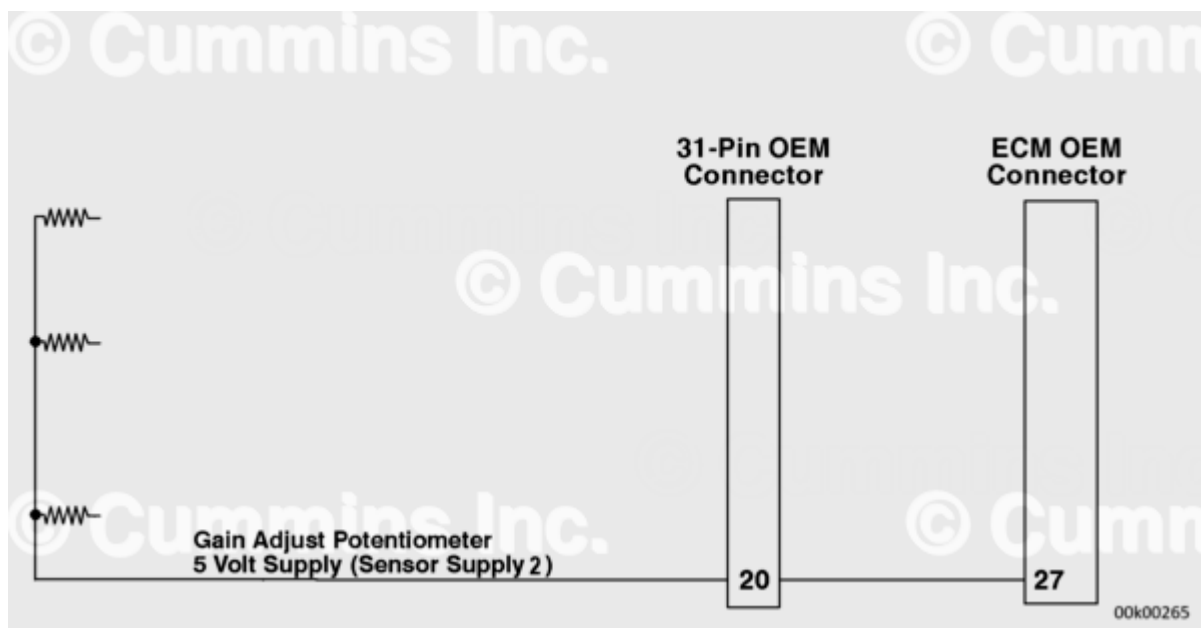
## QSK19 CM2150 Power Generation - Sensor Supply 2 Circuit

The sensor supply 2 circuit of the engine control module (ECM) provides a 5 volt supply to various sensors.
