Service Bulletin Number: 2883594

EGR Cooler Reuse Guidelines

- All exhaust gas recirculation (EGR) equipped engines.

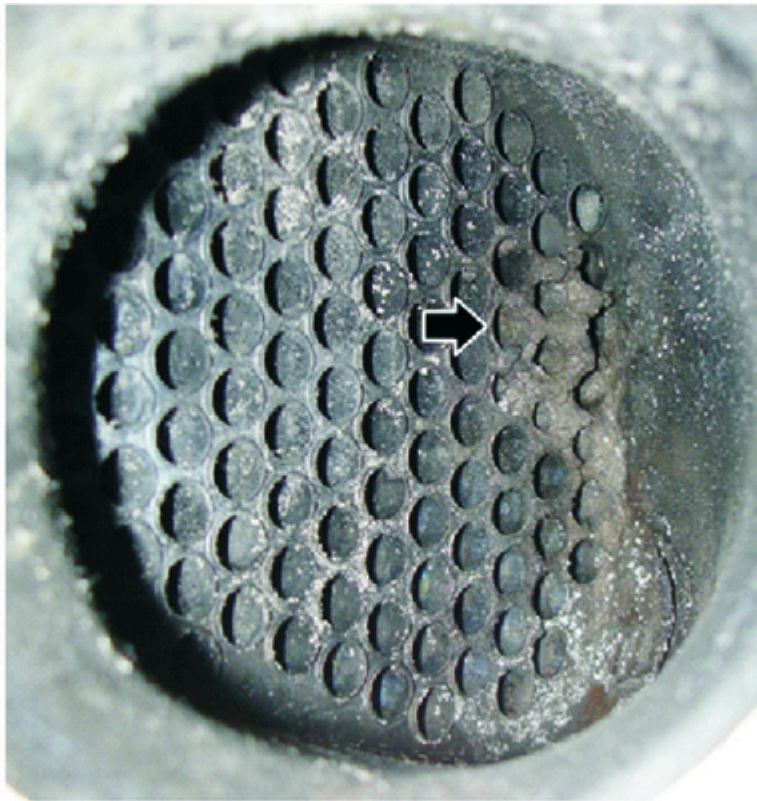
11o00028

Figure C. Uneven soot buildup, white coolant tracks.

| Table 1, Reuse Guidelines for Figures A, B, C, D, E, F, G, H, I, and J | | |
|---|---|---|
| C, D, and E | Uneven soot buildup, coolant tracks | Replace <sup>2</sup> |

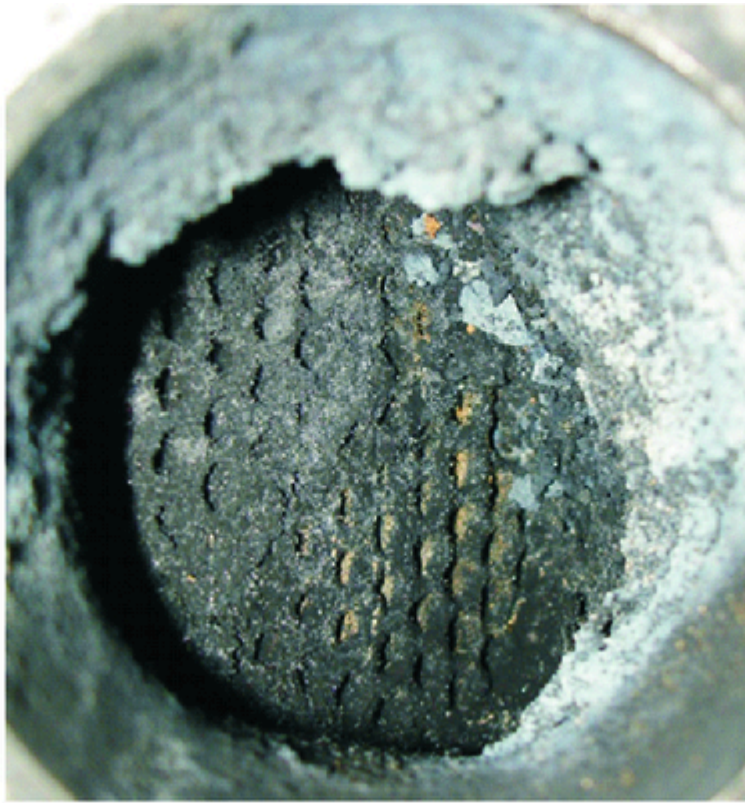
11o00032

Figure G. Very heavy soot buildup in the EGR cooler exhaust outlet.

| Table 1, Reuse Guidelines for Figures A, B, C, D, E, F, G, H, I, and J | | |
|---|---|---|
| G and H | Very heavy soot buildup | Replace <sup>2</sup> |

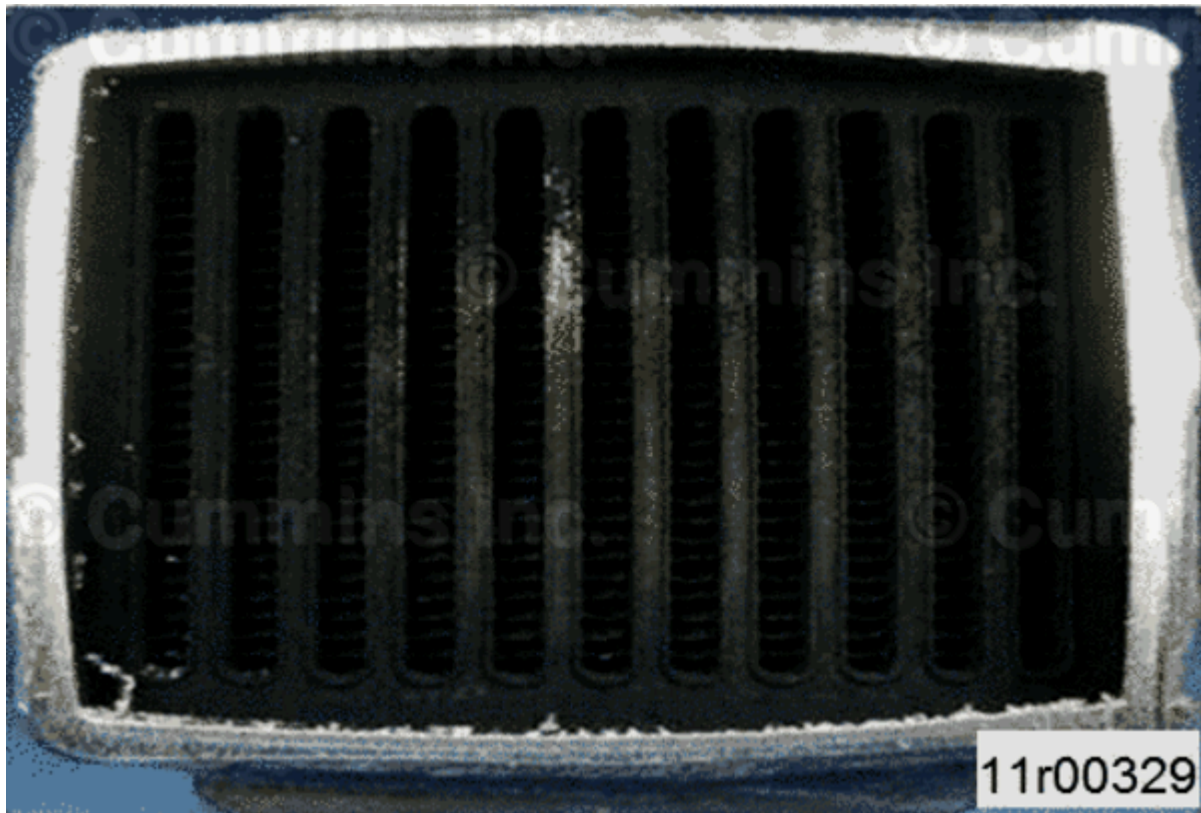
Figure L. ISB CM2350 and ISL CM2350 EGR Cooler.

ISB CM2350 and ISL CM2350 have different EGR cooler cross-section than what is as shown in Figure L. Table 1 applies to this EGR cooler.
