Service Bulletin Number: 5467581

Released Date: 19-may-2017

Aftertreatment Selective Catalytic Reduction (SCR) Reuse Guidelines

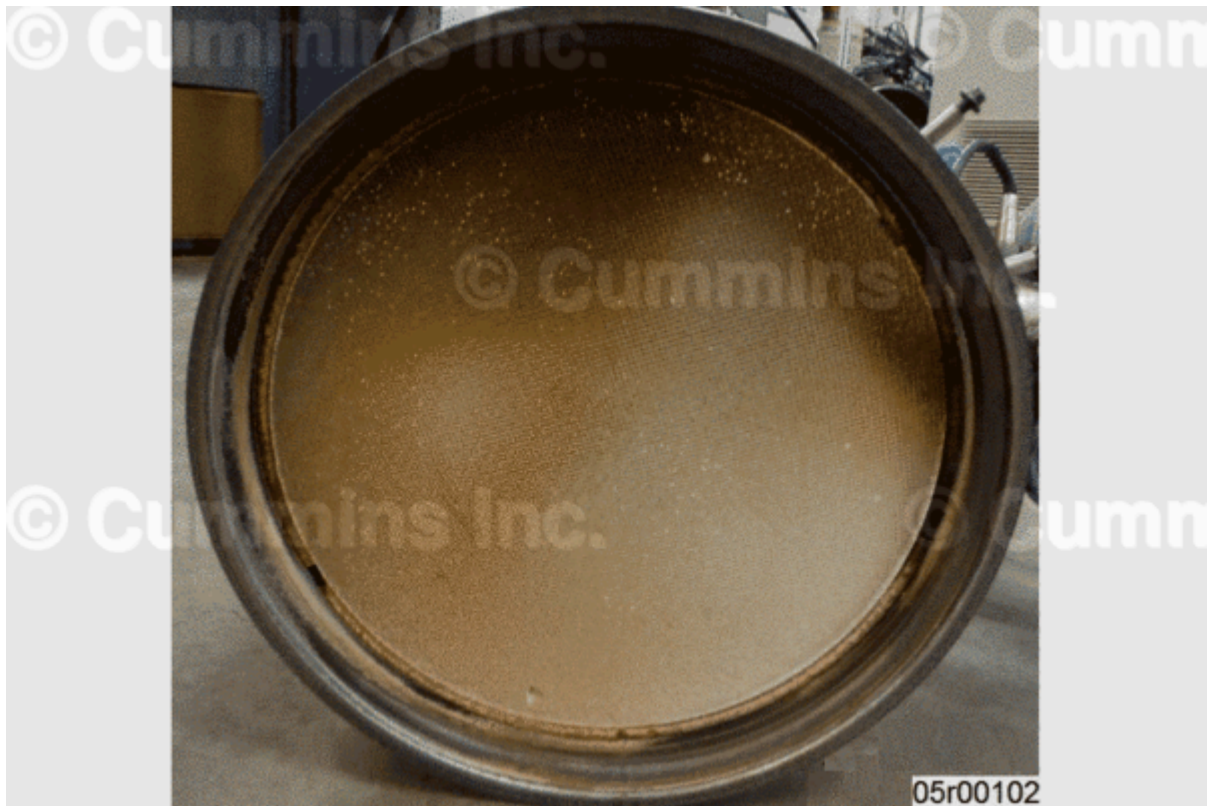
Figure 2, Aftertreatment SCR Inlet with Iron Oxide Deposits.

| Appearance | Brown discoloration on aftertreatment SCR inlet face. |
| Cause | Normal engine operation. |

| Action | None, can continue to be used. |

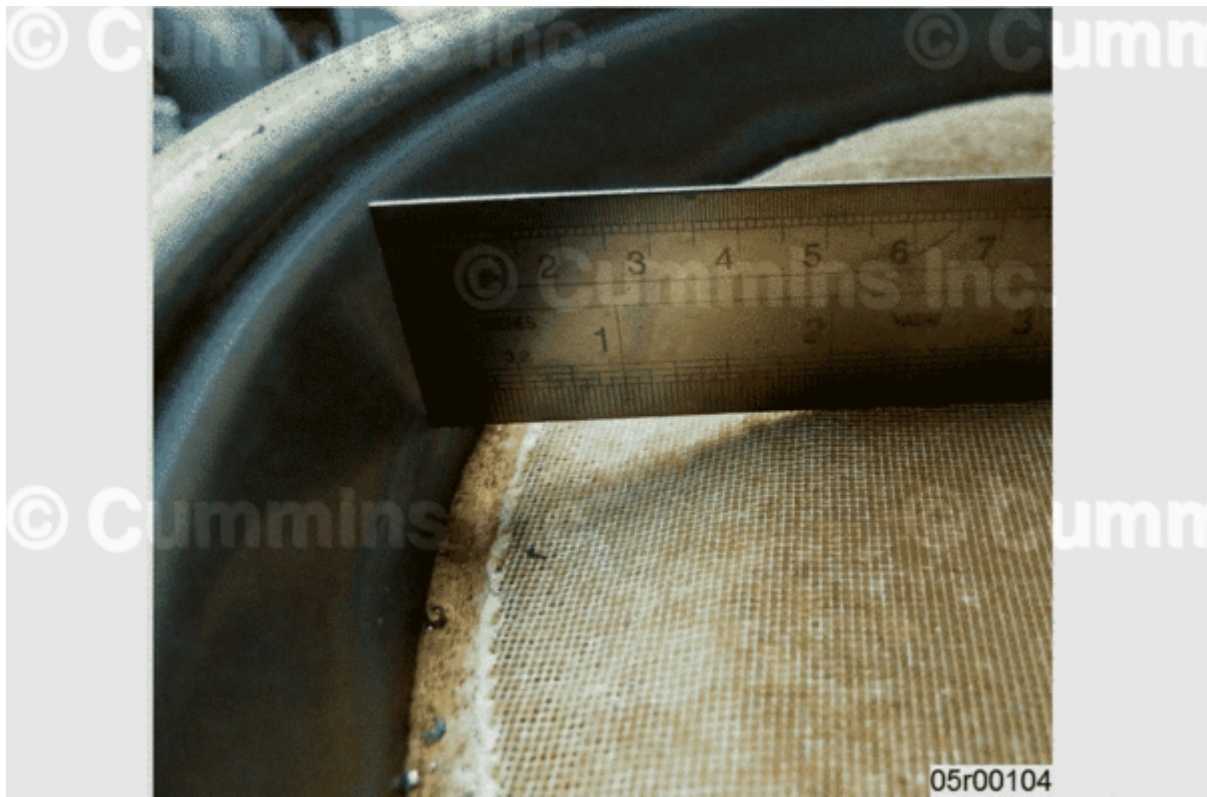
Figure 4, Aftertreatment SCR Inlet Media Erosion.

| Appearance | Uneven wear on aftertreatment SCR inlet face. |
| Cause | Normal engine operation . |

| Action | None, can continue to be used. |
