Service Bulletin Number: 5579487

Operation and Troubleshooting of Closed Crankcase Ventilation (CCV) Systems for Automotive Natural Gas Engines

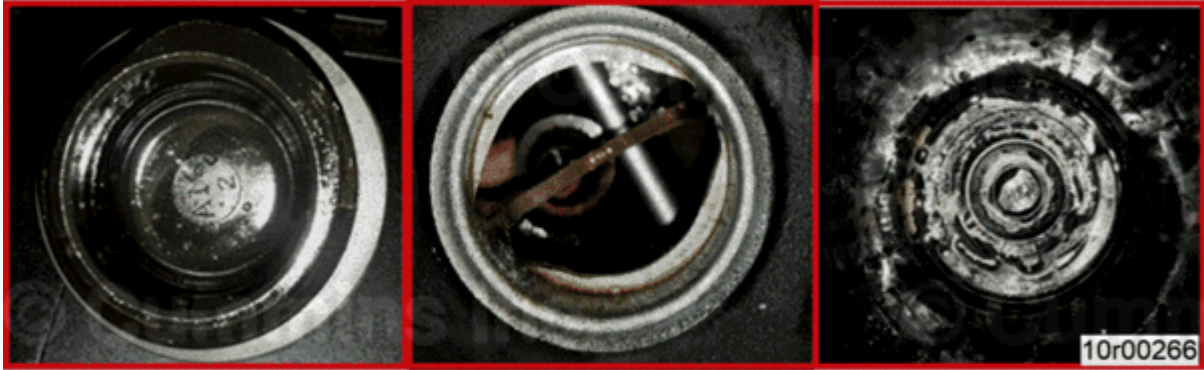
Figure 1, Left: Valve Cover Filler Cap. Center: Valve Cover Filler Hole. Right: CCV Filter Bowl.

| Figure | Action | Notes |
|---|---|---|
| 1 | None | The emulsion is completely dispersed by the CCV system. |

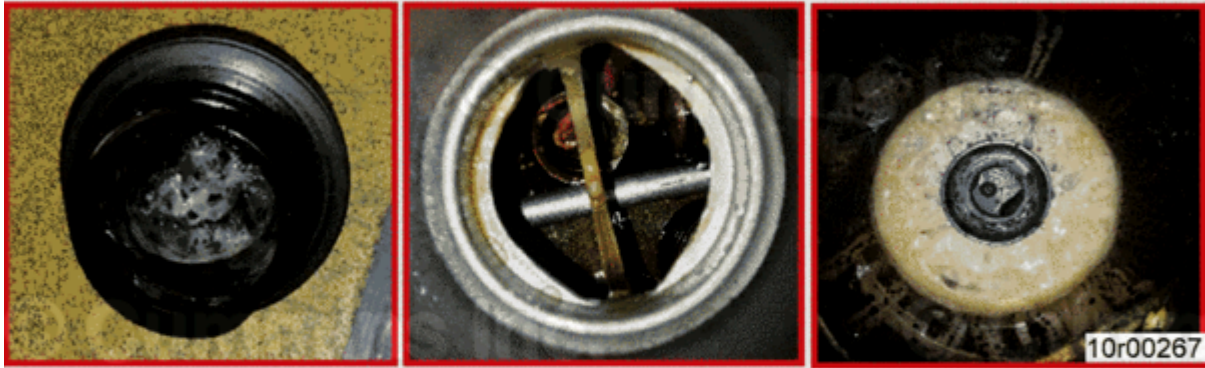
Figure 2, Left: Valve Cover Filler Cap. Center: Valve Cover Filler Hole. Right: CCV Filter Bowl.

| Figure | Action | Notes |
|---|---|---|
| 2 | None | Emulsion deposits are normal and are being processed by the CCV system. The drain passages at the bottom of the filter bowl are <b>not</b> restricted. Emulsion in the oil filler cap is normal and there is no or very little visible emulsion inside the valve cover. |

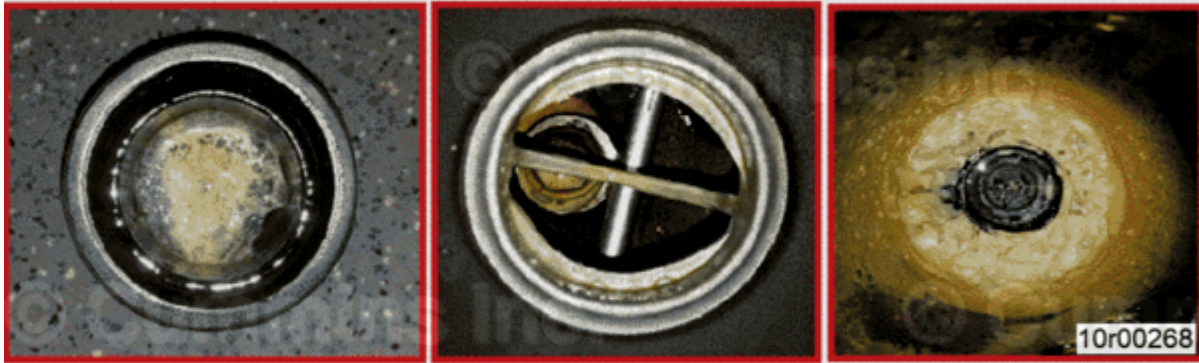
Figure 3, Left: Valve Cover Filler Cap. Center: Valve Cover Filler Hole. Right: CCV Filter Bowl.

| Figure | Action | Notes |
|---|---|---|
| 3 | Monitor | <p>Emulsion deposits are normal but are beginning to deposit on the interior wall of the CCV filter bowl. The drain passages of the CCV filter bowl are <b>not</b> restricted. Emulsion in the filler cap is opaque and there is visible emulsion inside the valve cover.</p> <p>This condition can either return to Condition # 2 or it may progress to Condition #4.</p> |

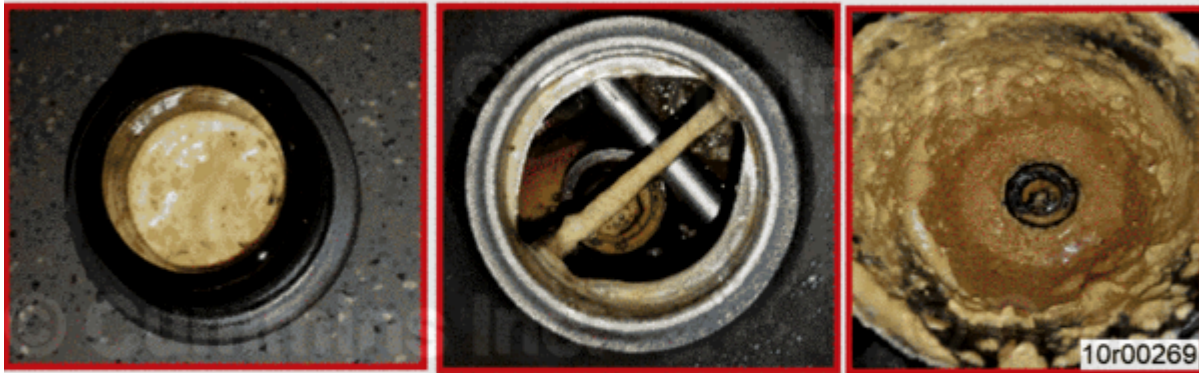
Figure 4, Left: Valve Cover Filler Cap. Center: Valve Cover Filler Hole. Right: CCV Filter Bowl.

| Figure | Action | Notes |
|---|---|---|
| 4 | Correction | <p>Emulsion deposits are <b>not</b> under control. Oil filler cap emulsion is opaque and thick. Oil filler hole shows visible emulsion.</p> <p>This condition is unlikely to return to Condition #3 or Condition #2 unless operating conditions change or corrective actions are taken.</p> |

The CCV system is **not** adequately controlling the accumulation of emulsion. The following points are to be checked. Correction of any one or a combination of these points will improve CCV system operation and are to be monitored for improvement as described in the 'monitor' section above:

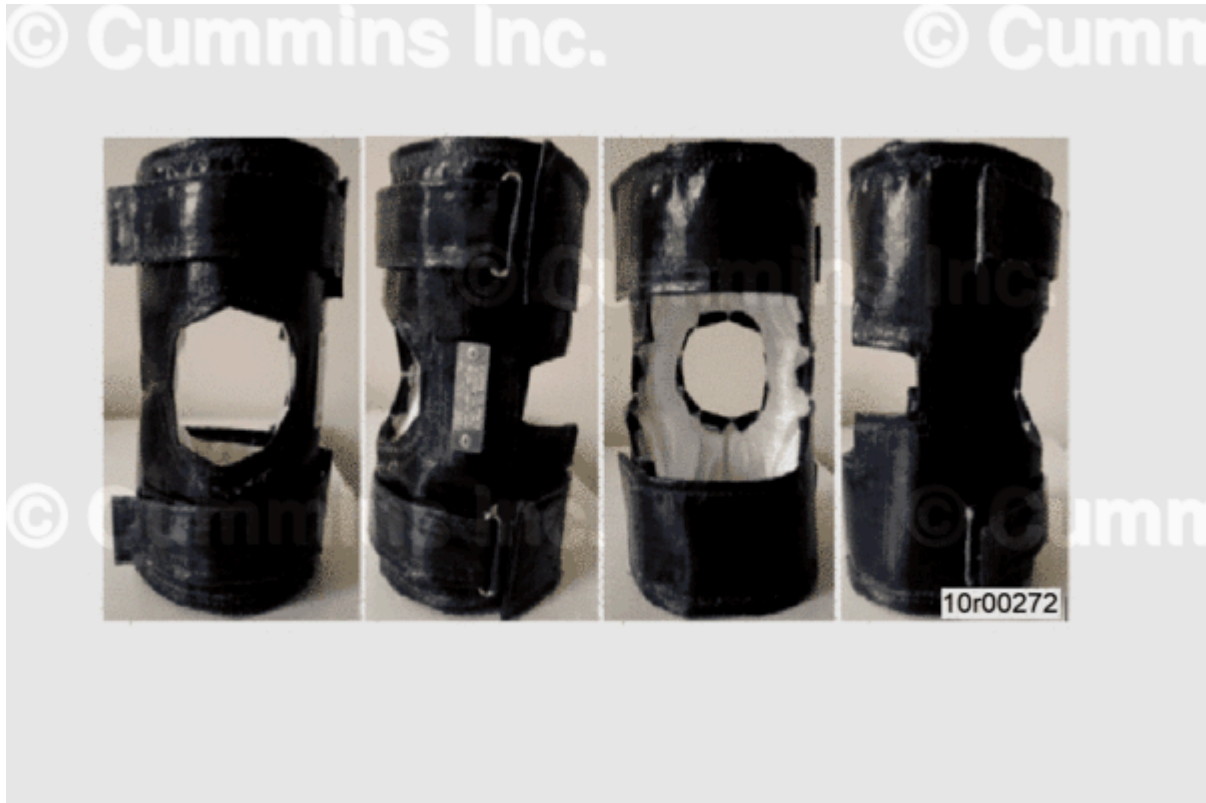
Figure 7, Insulation Jacket, Part Number 5399731.

Heated CCV systems are offered for ISL G Euro VI but are **not** required. If a non-heated CCV system is installed and the engine is operating in cold weather conditions, insulation jacket, Part Number 5399731, **must** be used.

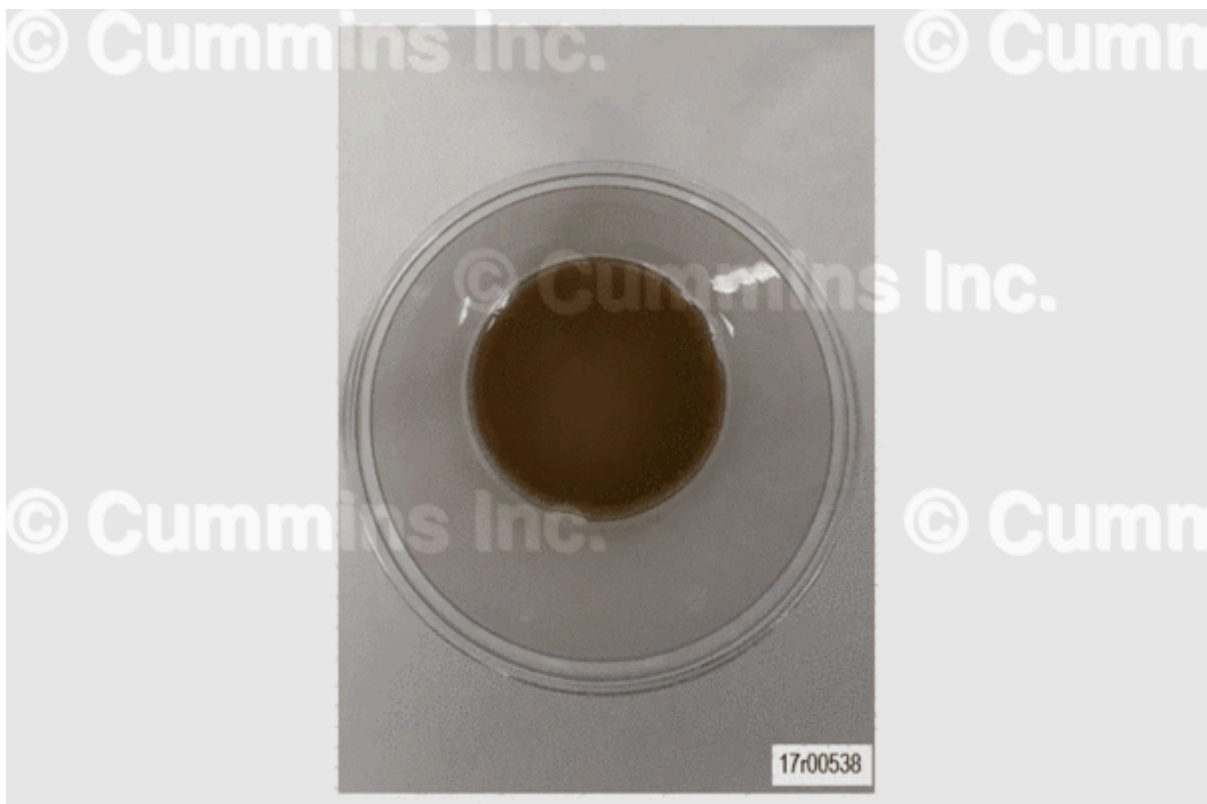
Figure 9, Lubricating Oil Sample Taken With Roughly Two Pints Of Water In The Crankcase Lubricating Oil.

Figure 8 above is a control sample taken shortly after a lubricating oil change, Figure 9 lubricating oil sample was taken with approximately two pints of water in the crankcase lubricating oil, and Figure 10 lubricating oil sample was taken after the unit was driven for twenty minutes. These lubricating oil samples were analyzed, and results showed that the initial and final lubricating oil samples had similar water concentrations that were below the 3000 parts per million specification listed in Section 378-013 of the Fluids for Cummins Products Service Manual, Bulletin 5411406. The water concentration in parts per million over the duration of this testing can be seen in Figure 11 below.
