Service Bulletin Number: 5659915

Closed Crankcase Ventilation System Engine Lubricating Oil Carryover and Associated Turbocharger Lubricating Oil Leak

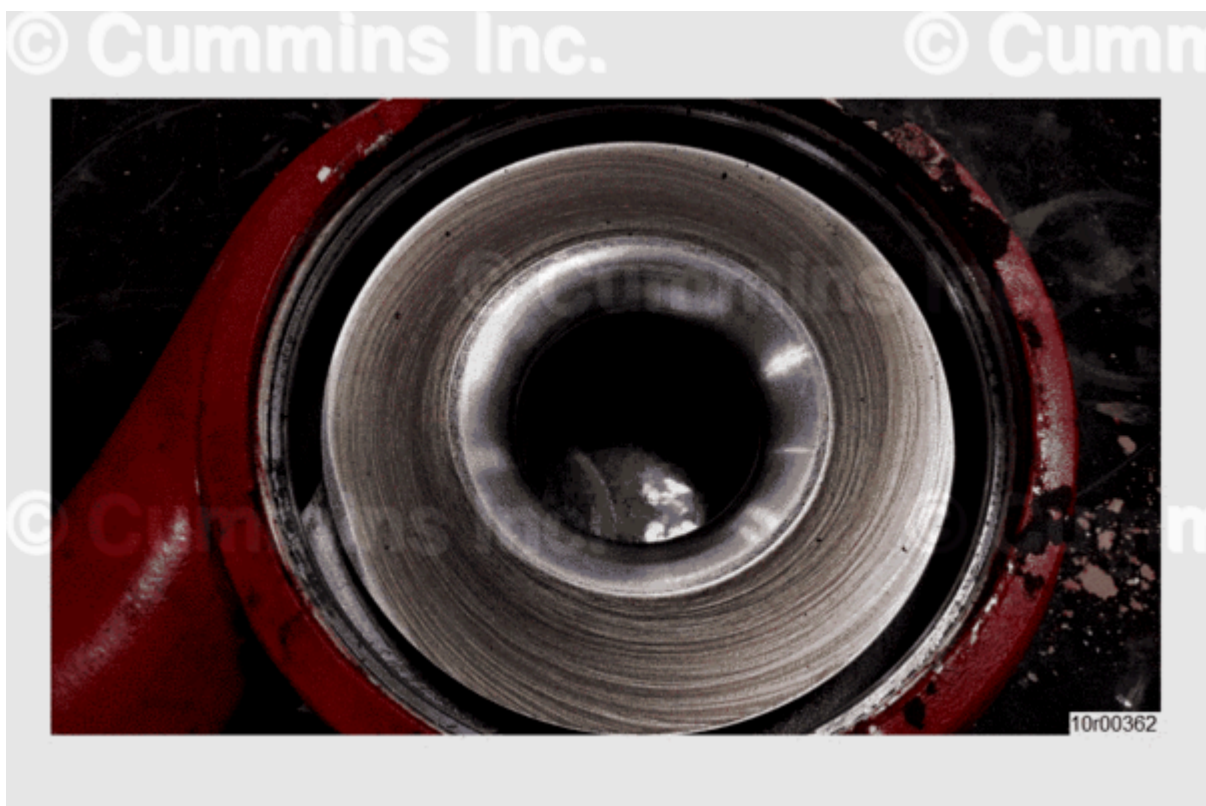
Figure 1, Turbocharger Compressor Cover Oil Swirling.

| Appearance: | Oil swirl pattern on inside of turbocharger compressor cover. |
| Cause: | Normal Closed Crankcase Ventilation system oil carryover. |

None.

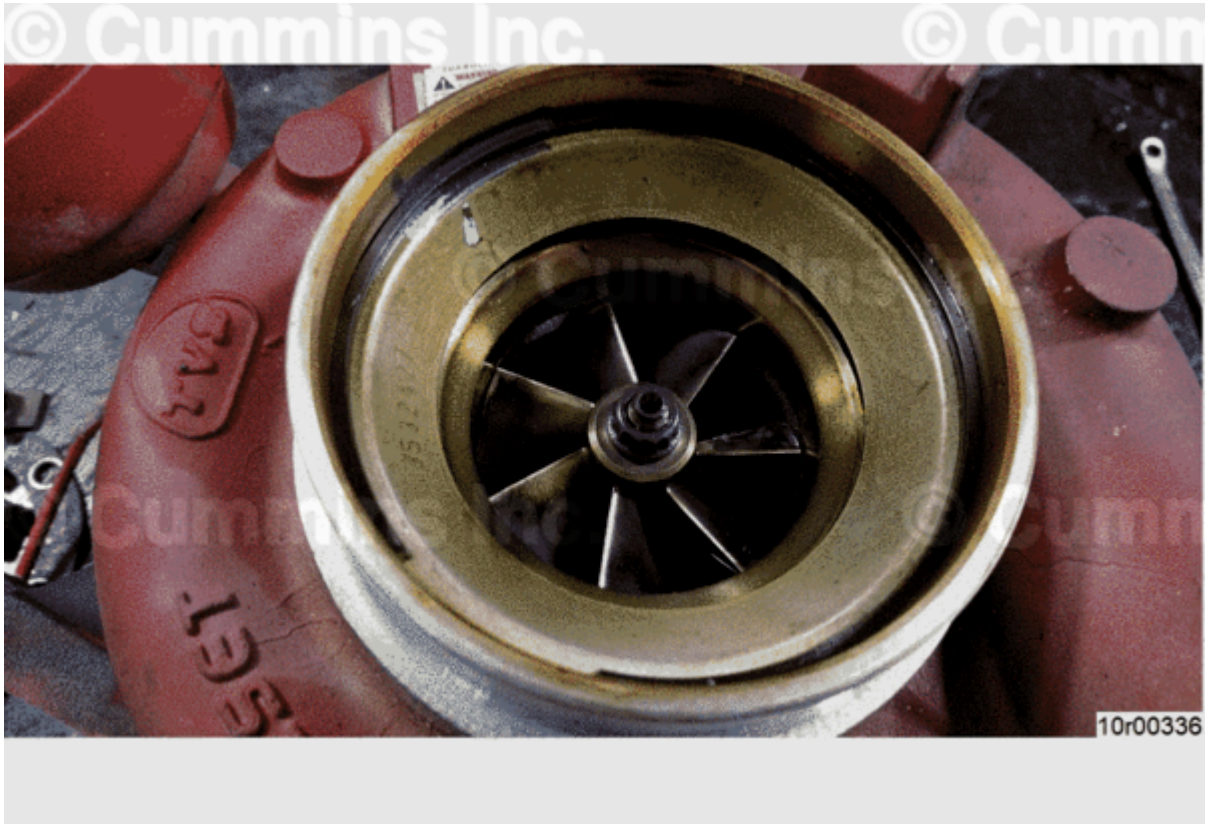
Figure 2, Turbocharger Compressor Inlet Oil Staining.

Oil staining on turbocharger compressor wheel and turbocharger compressor cover.

Normal Closed Crankcase Ventilation system oil carryover.

None.

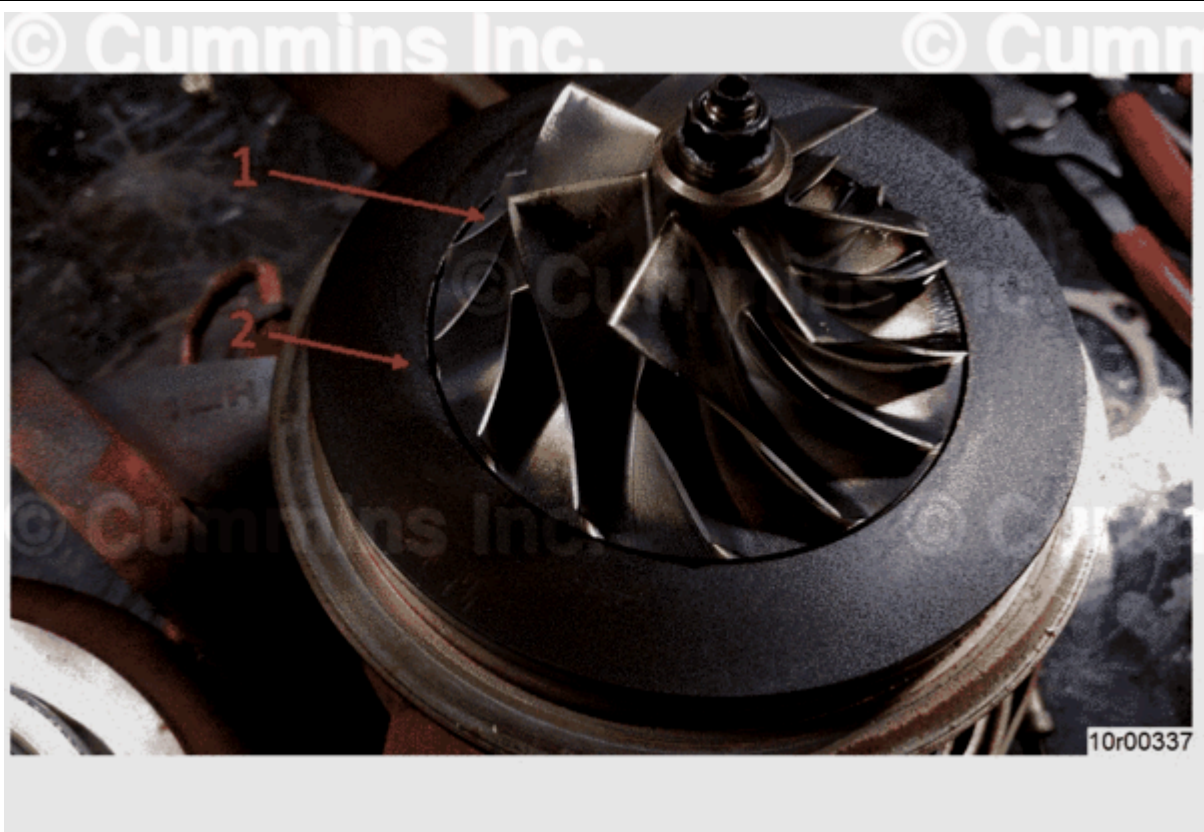
Figure 3, Turbocharger Compressor Wheel Oil Staining.

| Appearance: | Dark oil staining on turbocharger compressor wheel and turbocharger compressor cover. |
| Cause: | Normal Closed Crankcase Ventilation system oil carryover. |

| Action: | None. |

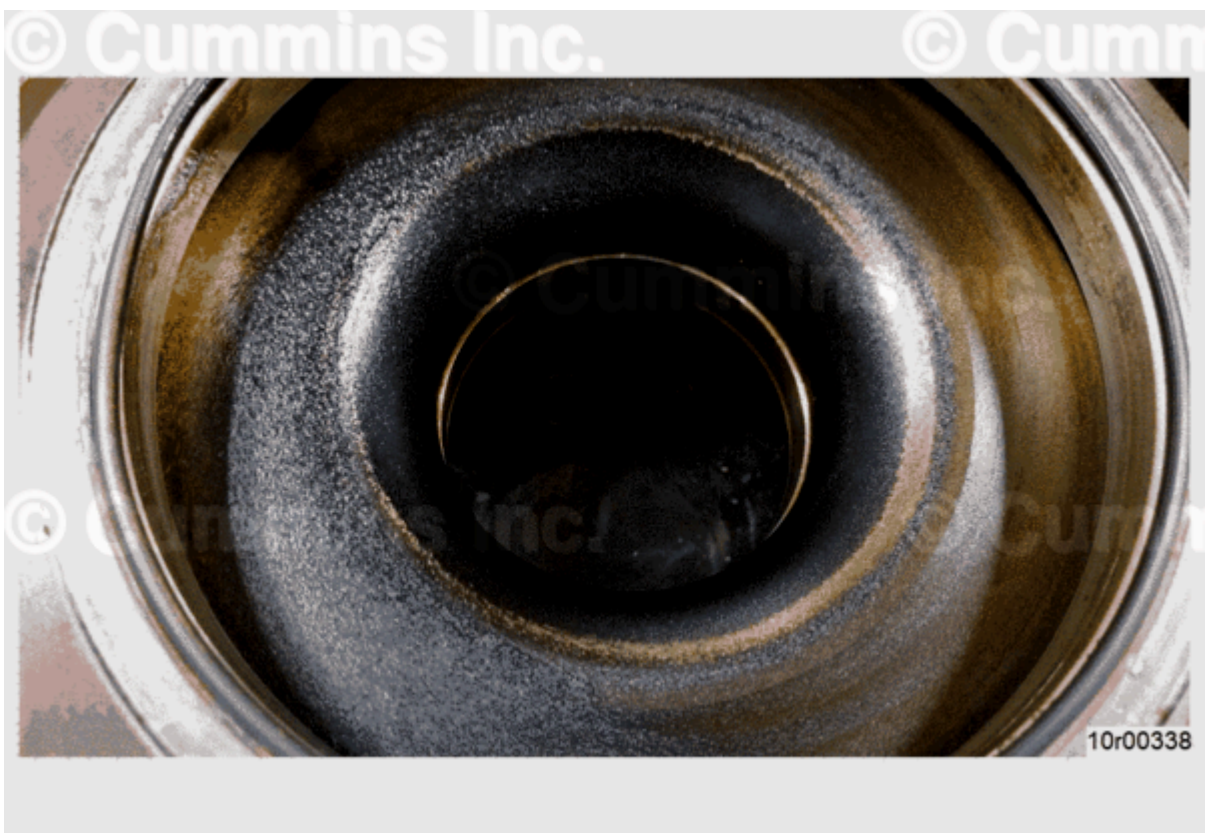
Figure 4, Turbocharger Compressor Cover Oil Staining.

| Appearance: | Dark oil staining on inside of turbocharger compressor cover. |
| Cause: | Normal Closed Crankcase Ventilation system oil carryover. |

| Action: | None. |

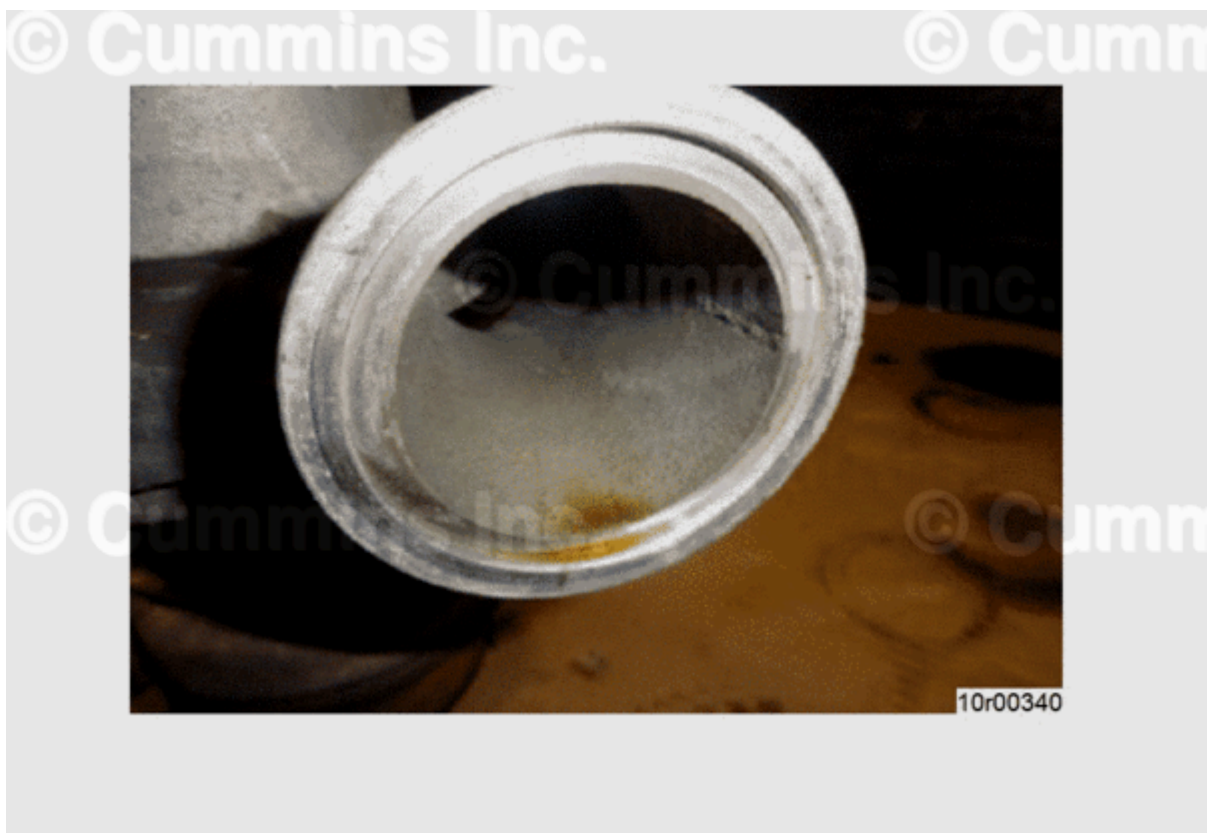
Figure 6, Turbocharger Compressor Outlet Oil Pooling.

| Appearance: | Excessive engine lubricating oil pooling at turbocharger compressor outlet |
| Cause: | Closed Crankcase Ventilation system malfunction. |

| Action: | Check the closed crankcase ventilation system and drain tubes. See corresponding Service Manual. Reference Procedure 003-024 in Section 3. Clean the turbocharger, charge air cooler plumbing and / or charge air cooler. |
