Technical Service Bulletin: tsb080089

Released Date: 08-Dec-2008

Alternator Issues in Arctic Conditions

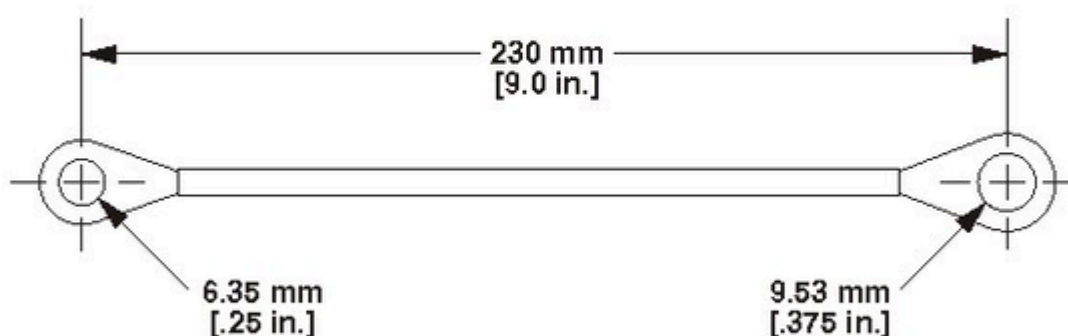
13400153

The specification for the ground wire is:

**2 AWG**

**230 mm [9 in] long**

**One eyelet with an internal diameter of 6.35 mm [1/4 in]**

**One eyelet with an internal diameter of 9.53 mm [3/8 in]**

This is shown in the photograph below.

When upgrading to the Prestolite alternator, the ground wire will have to be changed as the Prestolite BLD 3314GH has a higher output than the Delco-Remy™ 33SI. The ground wire is presently **not** available for purchase from Cummins Inc.

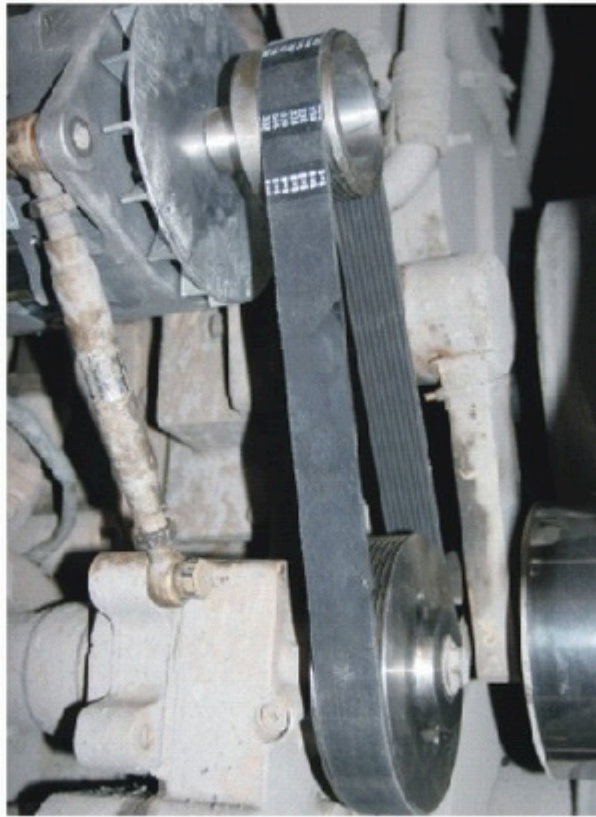
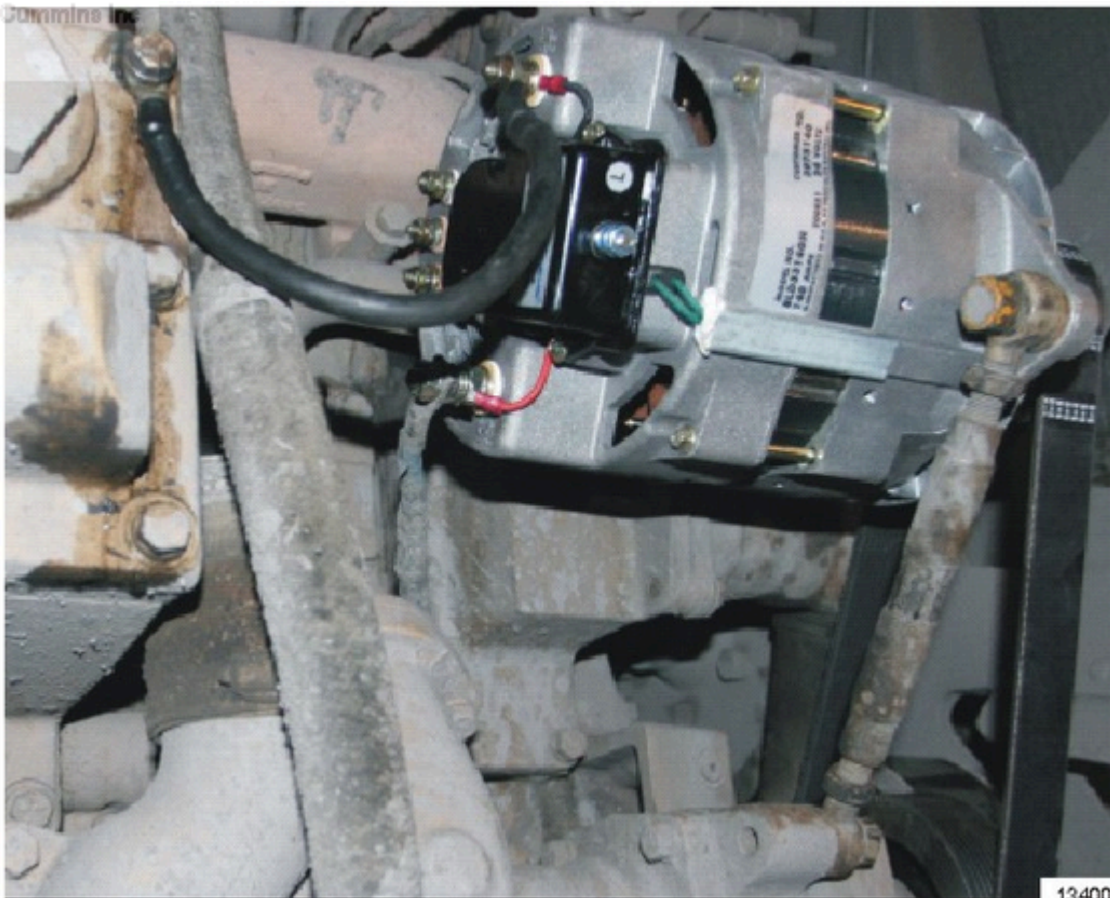
Photographs of an installed Prestolite BLD 3314GH alternator.

Replace failed Delco-Remy™ 33SI alternators with the Prestolite BLD 3314GH alternator, as the Prestolite alternator is more capable of coping with extreme arctic temperatures of -40°C [-40°F].

All 19L engines built after November 2008 for arctic applications now include the Prestolite BLD 3314GH alternator and the required change of pulleys, belt, and ground wire.
