# Technical Service Bulletin

| Technical Service Bulletin: tsb090062 | Released Date: 06-Jan-2010 |
| Oil Leak at Lower Front Cover | |

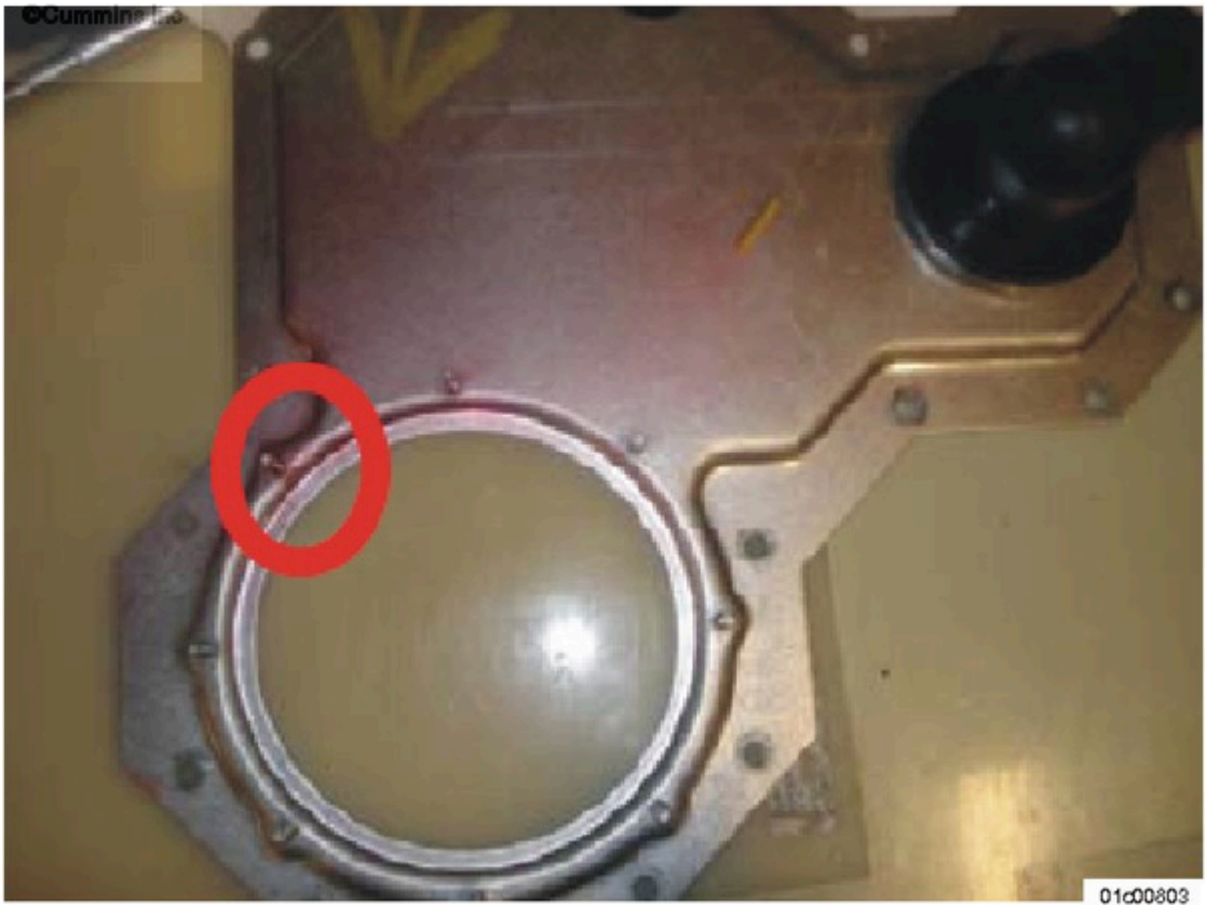
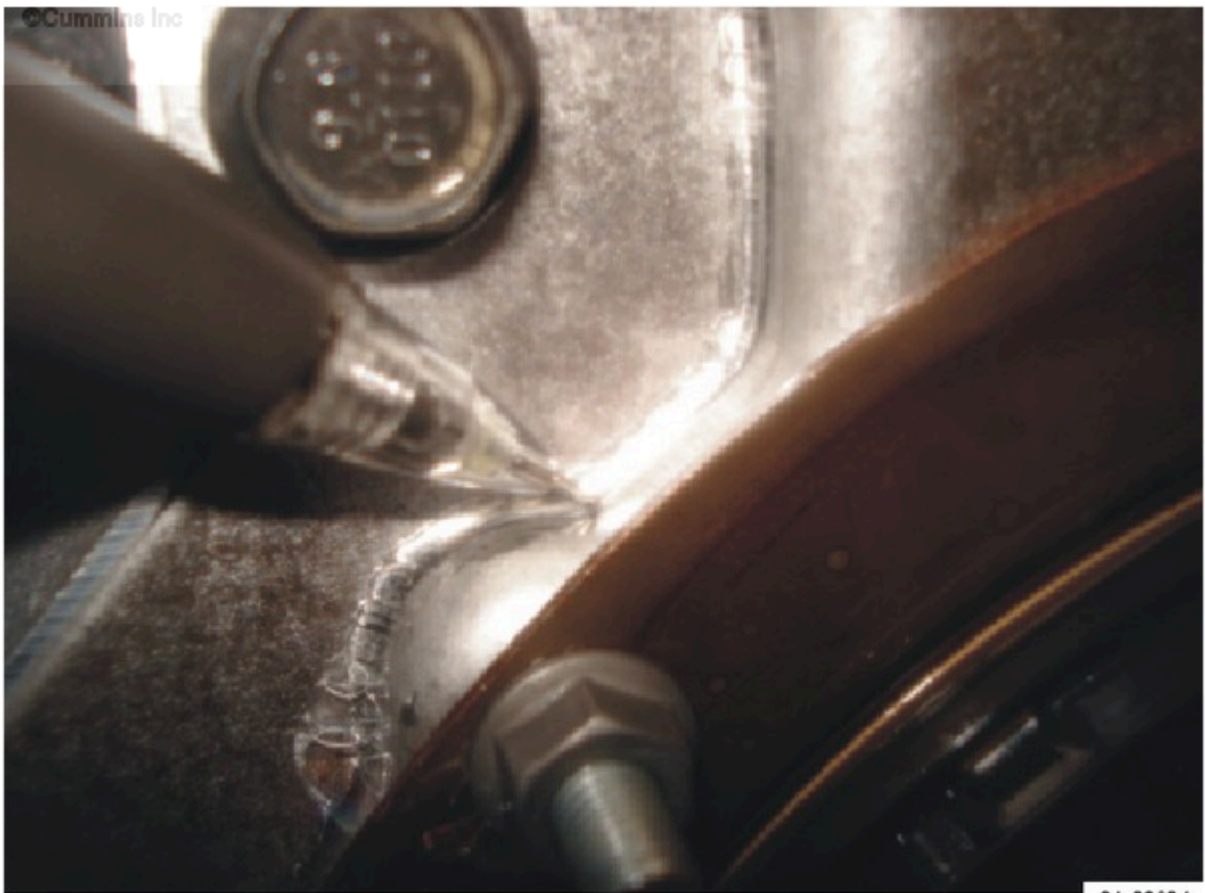
Symptoms and observations are an external oil leak that initiates behind the vibration damper and runs down the lower front gear cover.

Put dye in the oil and operate the engine to verify that the leak initiates from behind the vibration damper. Remove the vibration damper and inspect for a crack in the gear cover crankshaft seal boss at the 10 o'clock position. The typical crack location is at the bend transition between the flat cover surface and the raised stud boss.

Manufacturing issue at supplier resulting in a crack at this location.

Replace the lower gear cover.
