Technical Service Bulletin: TSB101099

Released Date: 01-Dec-2010

Crankcase Blowby Measurement Procedure Update

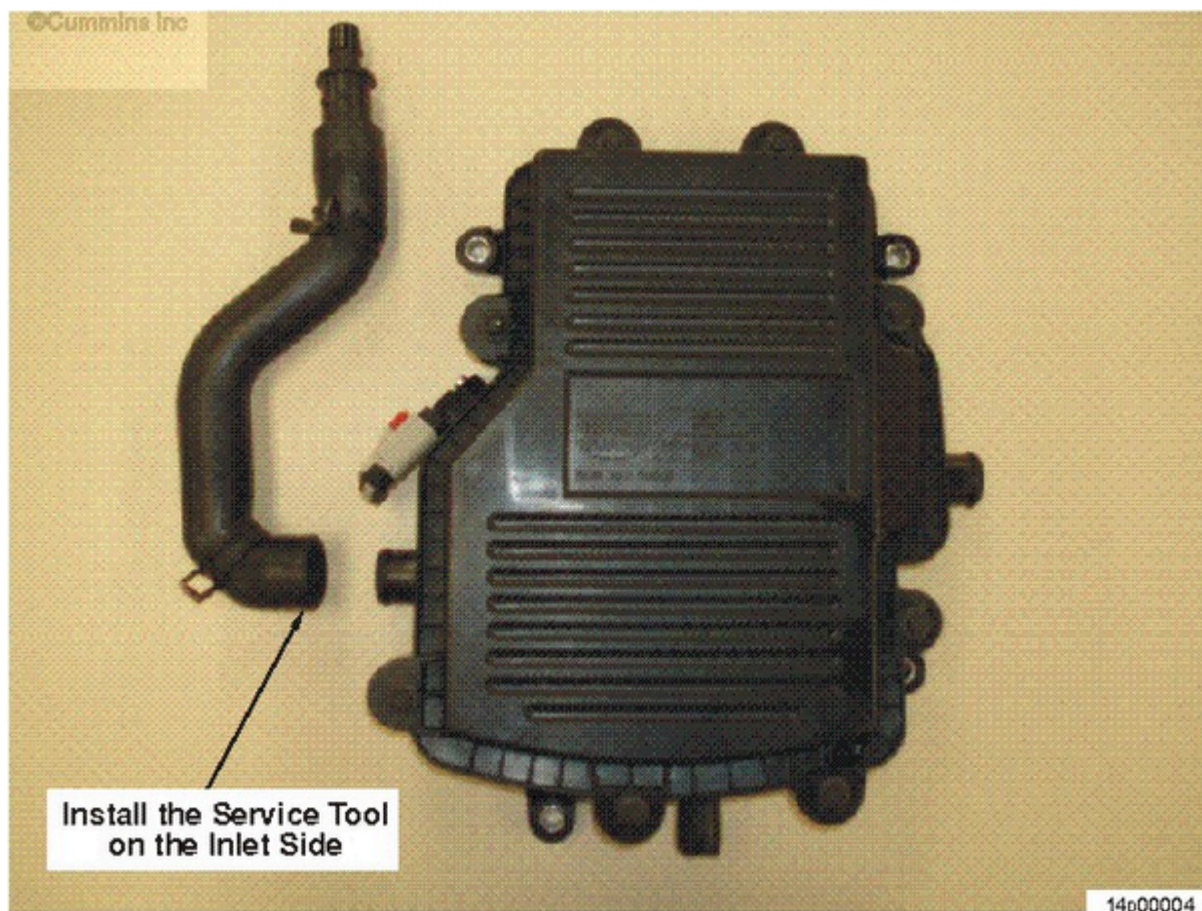
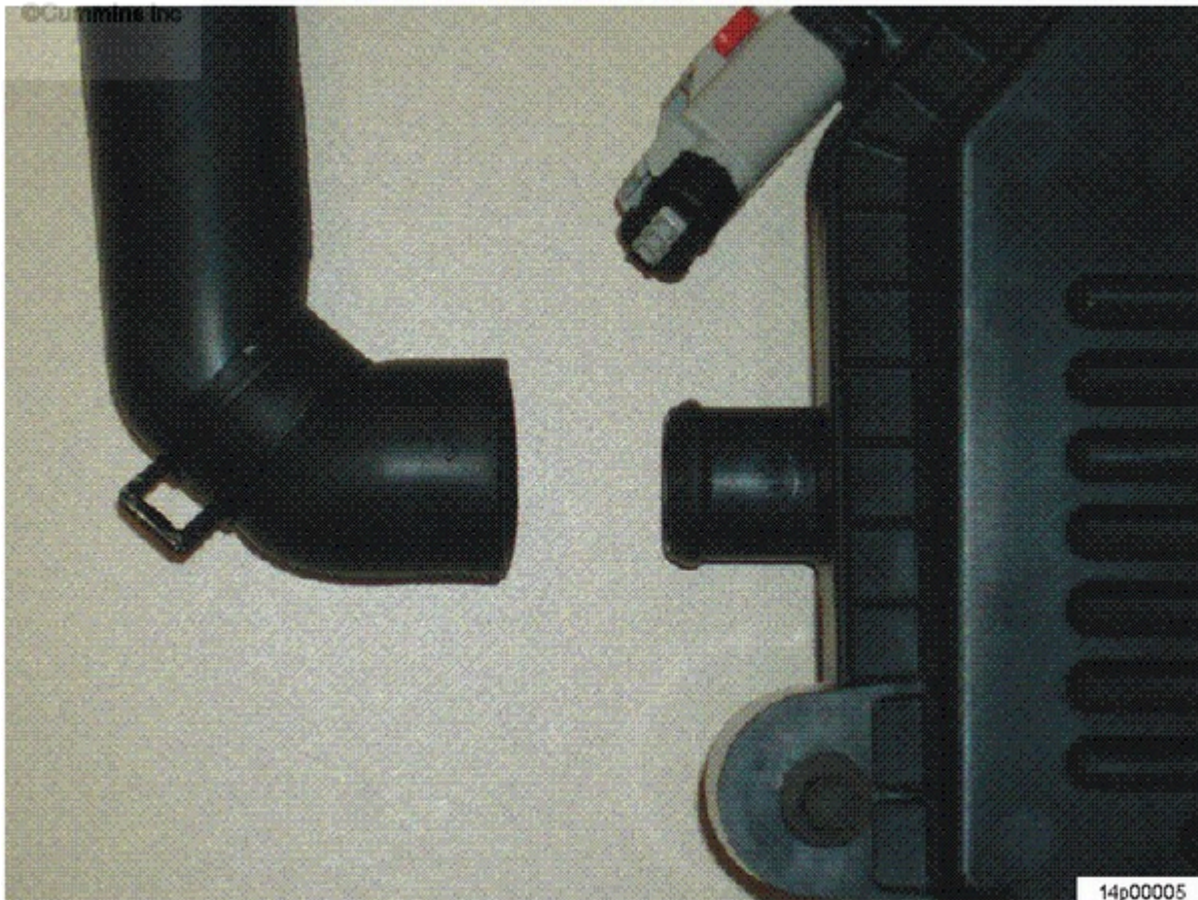
For engines equipped with external coalescent breather elements (ECMs CM871, CM876, CM2250, CM2150, and engines equipped with Enviroguard filters), connect the appropriate blowby service tool to the crankcase breather tube on the inlet side of the coalescent breather housing.

Make sure to install the service tool on the inlet side.

By installing the blowby service tool into the inlet side crankcase breather tube, the potential for inaccurate blowby measurements caused by varying filter restrictions is eliminated.
