# Technical Service Bulletin

Technical Service Bulletin: tsb101791

Released Date: 03-Jan-2006

Cylinder Head Reuse for Update from 13-Piece to Single-Piece Cylinder Head Gasket

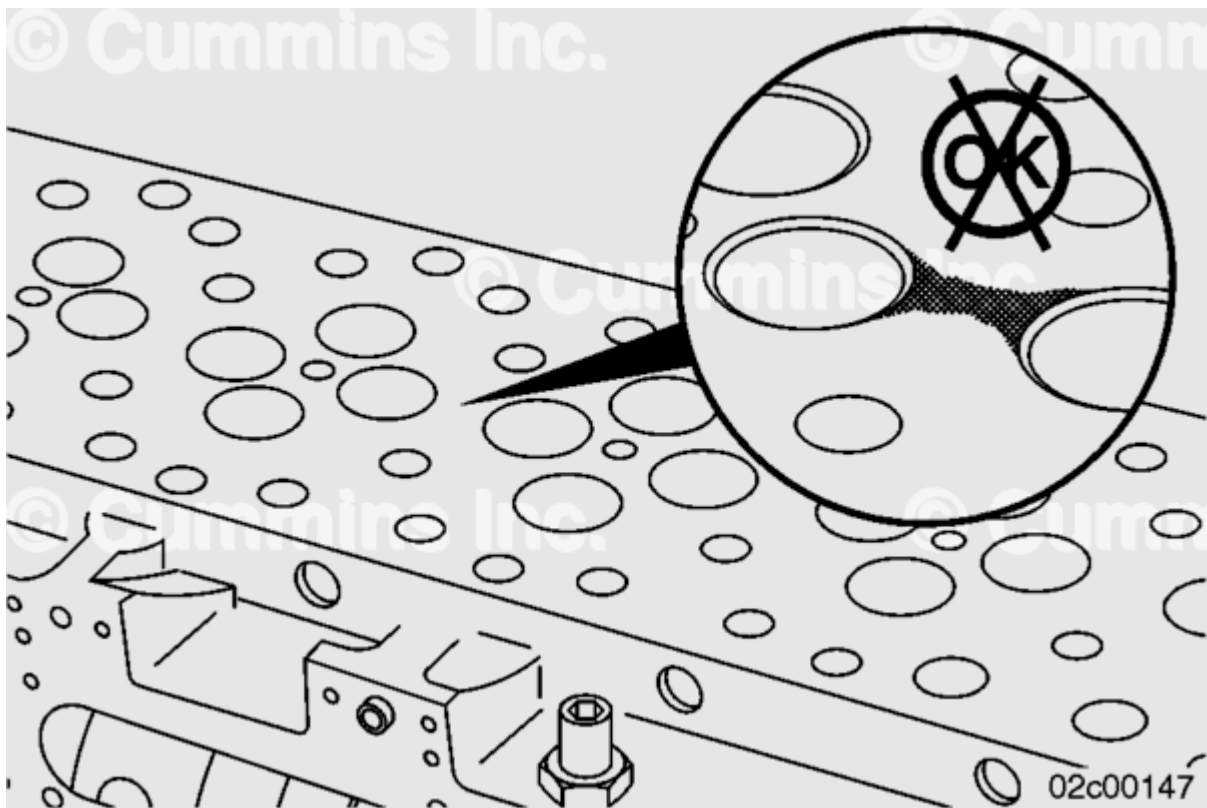
This change in Reuse Guidelines does **not** apply to instances when, after the cylinder head has been cleaned, there is detectable depth across the sealing area between two cylinders or between a cylinder and coolant passage or a cylinder and capscrew hole.

Depth Across Sealing Area

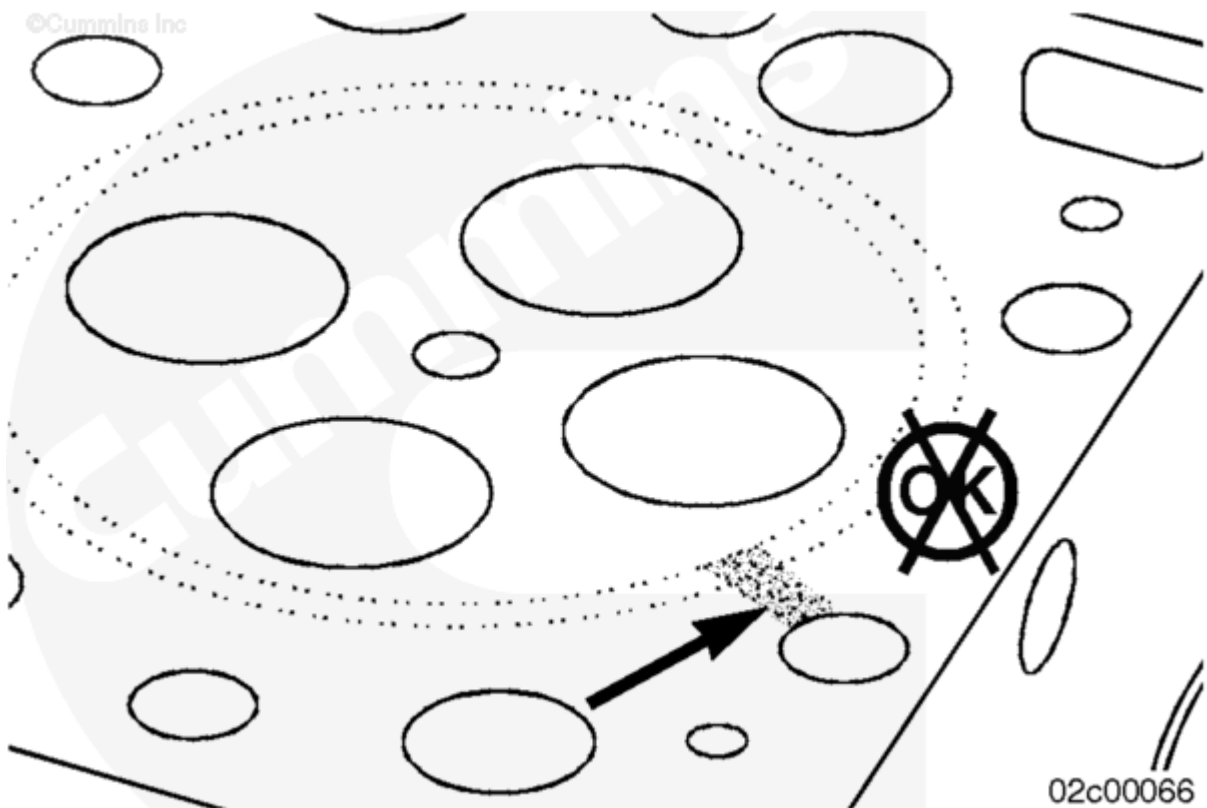
Leak Path Between Cylinder and Cylinder Head Capscrew Hole

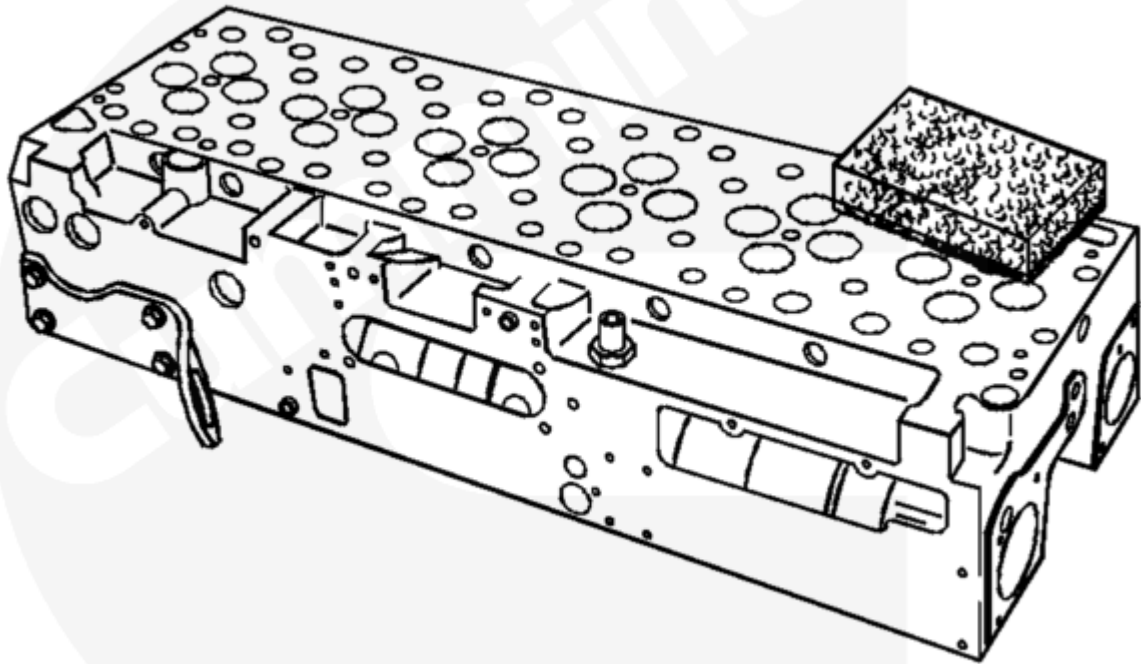
02c00111

Clean Cylinder Head

Use Scotch-Brite™ 7448 abrasive hand pad, Part Number 3823258, or equivalent, to clean the cylinder head combustion face. Also make sure there is no loose debris sitting in the valve pockets around the head of the valve.

Do **not** use power tools to clean the combustion face of the cylinder head.

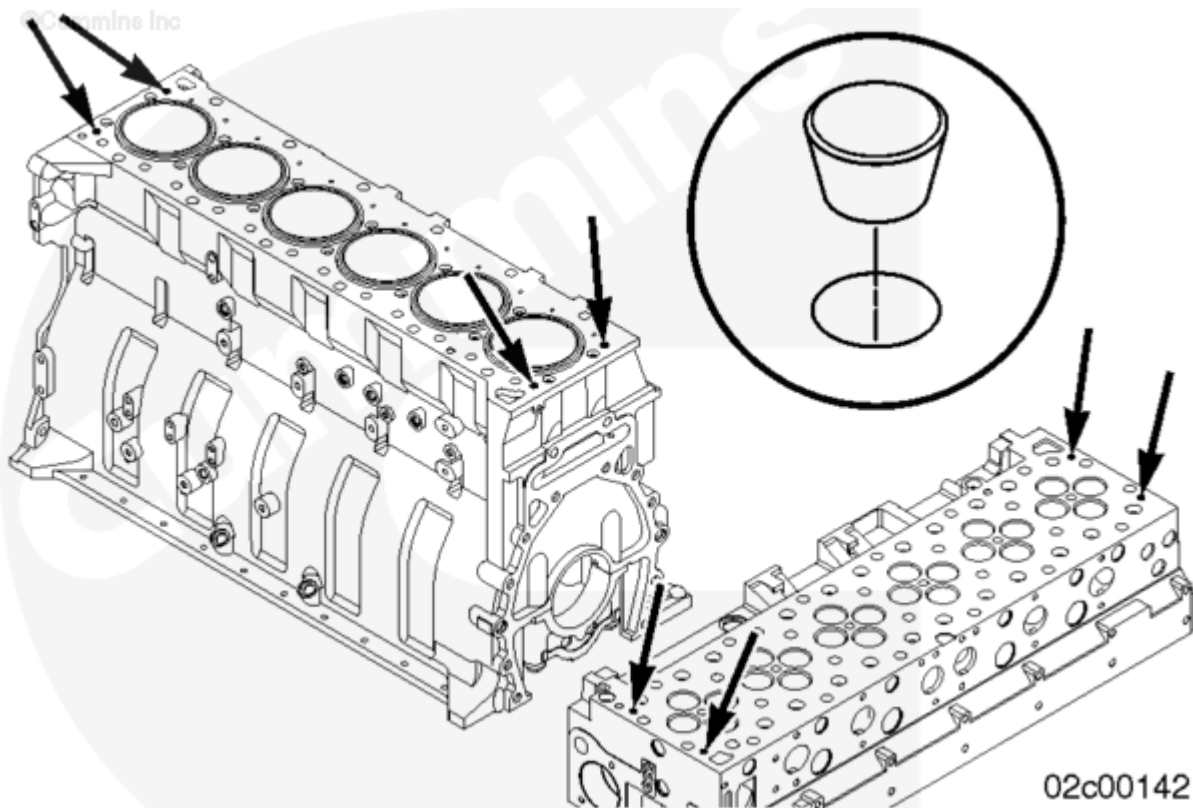
### Protective Plug Locations

Prior to cleaning the combustion face of the cylinder head, small rubber plugs, Part number 4089255, and tape **must** be used to plug or cover the oil supply holes at the ends of the cylinder head to prevent debris from entering the oil passages.
