| Technical Service Bulletin: TSB120285 | Released Date: 07-Nov-2018 |
| Belt Shredding on QSX15 CM570 With Fan Centers 18" and Above | |

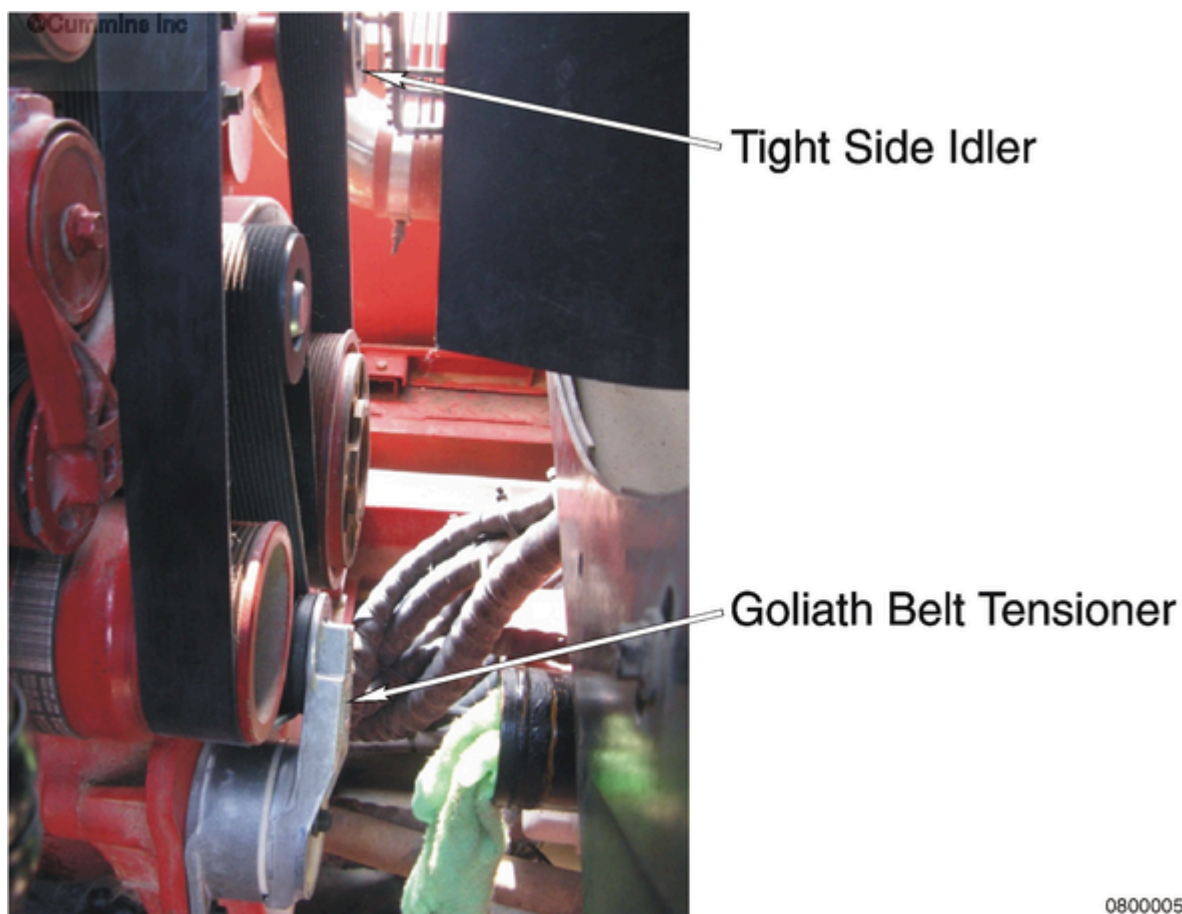
Photograph 1: Side View of Goliath Tensioner Configuration and Tight Side Idler

If the belt shredding and the fan center match the verification, a tight side idler needs to be installed on the unit to reduce the amount of vibration seen during deceleration events. Addition of a Goliath tensioner, on some FA options, increases the tension in the system, reducing belt vibration.

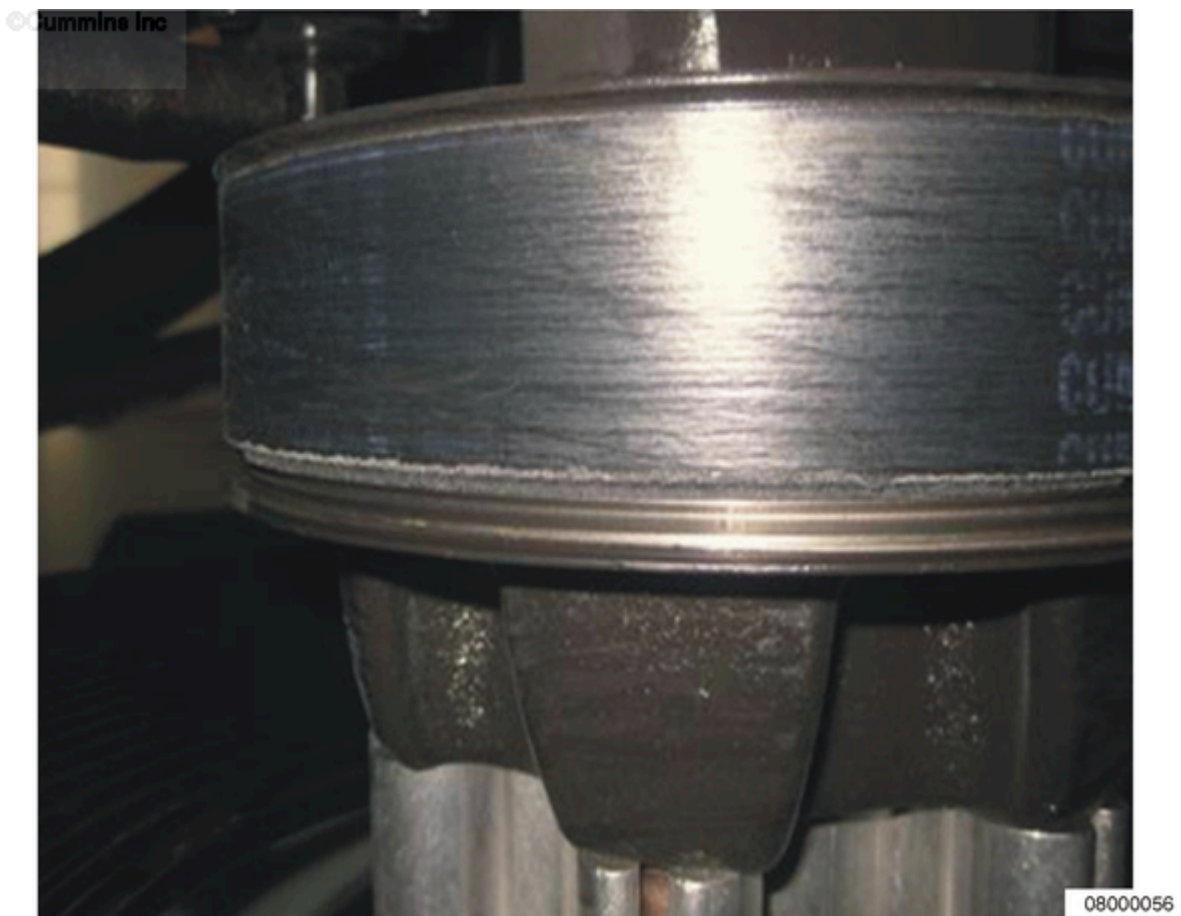
There are QSX engines with fan centers 18" and above experiencing belt shredding due to long belt spans between the fan hub and the crankshaft, as well as the fan hub and the water pump. The span lengths are susceptible to vibration and quick deceleration events which cause the belt to jump grooves and start shredding on the edges of the pulleys. The customer will notice the coolant temperature rising, and find that the belt is missing ribs or is completely gone.

Photograph 3 - Rib missing while belt is installed on the fan hub pulley.

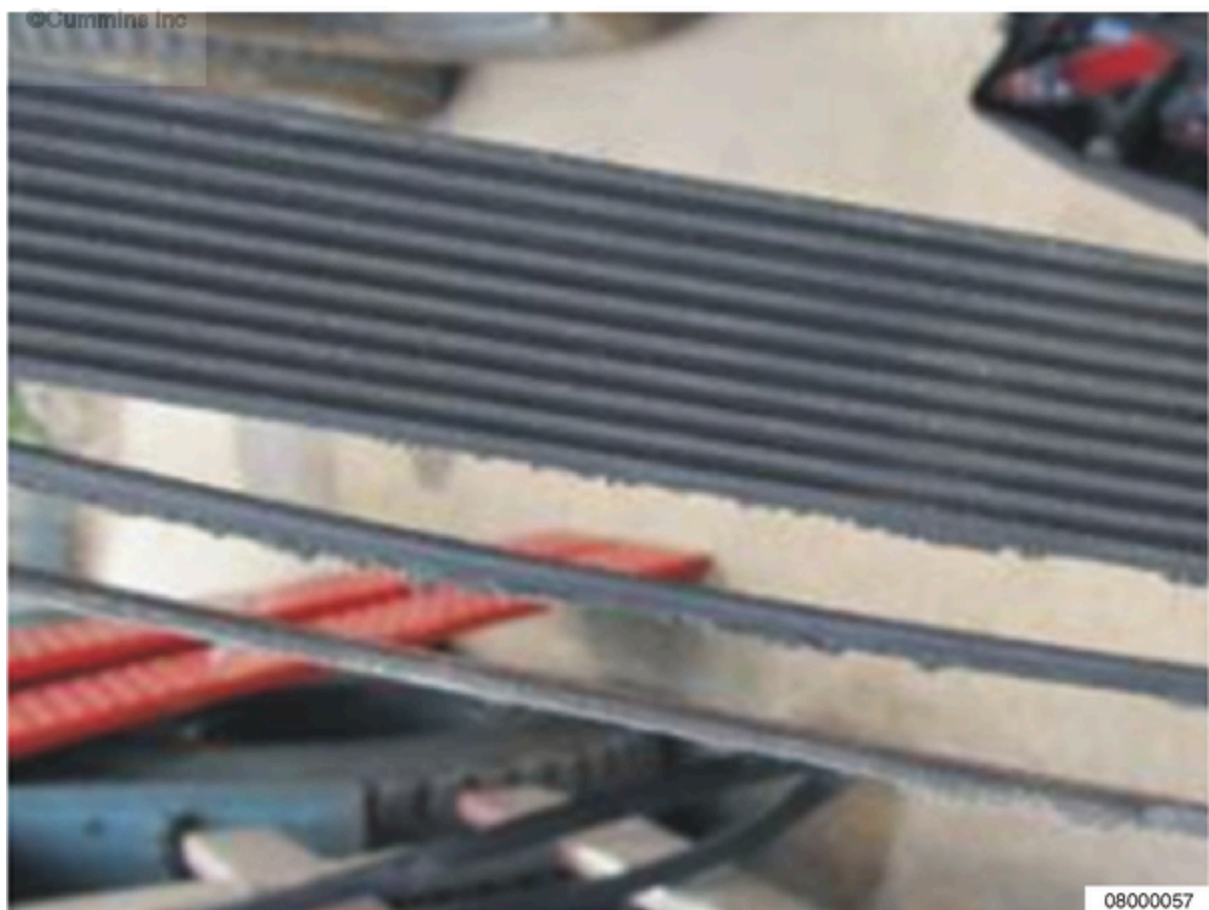
Photograph 4 - The eleventh and twelfth ribs separating from the belt.

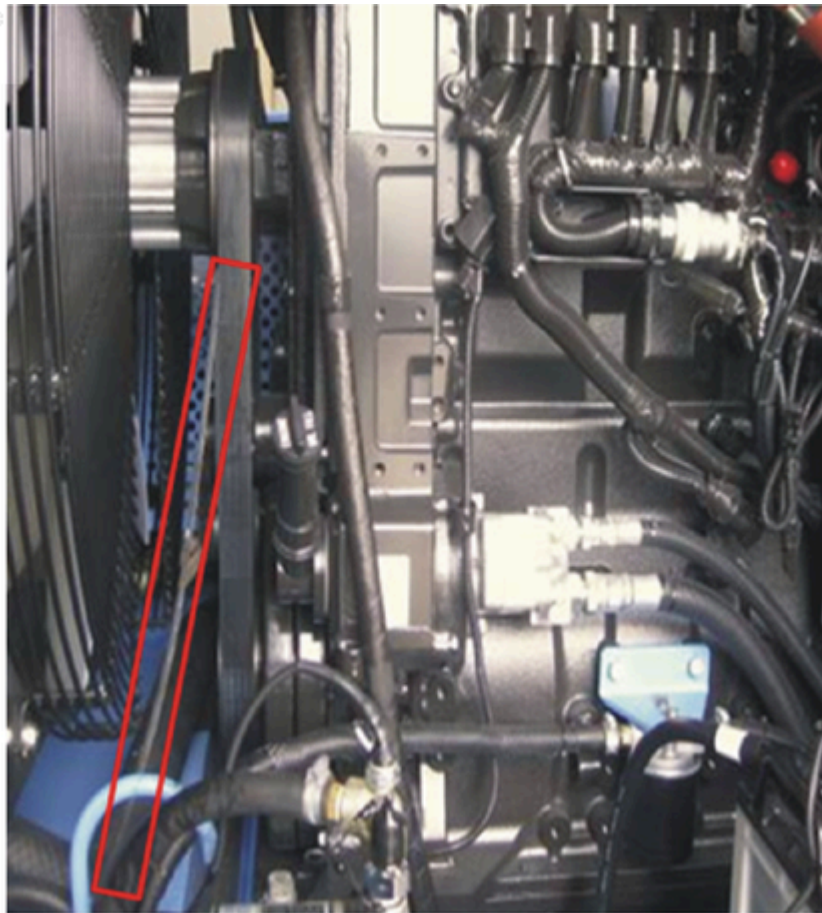
Photograph 5 - The ribs separating from the belt shown in the red box.
