Technical Service Bulletin: TSB150130

Released Date: 05-Dec-2016

Intake Valve Chordal Malfunctions

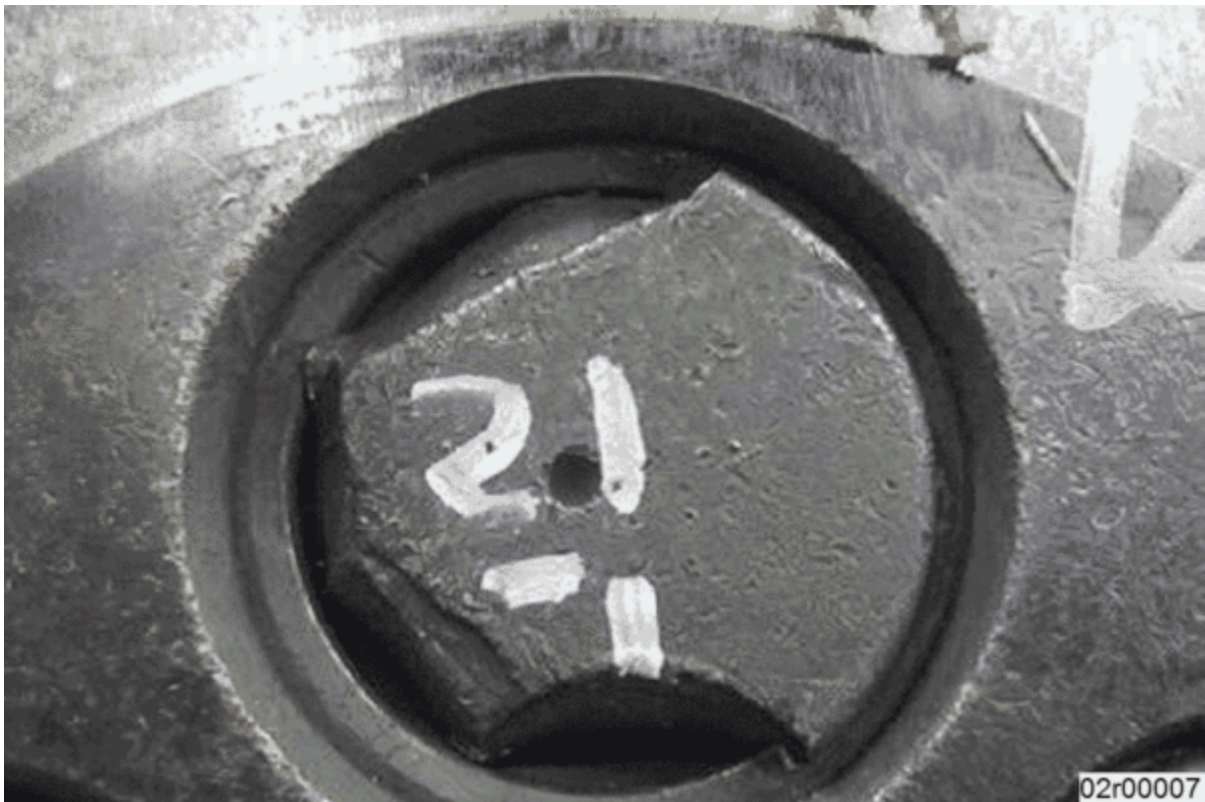
Under severe operating conditions, acidic corrosion and thermal stresses induced in the intake valve can initiate fatigue cracking which, over time, can propagate until a portion of the intake valve separates from the valve head and enters the cylinder. This type of valve malfunction is commonly known as a chordal malfunction. Once the valve has malfunctioned, performance of the engine is compromised and progressive damage to the piston, cylinder liner, cylinder head and turbocharger can occur. Typical complaints following intake valve chordal malfunctions include but are not limited to check engine light, low engine power, cylinder misfire, "popping" noise from the air intake manifold, excessive engine noise, and engine shut down and no start conditions.

- Chordal malfunction of the intake valve can **only** be reliably determined by borescope inspection or removal of the cylinder head.
- A chordal malfunction of an intake valve is characterized by a piece or pieces of valve head missing from an intake valve. Reference Figure 1 and Figure 2 below.

Figure 1, Broken Intake Valve in Cylinder Head.

- A new intake valve, Part Number 3685996, has been released for assembly in all ISX and QSX cylinder heads.
- To address malfunctions specific to dual cam cylinder heads, a new intake valve insert, Part Number 4393425, has been released for assembly in dual cam ISX and QSX cylinder heads **only**.
- Both the new intake valve and insert are manufactured from premium materials and improve robustness against acidic corrosion and thermal fatigue that are primary contributors to chordal malfunctions.

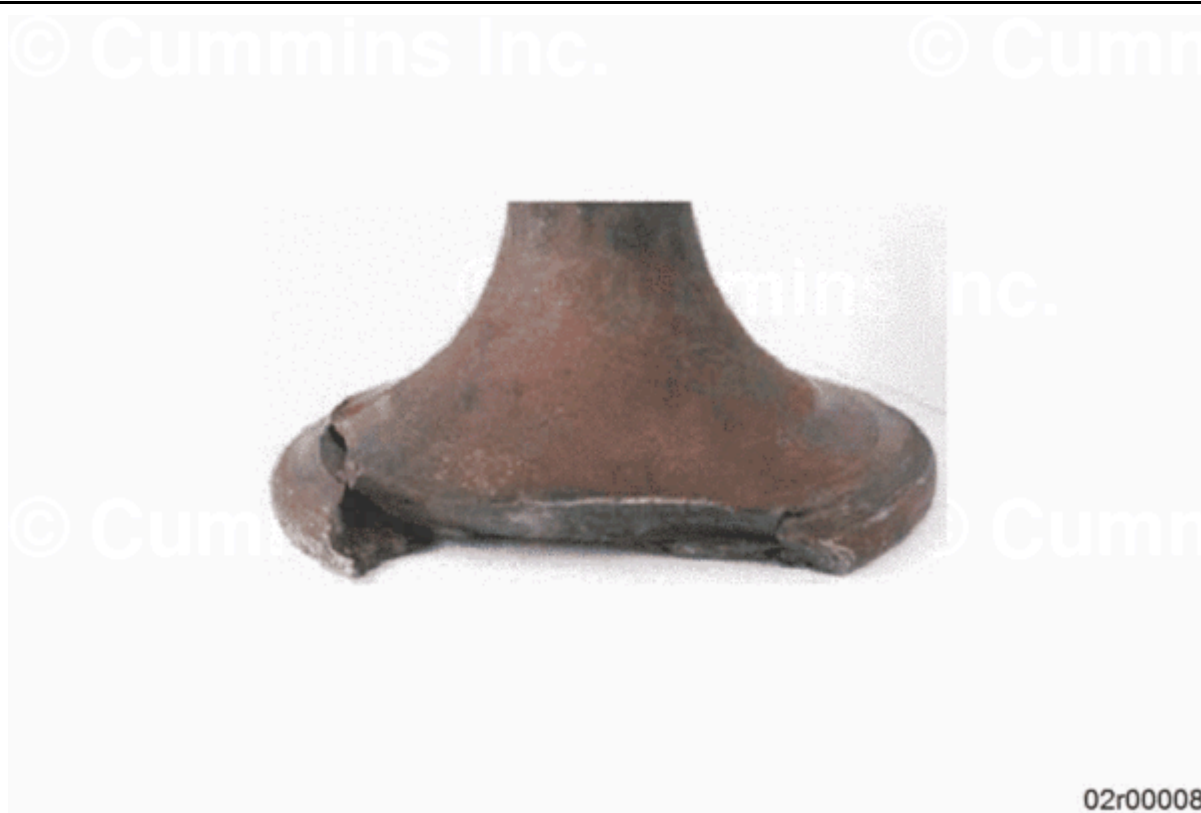
Figure 2, Broken Intake Valve Showing Radial/Chordal Fracture.
