Technical Service Bulletin: TSB190170

Front Gear Cover Inspection to Prevent Front Gear Cover Cracking

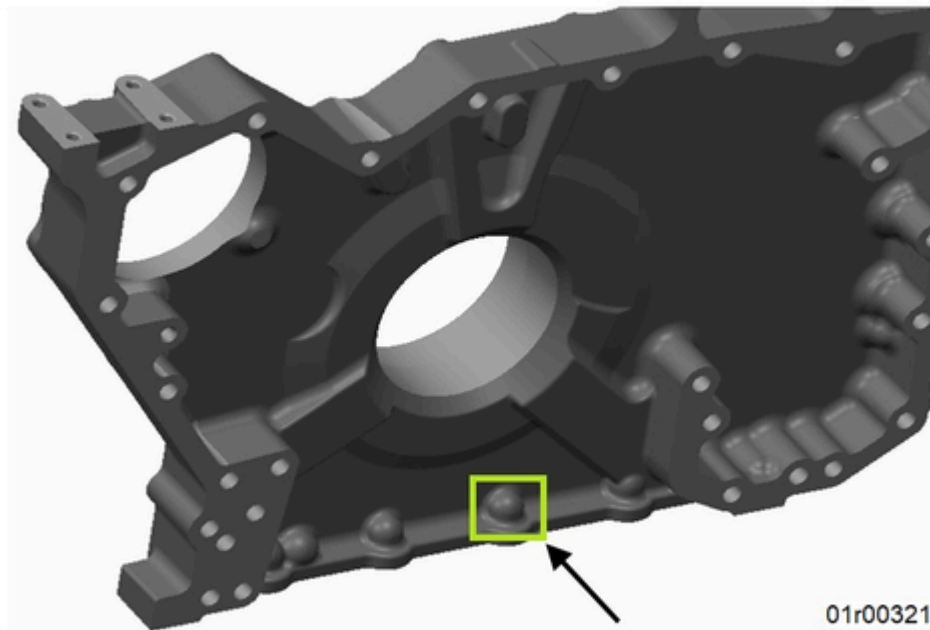
- Debris or sealant in blind tapped holes in front gear cover

Figure 1, Example Location of a Blind Tapped Hole on Front Gear Cover.

- When removing the front gear cover, clean and remove debris and sealant from the blind tapped holes in the front gear cover.
- The presence of sealant in the blind tapped hole in the front gear cover leads to less capscrew thread engagement. The exerted pressure when the capscrew is torqued, can cause the front gear cover to crack.

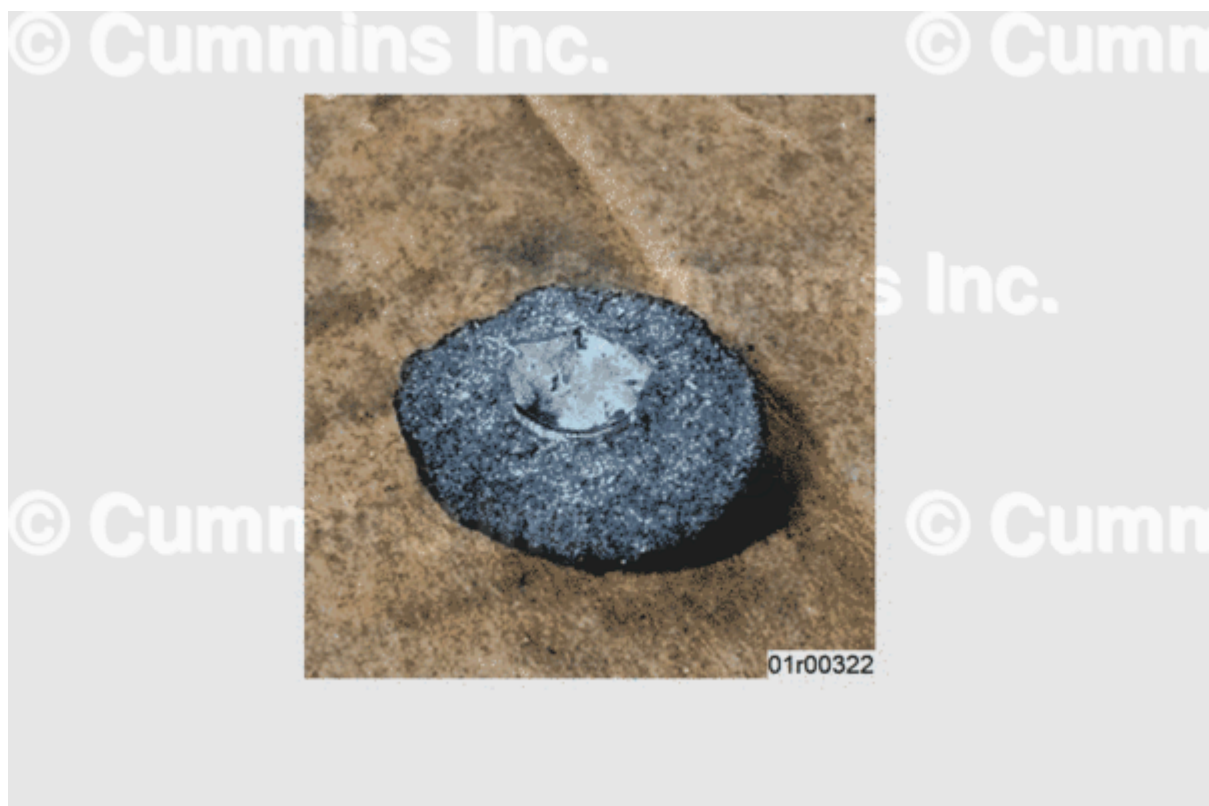
- Front gear cover cracking

Figure 2, Fractured Front Gear Cover Material.
