Technical Service Bulletin: TSB200004

New Idler Pulley and Secondary Tensioner with Dust Seals

- QSX15 CM570 (Excavator and driller application **only**)

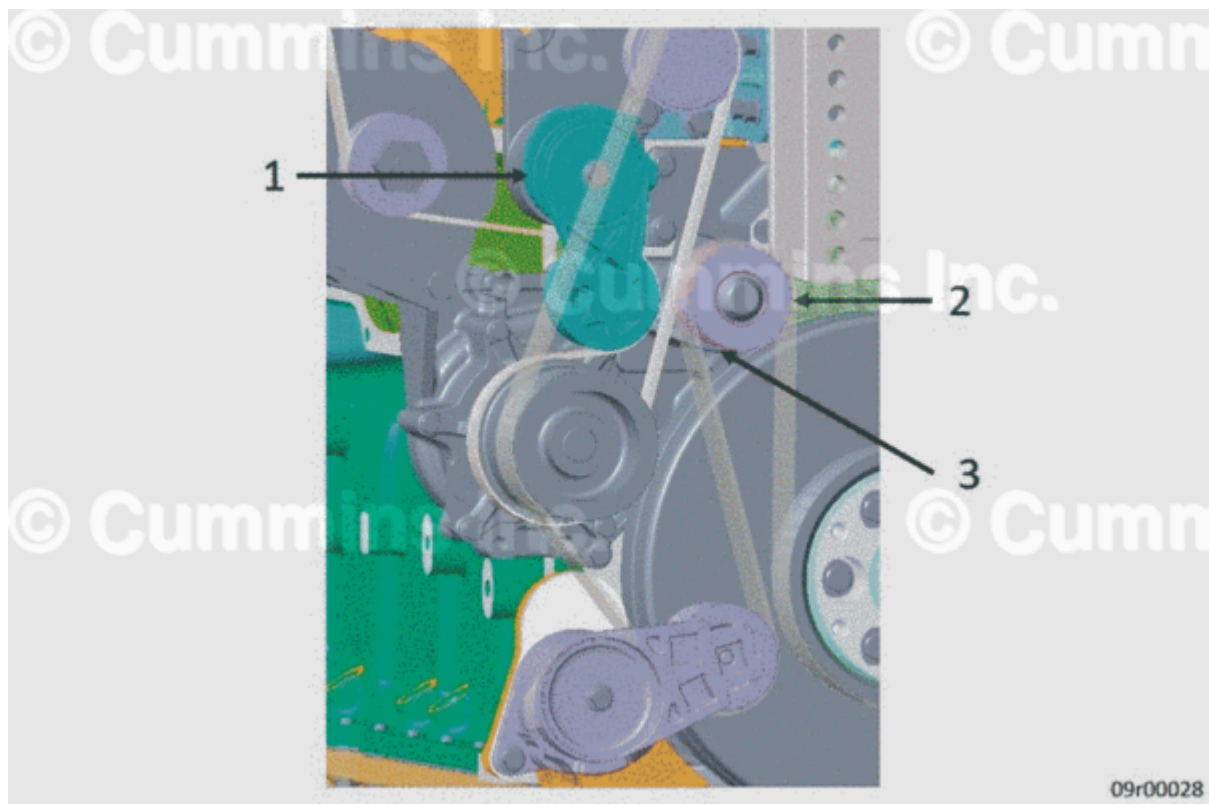
Figure 1, Drive Layout

1. Secondary Tensioner
2. Primary Idler Pulley
3. Pilot Adapter

1. Remove primary drive belt (Drive Belt, Water Pump). Refer to Procedure 008-003 (</qs3/pubsys2/xml/en/procedures/10/10-008-003.html>).
2. Remove secondary drive belt (Drive Belt, Refrigerant Compressor). Refer to Procedure 009-052 (</qs3/pubsys2/xml/en/procedures/10/10-009-052-tr.html>).
3. Remove primary idler pulley, part number 3681587, and pilot adapter, part number 3681715. See Figures 1 and 2. Refer to Procedure 008-062 (</qs3/pubsys2/xml/en/procedures/10/10-008-062-tr.html>).

4. Remove secondary tensioner, part number 3104027. See Figure 1. Refer to Procedure 009-053 (/qs3/pubsys2/xml/en/procedures/10/10-009-053-tr.html).
5. Install new pilot adapter, part number 5582573, and new idler pulley assembly, part number 5582393. Refer to Procedure 008-062 (/qs3/pubsys2/xml/en/procedures/10/10-008-062-tr.html).

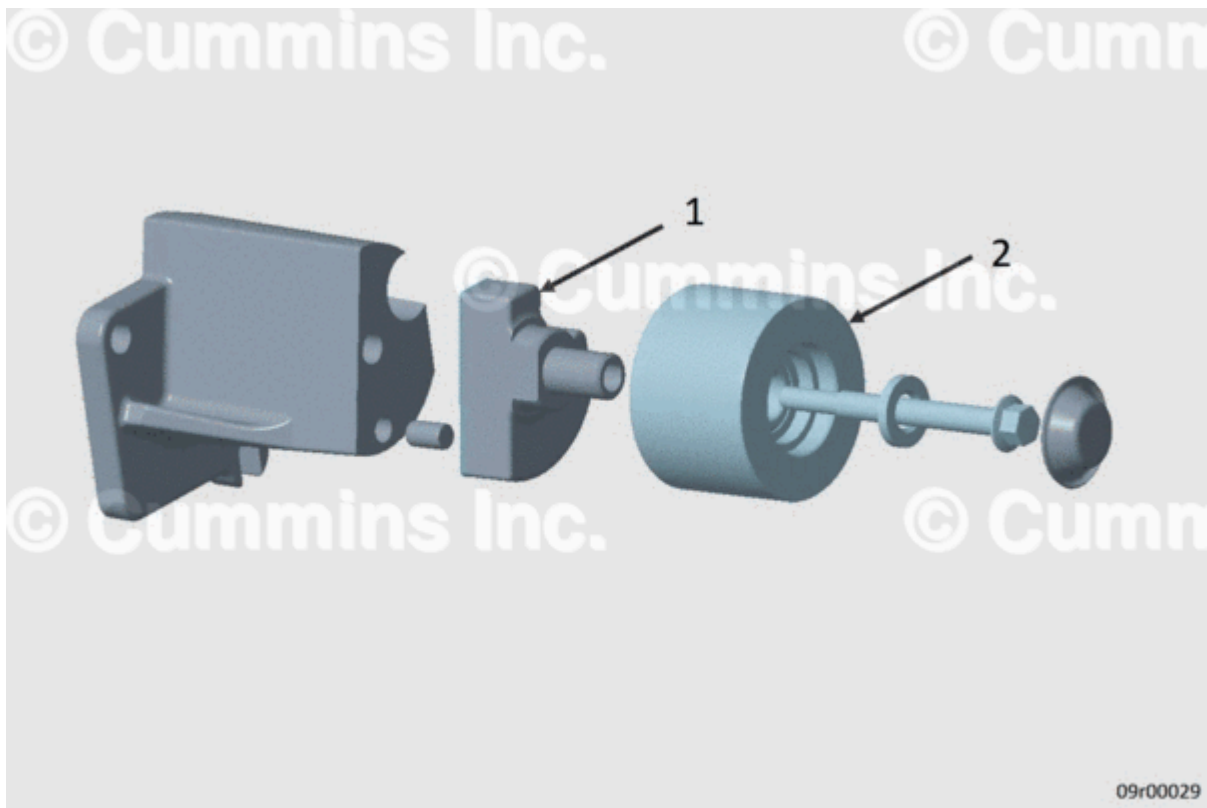
Figure 2, Existing Pilot Adapter and Idler Pulley Assembly

1. Pilot Adapter
2. Primary Idler Pulley
