Technical Service Bulletin: TSB200168

Engine Wiring Harness Routing

- QSK23 CM500

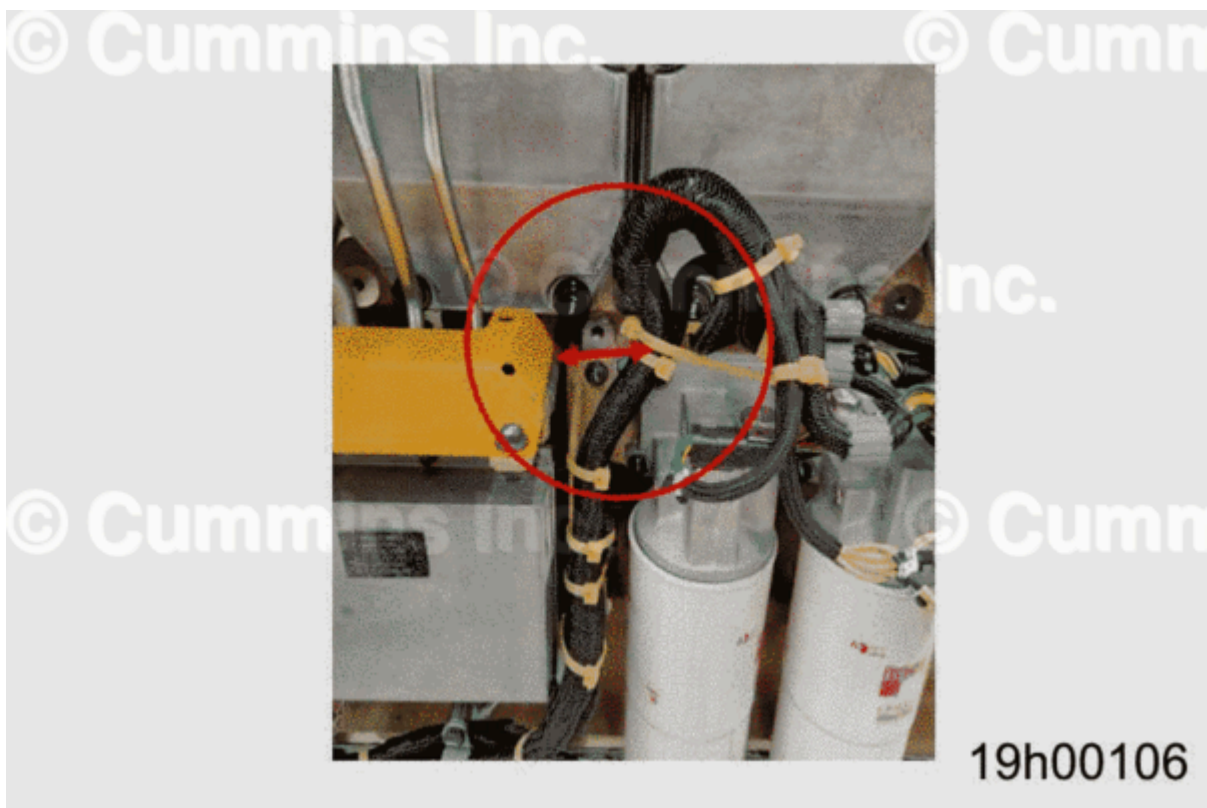
Engine wiring harness interference with the ECM cover plate.

- Engine wiring harness rubs through the ECM cover plate.

- Engine wiring harness routing not robust.

Figure 1, Wiring Harness Installed with Wire Ties

Add wire tie to hold the harness away from ECM cover plate to prevent interference. There should be a gap of at least 25 mm (1 in) between the cover plate and the wiring harness.

Wire tie the harness to prevent interference with the ECM cover plate.
