# Fault Code: 627

## Exhaust Gas Temperature Deviation Low for Cylinder 13 - Data Valid But Below Normal Operating Range - Least Severe Level

Exhaust Gas Temperature Sensor Circuit Cylinder 13 - QSK45 and QSK60 Engines

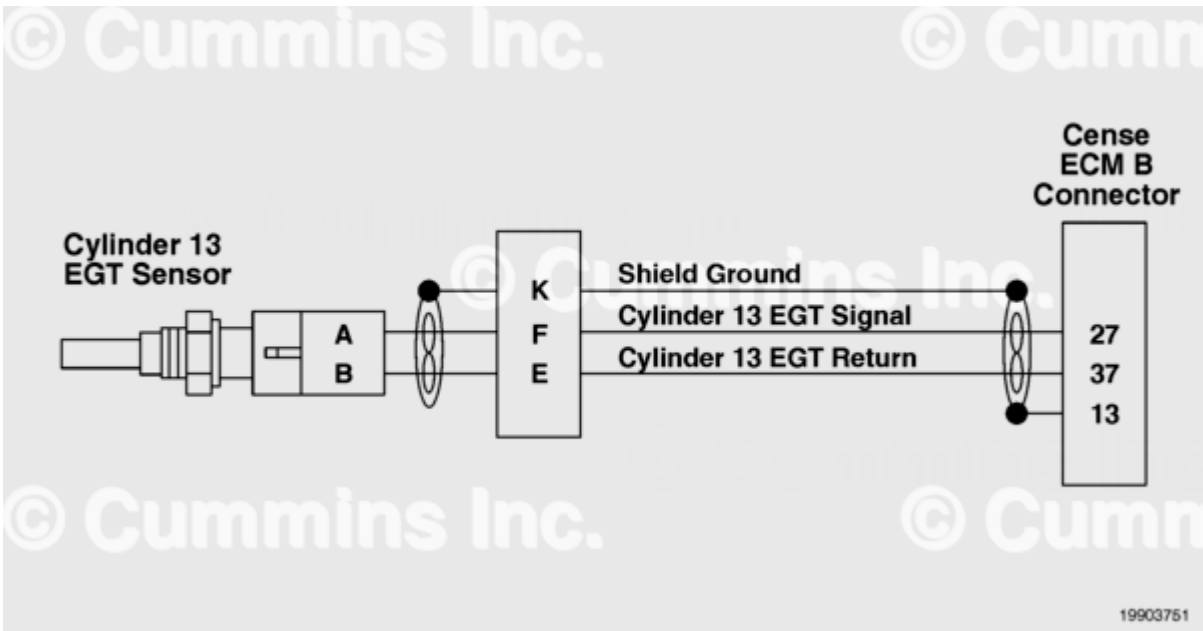
The exhaust gas temperature sensor circuit cylinder 13 monitors exhaust gas temperature and passes information to the engine control module (ECM) through the engine harness.

The exhaust gas temperature sensor circuit cylinder 13 is located in the engine harness and extends between the number 13 cylinder head and the ECM.

The exhaust gas temperature sensor circuit cylinder 13 measures the exhaust temperature of cylinder 13. The ECM monitors the temperature and compares it to the exhaust gas temperatures of other cylinders.

It is possible that the exhaust gas temperature sensor 5 volt supply can be open and a fault will **not** be set. If this happens, the temperature of the exhaust gas temperature sensor will read 474°C [885°F] for the entire bank of sensors connected to that exhaust gas temperature sensor convertor. See the Engine Performance Troubleshooting Tree in Section TT of the QSK45 and QSK60 Service Manual, Bulletin 4021530, to troubleshoot this condition.

Possible causes of this fault include:

- Restricted aftercooler.
- Cylinder, valve, ring, or piston damage.
- Injector damage.

Refer to Troubleshooting Fault Code t05-627. (/qs3/pubsys2/xml/en/procedures/81/81-t05-627.html)
